ARBORICULTURAL IMPACT ASSESSMENT FOR DEVELOPMENT.

**31 Ferncroft Avenue,
London,
NW3 7PG**

In accordance with BS5837:2012

Date: 20th February 2020; Rev: 2 6th April 2023

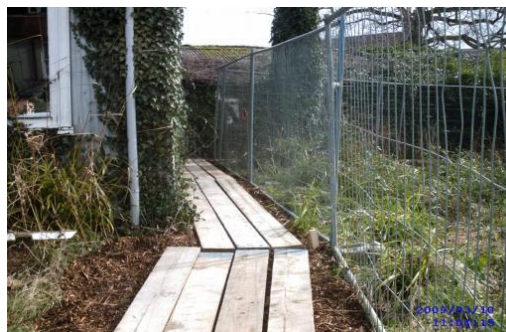
- a) *For pedestrian movements, a single thickness of scaffold boards over a raised scaffold frame so as to form a suspended walkway, or on top of a compression resistant layer such as woodchip to a depth of 100mm laid onto a geotextile membrane.*

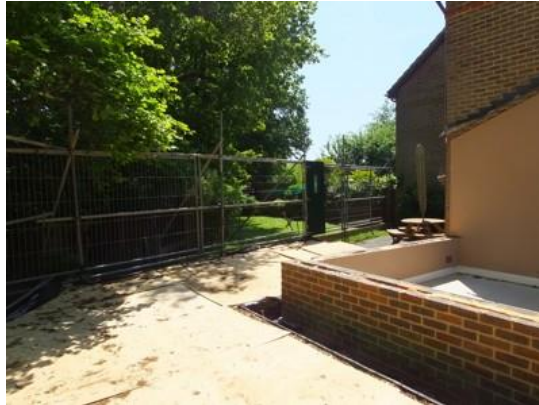
- b) *For pedestrian operated plant, up to 2 t, proprietary, interlinked ground protection boards, placed on top of a compressive resistant layer (i.e. woodchip at 150mm*

depth) laid onto a geotextile membrane.

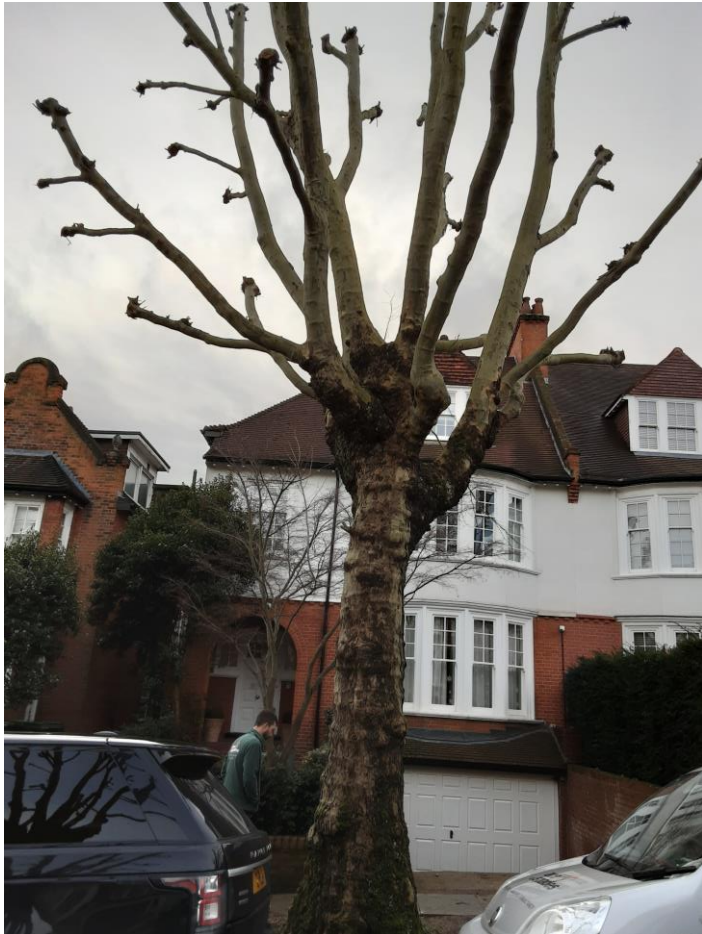
T001 is a mature London Plane situated within the roadside pavement area. At the time of the survey it had been re-pollarded leaving only a skeleton of the crown scaffold.

Photo 1: T001 – London Plane

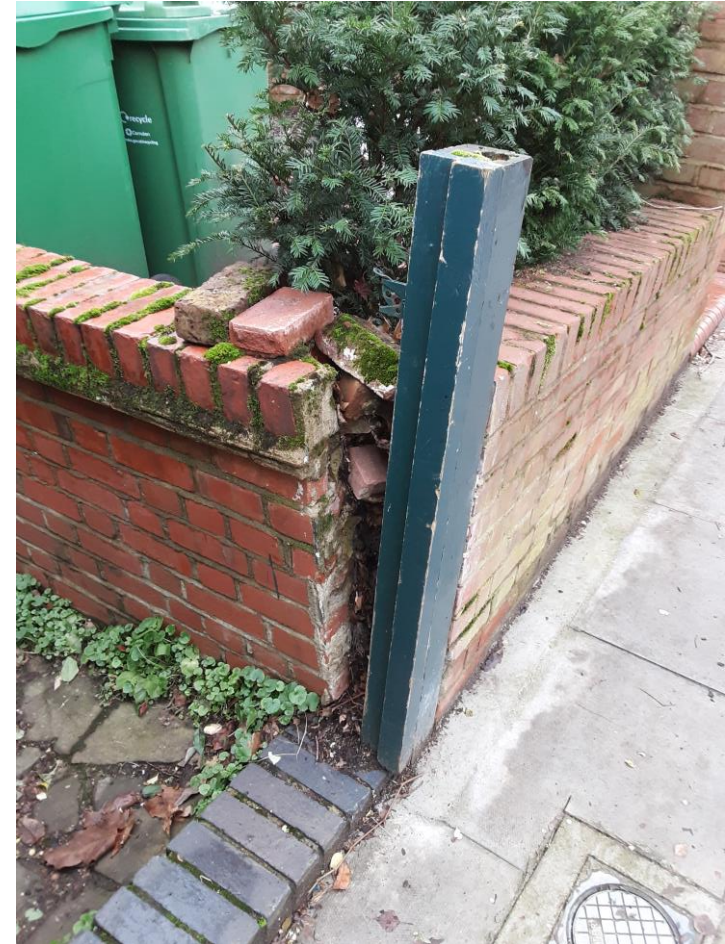
The trees roots are impacting upon the surrounding structures, the dwarf wall of the property which is approximately 600mm from the tree is showing evidence of cracking at its corner (see **Appendix 6 – Photo 5**), one of the gate pillars is leaning towards the road (see **Appendix 6 – Photo 3**) and the neighbouring gate post and wall corner are also leaning (see **Appendix 6 – Photo 2**).

Photo 2: Damage to neighbours gate post and wall

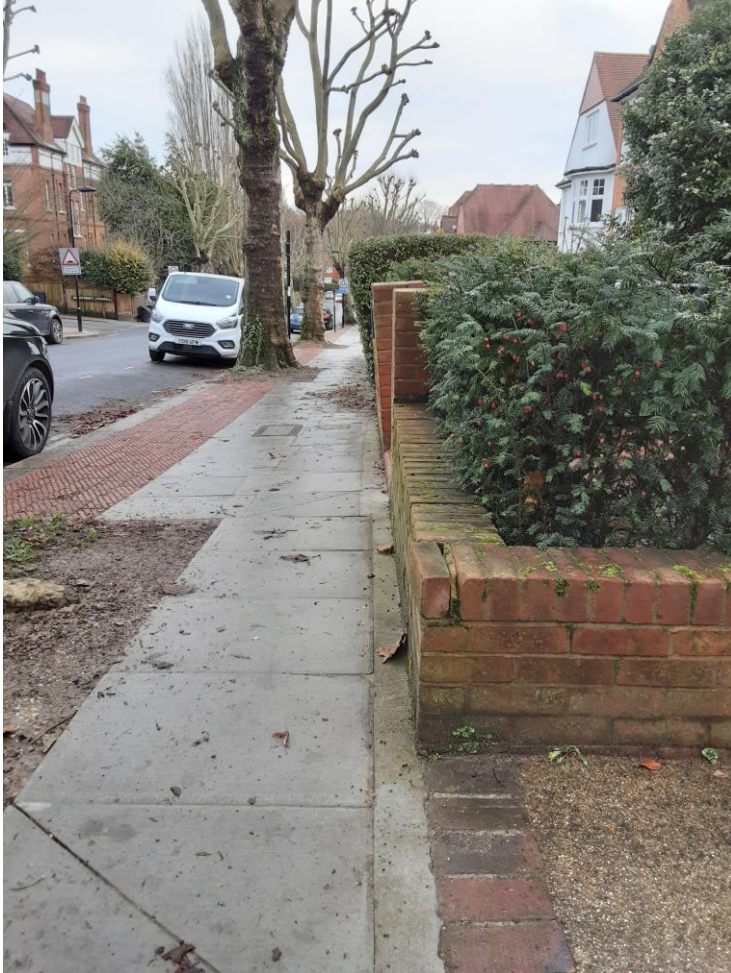
Photo 3: Brick pillar leaning towards pavement

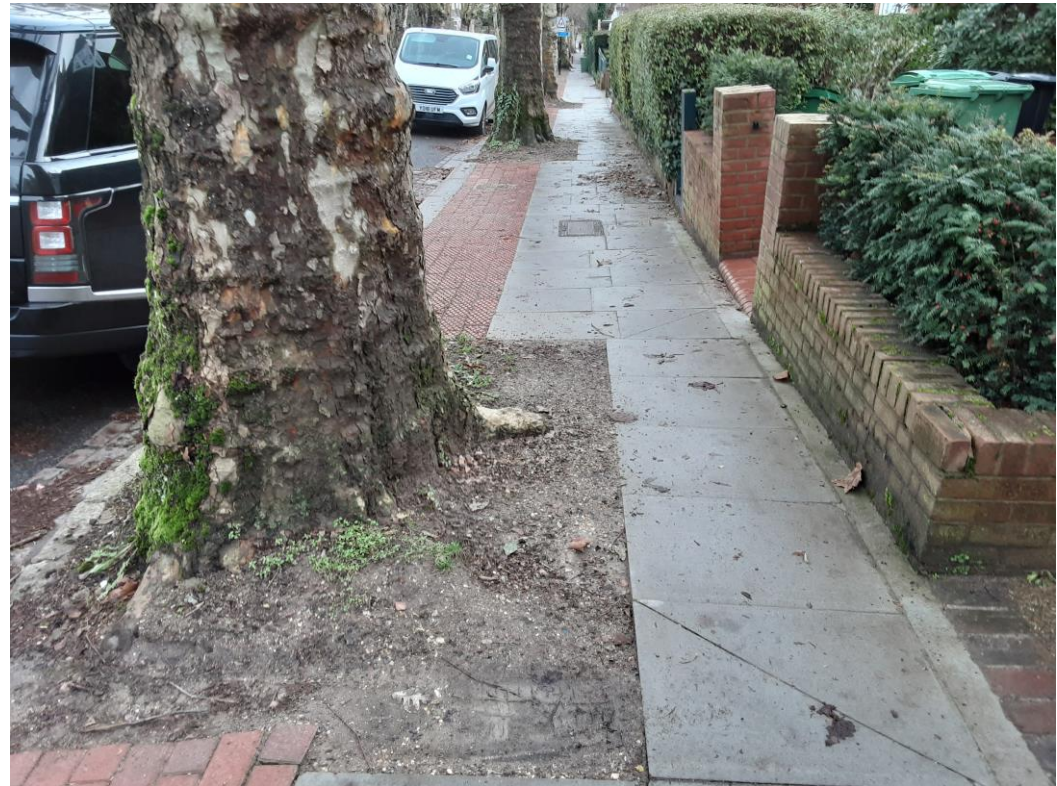
Photo 4: Damage to wall corner and brick pillar in relation to tree

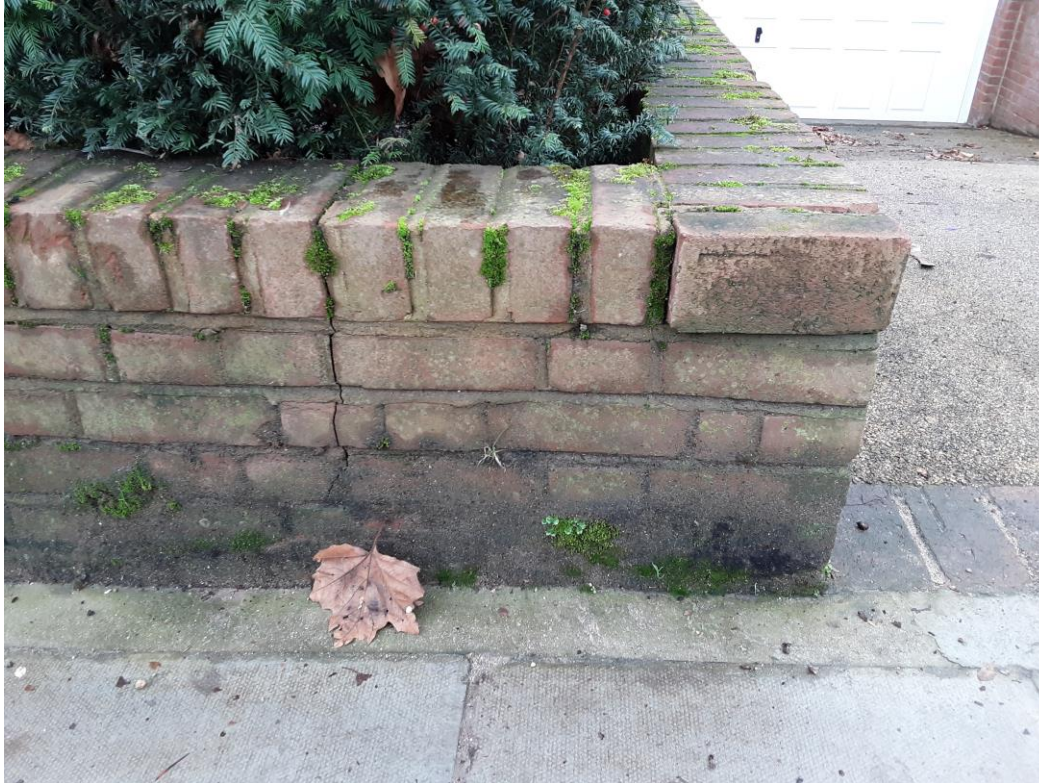
Photo 5: Cracking of wall corner

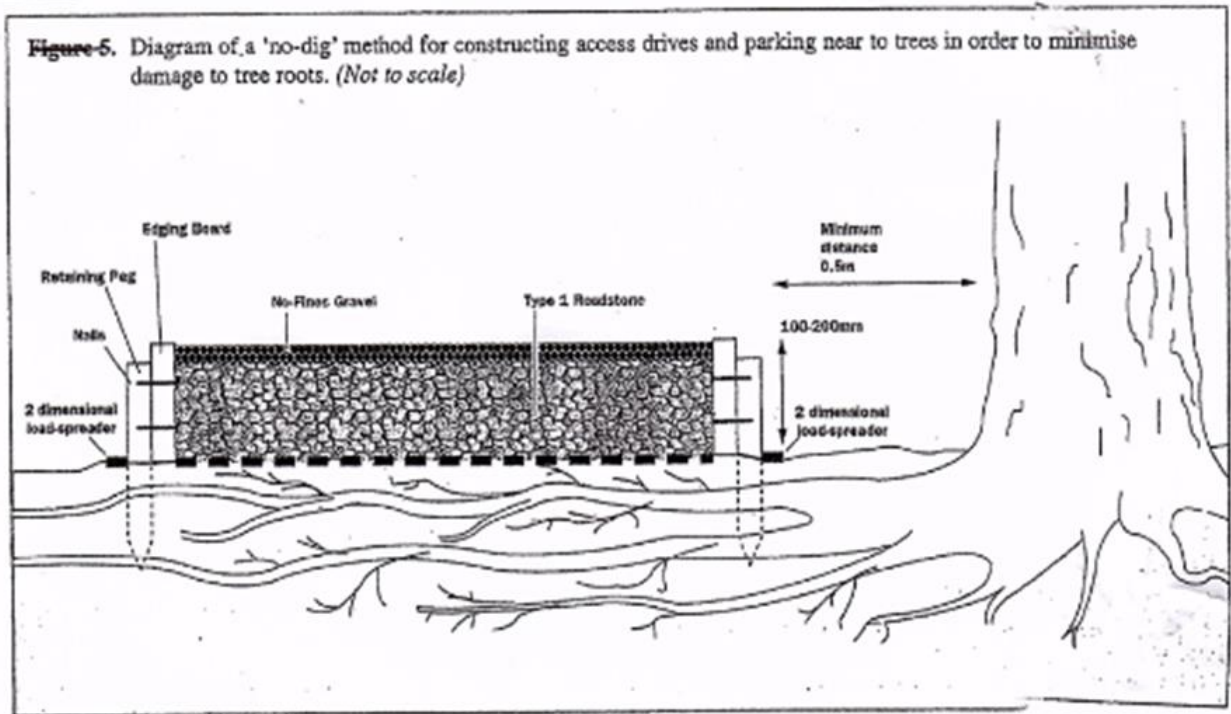
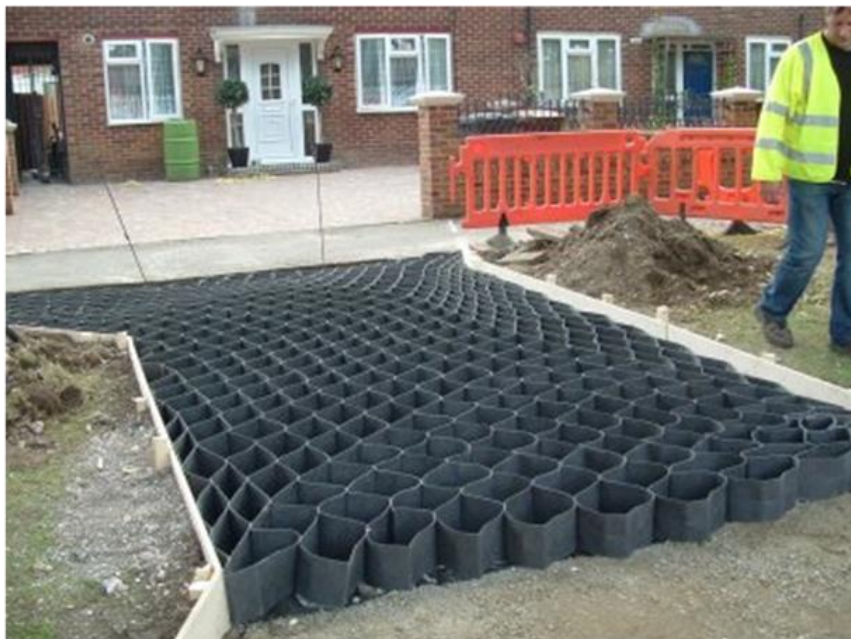
Appendix 7:No dig driveway close to tree roots

Therefore, roots must have oxygen for survival and large pore spaces within the soil which means better aeration. A no dig construction of the driveway with the use of a cellular confinement system that contains aggregate materials and makes them stronger and allows the depth of surface construction to be reduced. This sits over a geotextile layers at the subbase soil layer.

The hard surface shall be tolerant to root deformation and shall be set back from the tree stems by 500mm to allow for growth and movement. Gaps will be infilled with inert material. The use of a cellular confinement system as below is recommended.

- Geotextile layer installed between layers allowing water to pass through but stops different materials mixing. The base level geotextile shall be of a standard to prevent contaminant leakages.
- Load bearing 3 dimensional cellular systems to spread the weight and support over soft grounds. The load bearing specification of the cellular system shall be for light vehicle standards.
- Edge containment such as peg boards or sleepers to prevent the structure creeping.
- No fines granular subbase.
