#### Monitoring Details:

Provider Name: CET

Client: Sedgwick

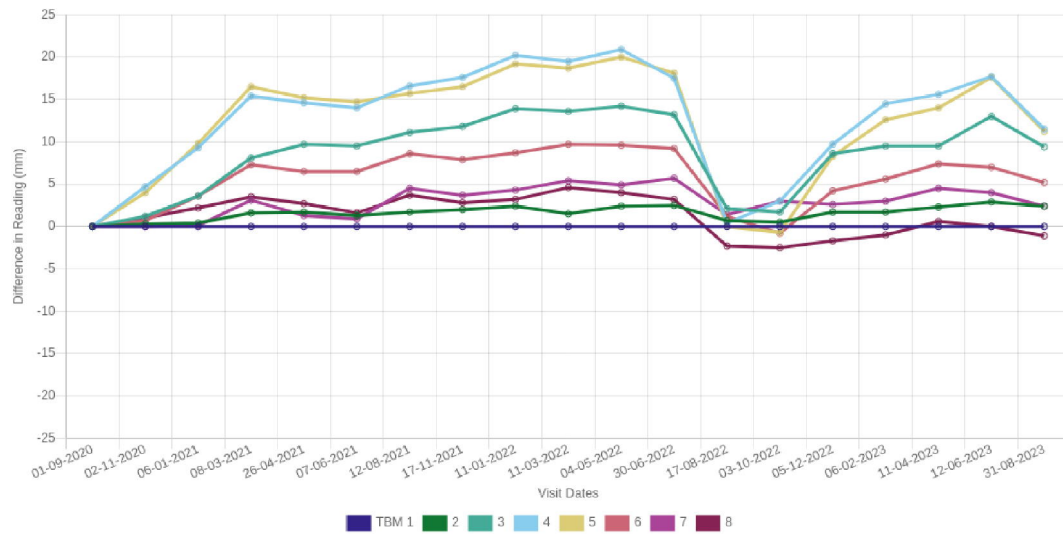
Level Readings Chart (Points TBM 1 - 8)

## Level Movement (Displayed in Millimeters)

| | Visit 1 | Visit 2 | Visit 3 | Visit 4 | Visit 5 | Visit 6 | Visit 7 | Visit 8 | Visit 9 | Visit 10 |
|---|---|---|---|---|---|---|---|---|---|---|
| 2 | 0 | +0.3 | +0.4 | +1.6 | +1.7 | +1.3 | +1.7 | +2 | +2.4 | +1.5 |
| 3 | 0 | +1.2 | +3.6 | +8.1 | +9.7 | +9.5 | +11.1 | +11.8 | +13.9 | +13.6 |
| 4 | 0 | +4.7 | +9.3 | +15.4 | +14.6 | +14 | +16.6 | +17.6 | +20.2 | +19.5 |
| 5 | 0 | +4 | +9.8 | +16.5 | +15.2 | +14.7 | +15.7 | +16.5 | +19.2 | +18.7 |
| 6 | 0 | +0.7 | +3.6 | +7.3 | +6.5 | +6.5 | +8.6 | +7.9 | +8.7 | +9.7 |
| 7 | 0 | 0 | +0.1 | +3.1 | +1.3 | +0.9 | +4.5 | +3.7 | +4.3 | +5.4 |
| 8 | 0 | +1 | +2.2 | +3.5 | +2.7 | +1.6 | +3.7 | +2.8 | +3.2 | +4.6 |

| | Visit 11 | Visit 12 | Visit 13 | Visit 14 | Visit 15 | Visit 16 | Visit 17 | Visit 18 | Visit 19 | Visit 20 |
|---|---|---|---|---|---|---|---|---|---|---|
| 3 | +14.2 | +13.2 | +2.1 | +1.7 | +8.6 | +9.5 | +9.5 | +13 | +9.4 | |
| 4 | +20.9 | +17.5 | +0.4 | +3 | +9.7 | +14.5 | +15.6 | +17.7 | +11.5 | |
| 5 | +20 | +18.1 | 0 | -0.7 | +8.3 | +12.6 | +14 | +17.6 | +11.2 | |

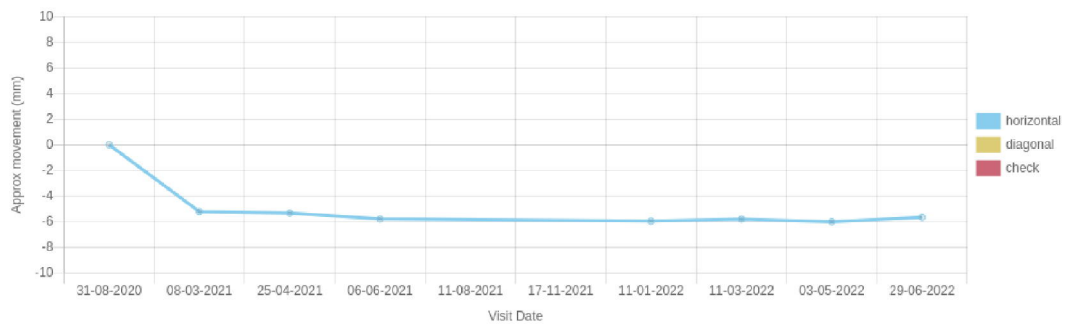
EXT RH side of steps to main building

EXT RH side of steps to main building - Crack Readings Differences (Displayed in Millimetres)

| | Visit 1 | Visit 2 | Visit 3 | Visit 4 | Visit 5 | Visit 6 | Visit 7 | Visit 8 | Visit 9 | Visit 10 |
|---|---|---|---|---|---|---|---|---|---|---|
| H | 0 | -5.21 | -5.33 | -5.79 | | | -5.95 | -5.8 | -6 | -5.66 |

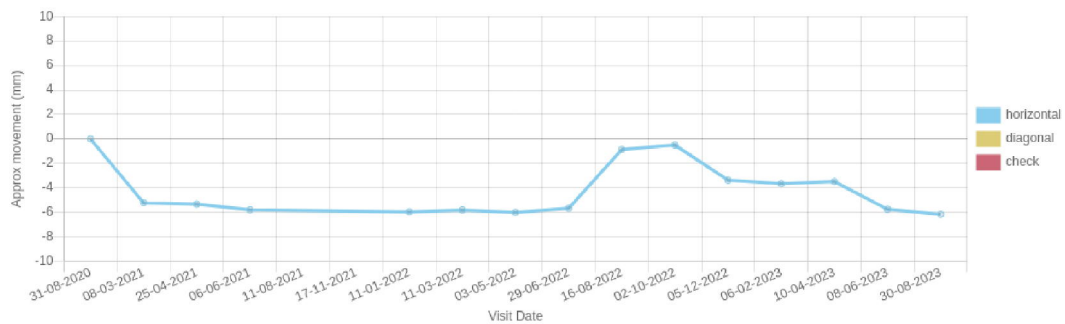
EXT RH side of steps to main building

EXT RH side of steps to main building - Crack Readings Differences (Displayed in Millimetres)

| | Visit 11 | Visit 12 | Visit 13 | Visit 14 | Visit 15 | Visit 16 | Visit 17 | Visit 18 | Visit 19 | Visit 20 |
|---|---|---|---|---|---|---|---|---|---|---|
| H | -0.85 | -0.5 | -3.37 | -3.65 | -3.48 | -5.74 | -6.15 | | | |

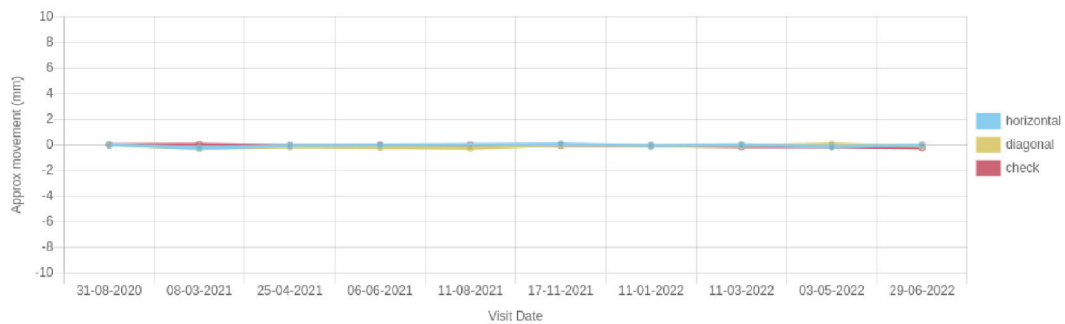
EXT LH side of steps above sotrage shed

EXT LH side of steps above sotrage shed - Crack Readings Differences (Displayed in Millimetres)

| | Visit 1 | Visit 2 | Visit 3 | Visit 4 | Visit 5 | Visit 6 | Visit 7 | Visit 8 | Visit 9 | Visit 10 |
|---|---|---|---|---|---|---|---|---|---|---|
| H | 0 | -0.25 | -0.06 | -0.01 | | 0.05 | -0.06 | 0 | -0.14 | -0.01 |
| D | 0 | -0.28 | -0.15 | -0.2 | -0.26 | -0.02 | -0.1 | -0.05 | 0.04 | -0.09 |
| C | 0 | 0.02 | -0.05 | -0.05 | -0.03 | -0.05 | -0.07 | -0.14 | -0.13 | -0.23 |

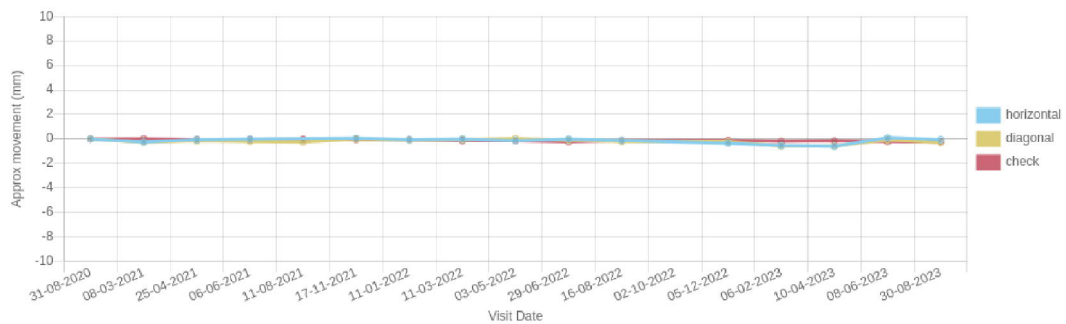
EXT LH side of steps above sotrage shed

EXT LH side of steps above sotrage shed - Crack Readings Differences (Displayed in Millimetres)

| | Visit 11 | Visit 12 | Visit 13 | Visit 14 | Visit 15 | Visit 16 | Visit 17 | Visit 18 | Visit 19 | Visit 20 |
|---|---|---|---|---|---|---|---|---|---|---|
| H | -0.11 | | -0.35 | -0.53 | -0.6 | 0.09 | -0.05 | | | |
| D | -0.21 | | -0.22 | -0.58 | -0.57 | -0.08 | -0.29 | | | |
| C | -0.12 | | -0.12 | -0.19 | -0.15 | -0.21 | -0.24 | | | |

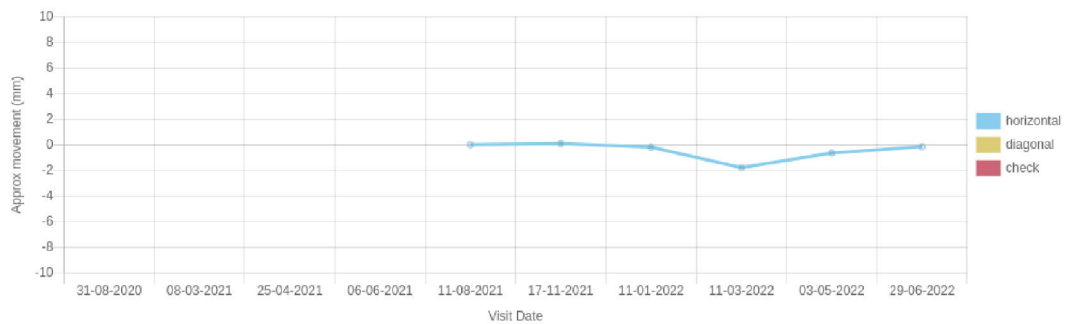
EXT :LH side steps to porch REFIT

EXT :LH side steps to porch REFIT - Crack Readings Differences (Displayed in Millimetres)

| | Visit 1 | Visit 2 | Visit 3 | Visit 4 | Visit 5 | Visit 6 | Visit 7 | Visit 8 | Visit 9 | Visit 10 |
|---|---|---|---|---|---|---|---|---|---|---|
| H | | | | | 0 | 0.09 | -0.19 | -1.79 | -0.64 | -0.15 |

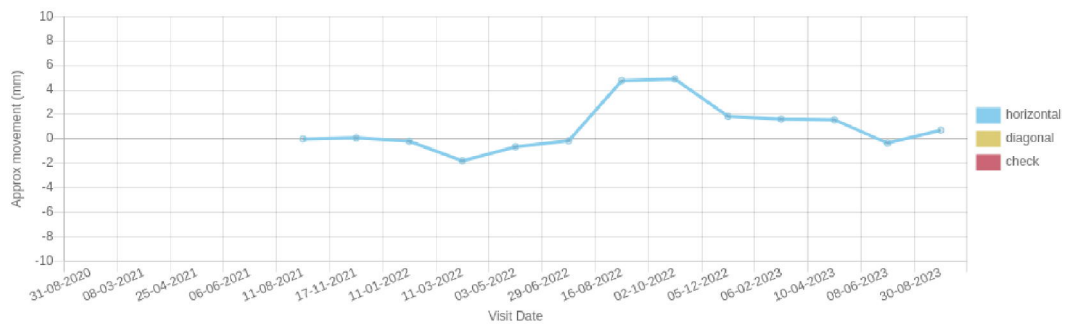
EXT :LH side steps to porch REFIT

EXT :LH side steps to porch REFIT - Crack Readings Differences (Displayed in Millimetres)

| | Visit 11 | Visit 12 | Visit 13 | Visit 14 | Visit 15 | Visit 16 | Visit 17 | Visit 18 | Visit 19 | Visit 20 |
|---|---|---|---|---|---|---|---|---|---|---|
| H | 4.77 | 4.89 | 1.85 | 1.62 | 1.56 | -0.34 | 0.71 | | | |

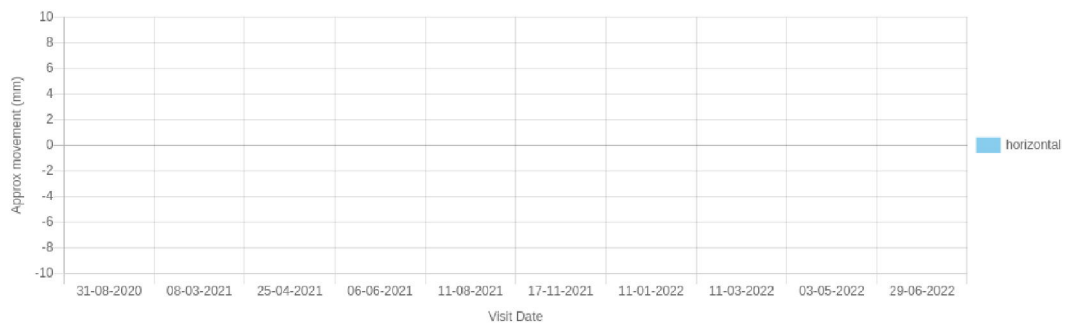
EXT RH side stairs to porch REFIT - Oldest photo

EXT RH side stairs to porch REFIT - Crack Readings Differences (Displayed in Millimetres)

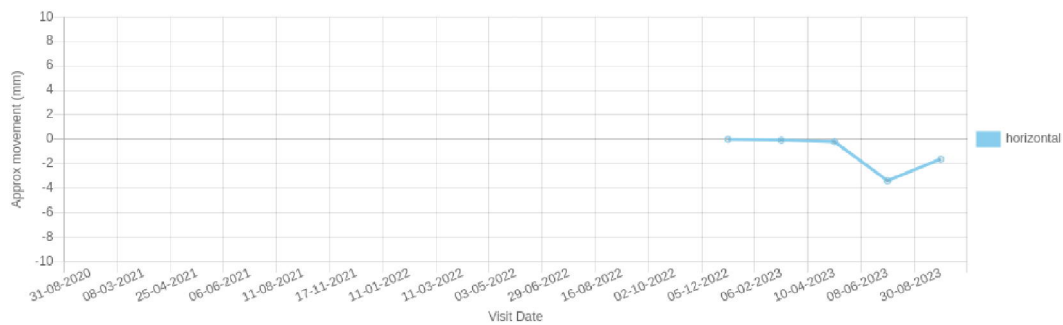
EXT RH side stairs to porch REFIT

EXT RH side stairs to porch REFIT - Crack Readings Differences (Displayed in Millimetres)

| | Visit 11 | Visit 12 | Visit 13 | Visit 14 | Visit 15 | Visit 16 | Visit 17 | Visit 18 | Visit 19 | Visit 20 |
|---|---|---|---|---|---|---|---|---|---|---|
| H | | | 0 | -0.06 | -0.18 | -3.38 | -1.62 | | | |
