Project:
KEATS COMM. LIBRARY
10 KEATS GROVE
LONDON NW3 2RR

Drawing:
BASEMENT & GRD FLR
EXISTING CCTV SYSTEM
LAYOUT

Drawing No: COL/KL/68/01

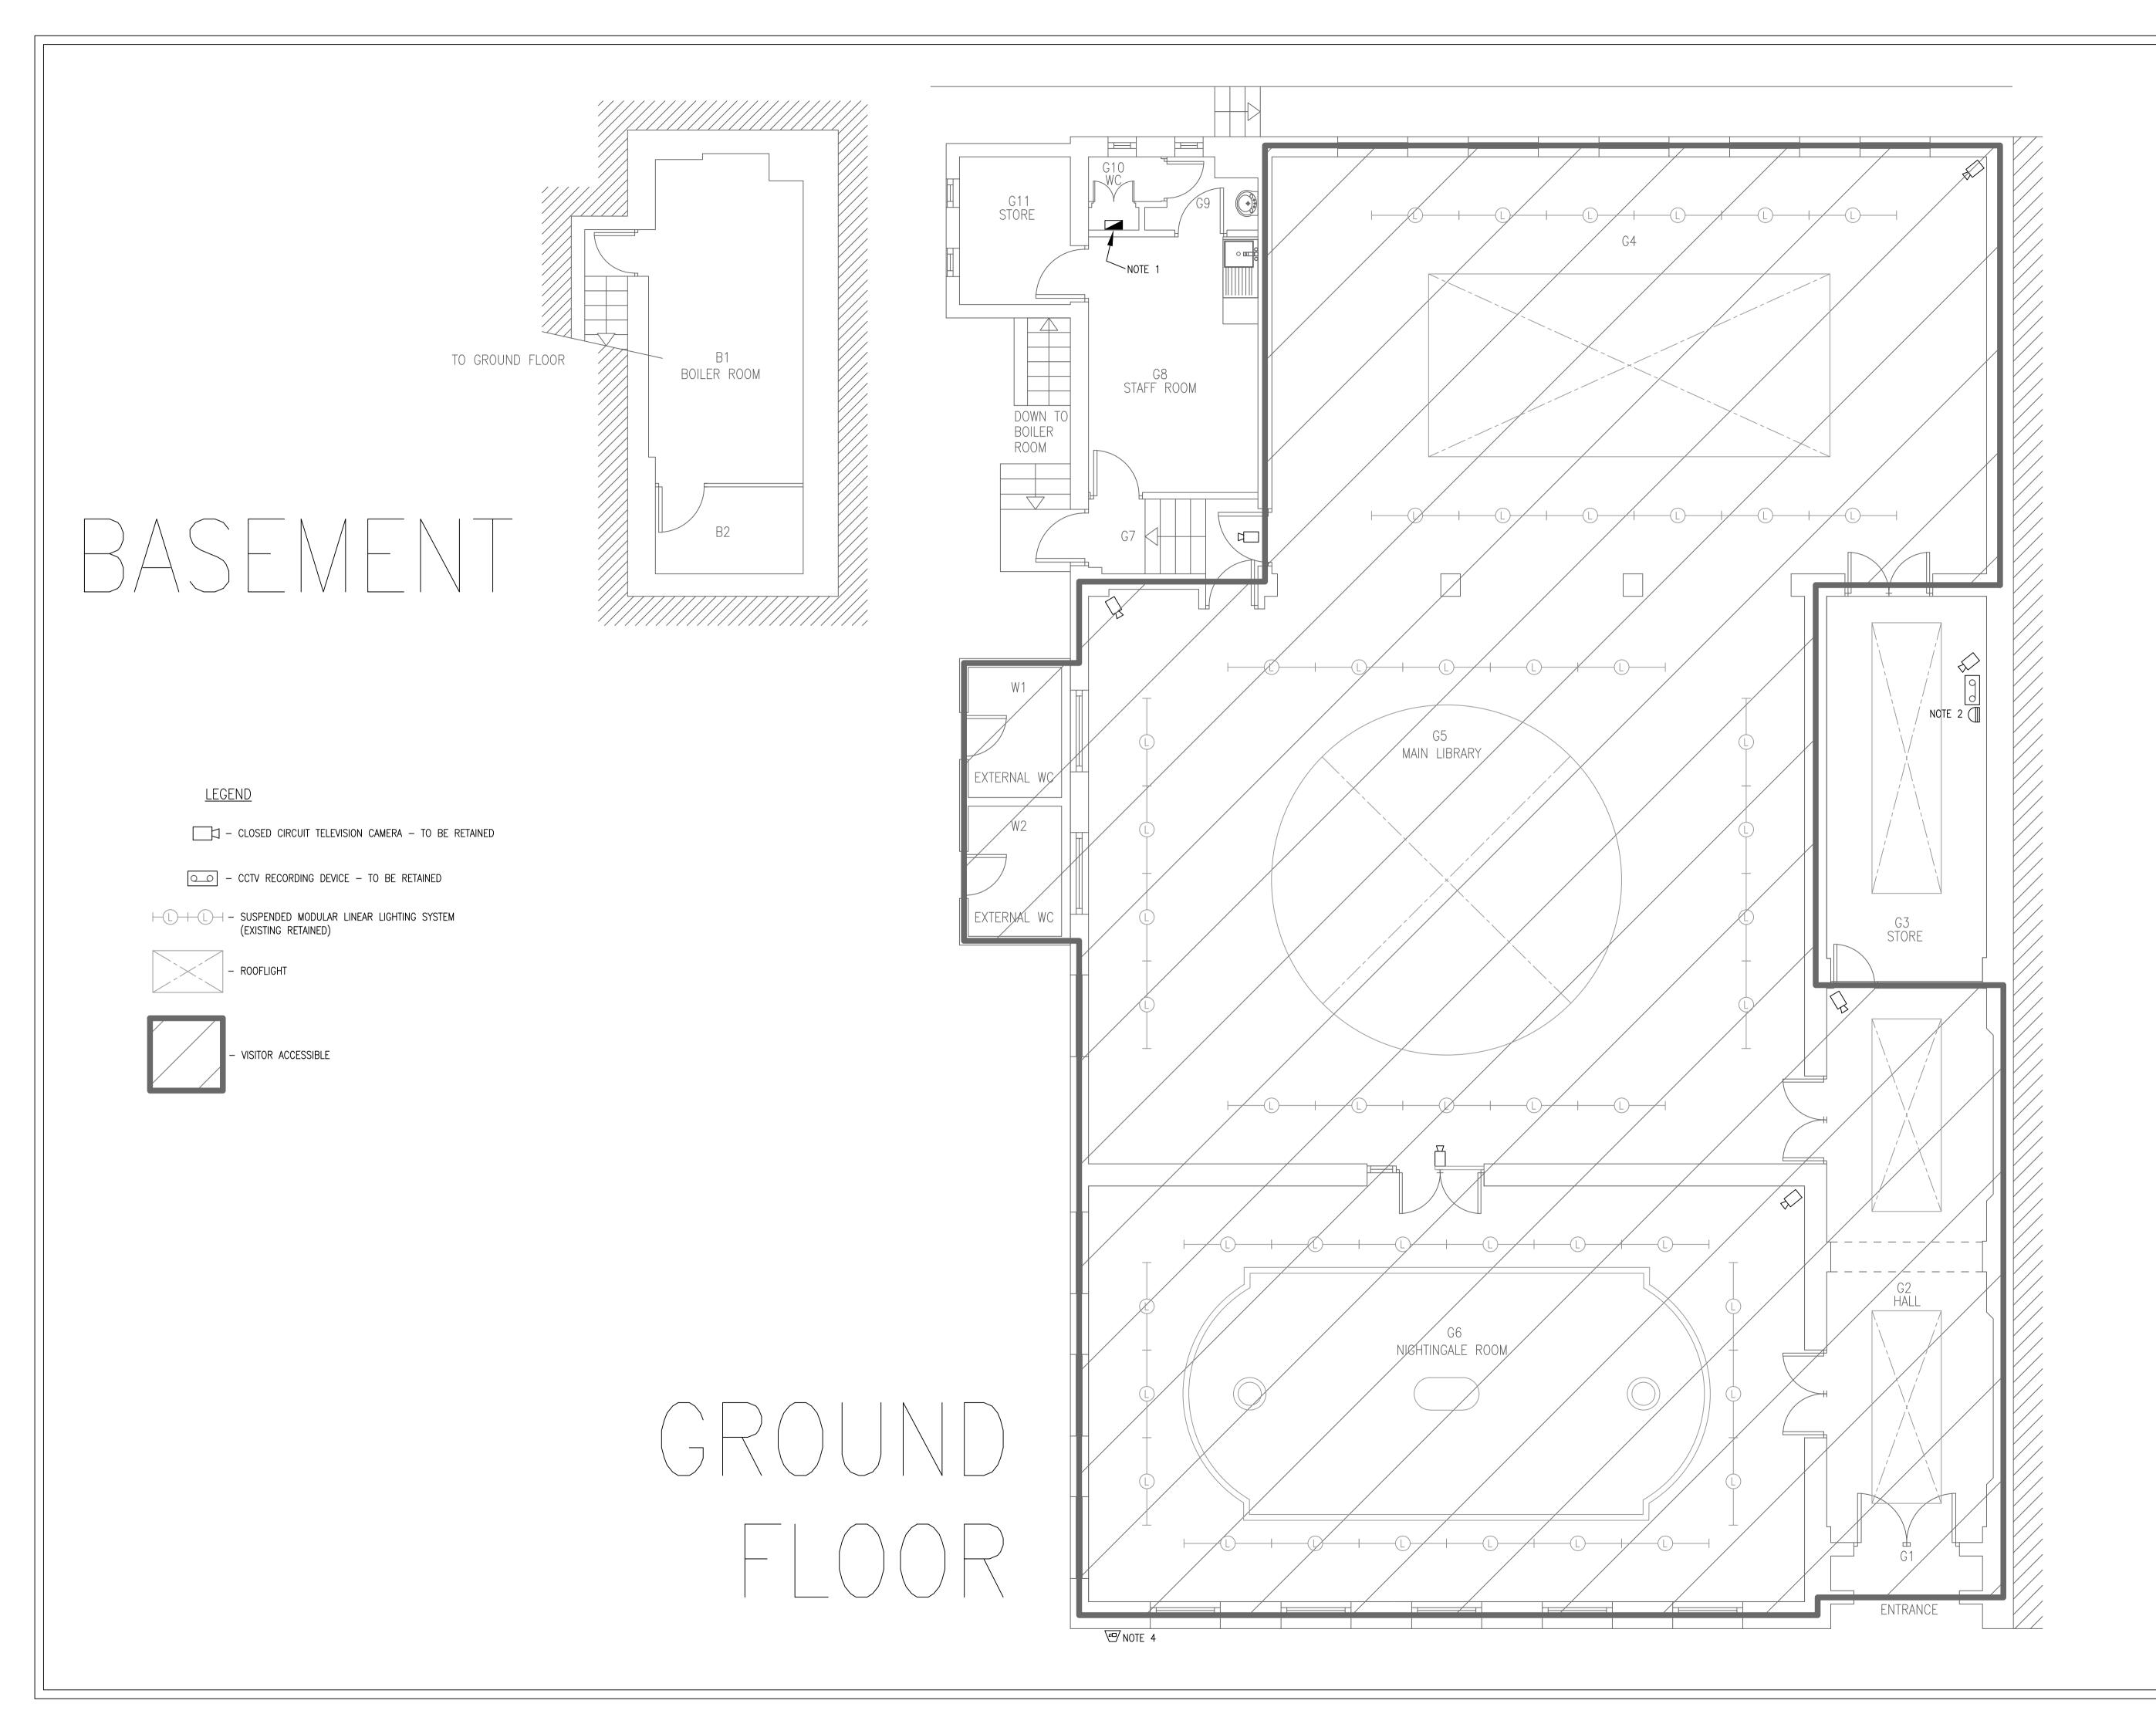
1. LOCATION OF DNO SERVICE HEAD & METER ALONG WITH THE LIBRARIES DISTRIBUTION BOARD.

2. AN EXISTING NON-FUSED CONNECTION UNIT IS IN-SITU TO SUPPLY THE CCTV SYSTEM. HOWEVER, IT IS UNKNOWN WHAT TYPE OF CABLE HAS BEEN UTILISED AND HOW IT IS SUPPLIED FROM THE LIBRARIES DISTRIBUTION BOARD.

THE CONTRACTOR SHALL INVESTIGATE AND IF FOUND TO BE UNSUITABLE A NEW CABLE IS TO BE INSTALLED AND THE CIRCUIT IS TO BE DEDICATED TO THE CCTV SYSTEM ONLY.

- 3. NO INTRUDER ALARM SYSTEM EXISTS.
- 4. INTRUDER ALARM SIREN (NON-FUNCTIONING DETERRENT) TO BE REMOVED.
- 5. THE CCTV SYSTEM IS TO BE RETAINED WITH NO NEW WORKS TO BE UNDERTAKEN.
- 6. WHERE PRACTICAL AND IT DOES NOT IMPAIR ITS OPERATION, ALL NEW & EXISTING DEVICES/EQUIPMENT (INCLUDING THE LIGHTINGS 'KLICK' CEILING ROSES) ARE TO BE PAINTED (EVENLY & WITHOUT RUNS) SO AS TO MATCH THE SURROUNDING WALL/CEILING SURFACE TO WHICH IT IS FIXED.
- 7. ALL REDUNDANT CABLING IS TO BE REMOVED AND ANY SURFACES MADE GOOD.
