Design and Access Statement

In support of Planning and Listed Building Application
Reference: PP-12081803, submitted to Camden Council on 9th April 2023

Address: 63A, Arlington Road London NW1 7ES

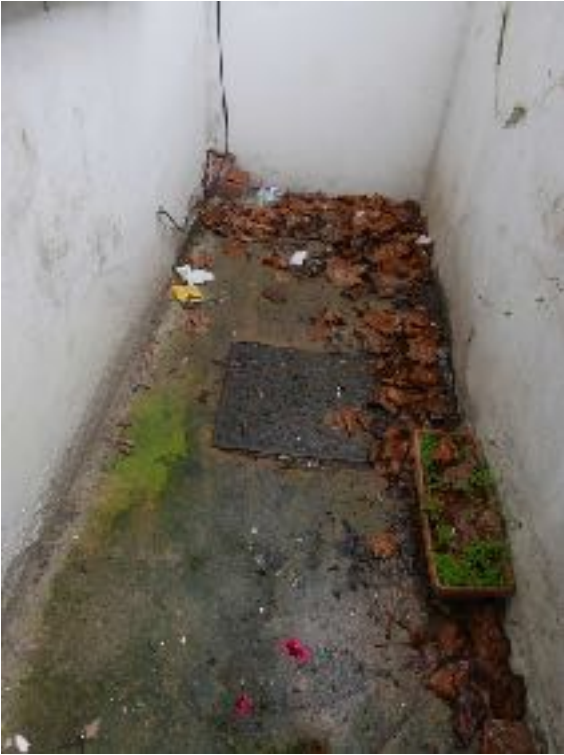
PHOTO 1: Front “Sunken “ area showing the damp in the external wall.

It is proposed to remove the existing wooden skirting and plaster on the walls to the basement area, as shown hatched in pink, on drawing no. JGPS/ARL/63/100. All the skirting to be carefully set aside for reinstatement.

External render from basement to ground floor level to be removed on the front elevation and affected areas to be made good, including the parapet to the window.

All the walls, externally and internally will be inserted with approved proprietary chemical damp proof courses. The specialist contractor to provide certified evidence for inspection and approval by the conservation officer.

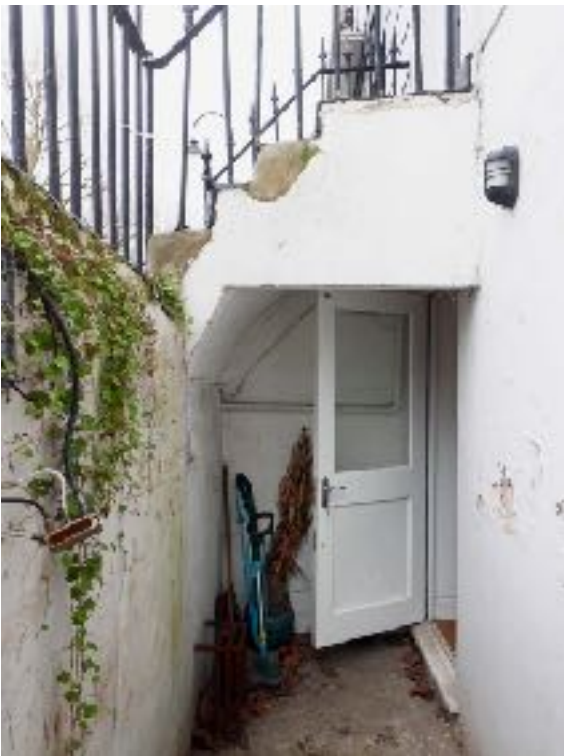
PHOTO 2: Front external area with access door, showing damp wall on the external elevation.

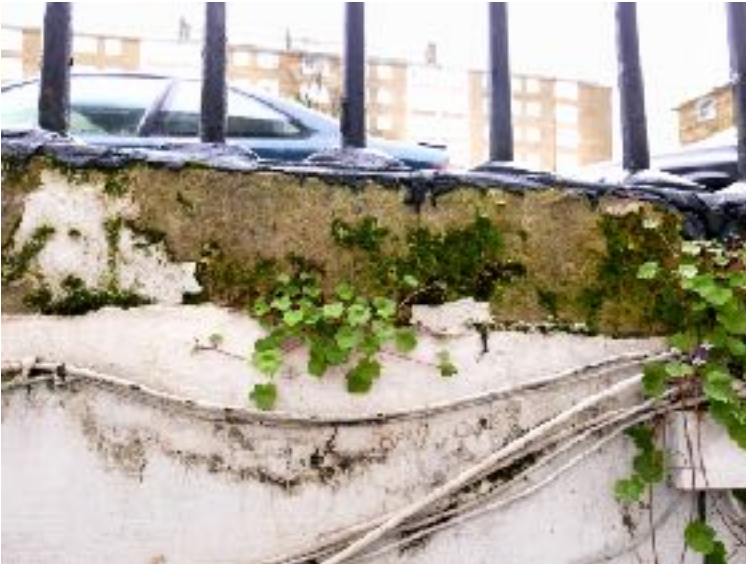
PHOTO 3: Damp retaining wall to the sunken area, resulting in cracked and crumbling fabric.

Wherever works will need to be redressed, removed, if necessary and replaced with heritage approved materials, such as render, replacement of bricks, mortar joints, broken flanking, to be repointed as such. Joinery, timber skirting to be reinstated and damaged areas to be replaced like for like to the approval of the conservation officer.

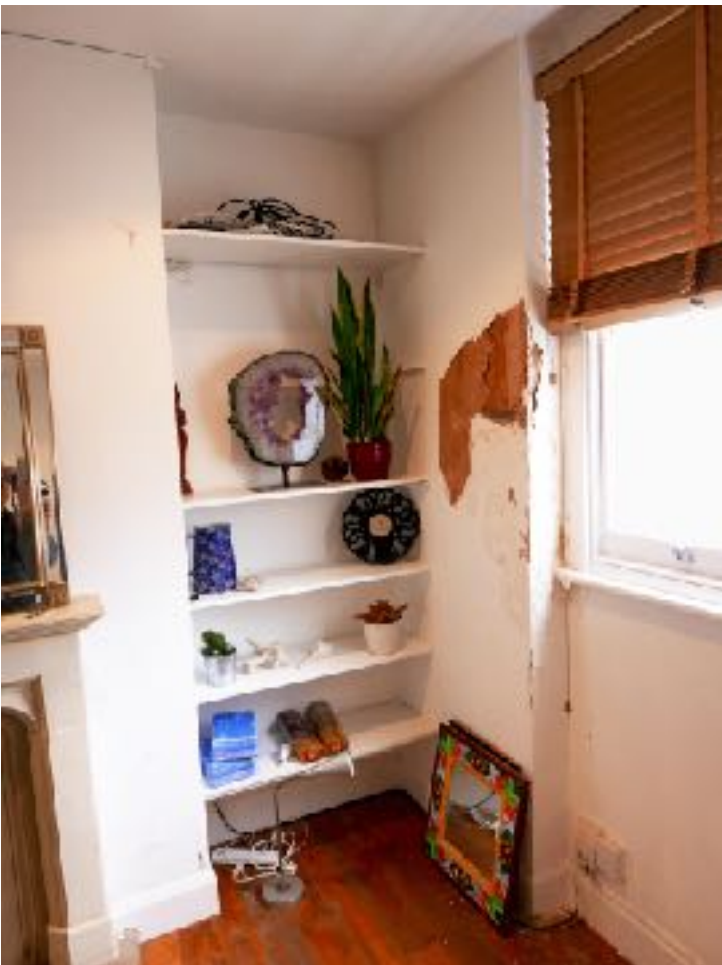
PHOTO 4: Damp and cracking fabric in the "Lounge" area. (External Wall).

Internally, all affected areas of the walls to be made good and prepared to receive render with waterproof lime based plaster. (renovation with silicon injection)

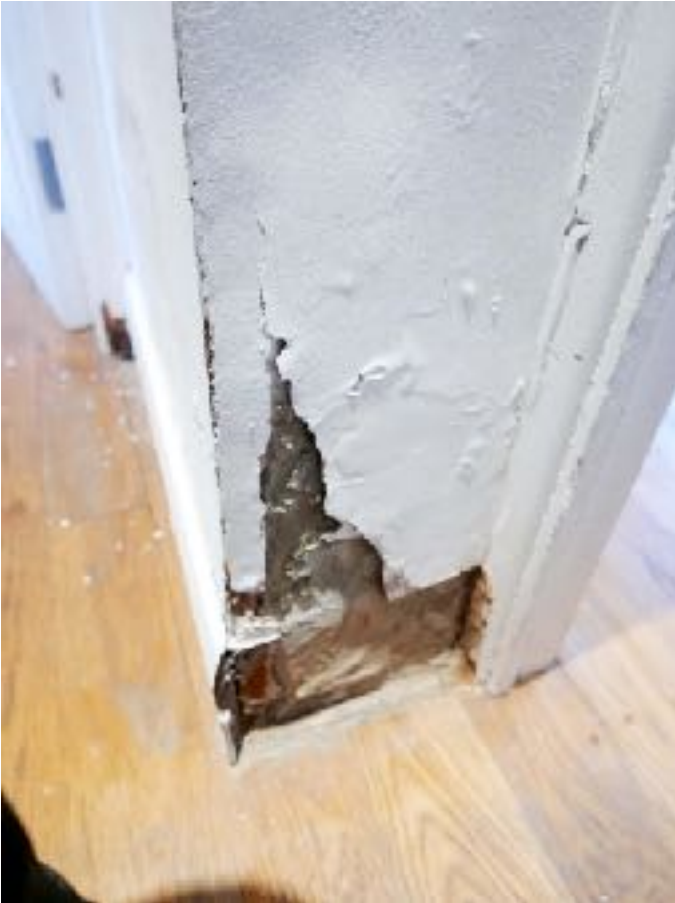
PHOTO 5: Dividing Wall between lounge and kitchen showing damp wall and cracking/peeling fabric.

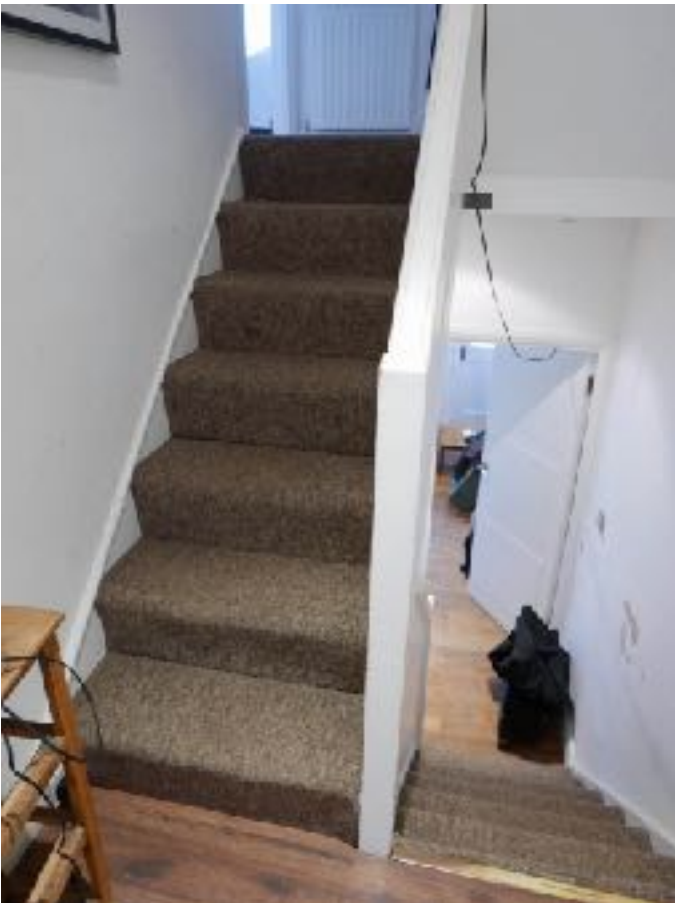
PHOTO 5: Damp and cracking fabric in party wall along the stair from basement to mezzanine level.
