DWG #	REV	CLIENT	TITLE PROPOSED GLAZING ELEVATIONS	WALTERS CONSULTANCY LTD architecture.interiors.project management 109 Castlehaven Road London NW1 8SJ +44 (0)7831 488 901 tedcwalters@gmail.com
SCALE	DRAWN BY	ADDRESS		
DATE				
FILE				
1:100@A3		EDELMANN		
4/12/23		19 WELL ROAD HAMPSTEAD LONDON NW3 1LH

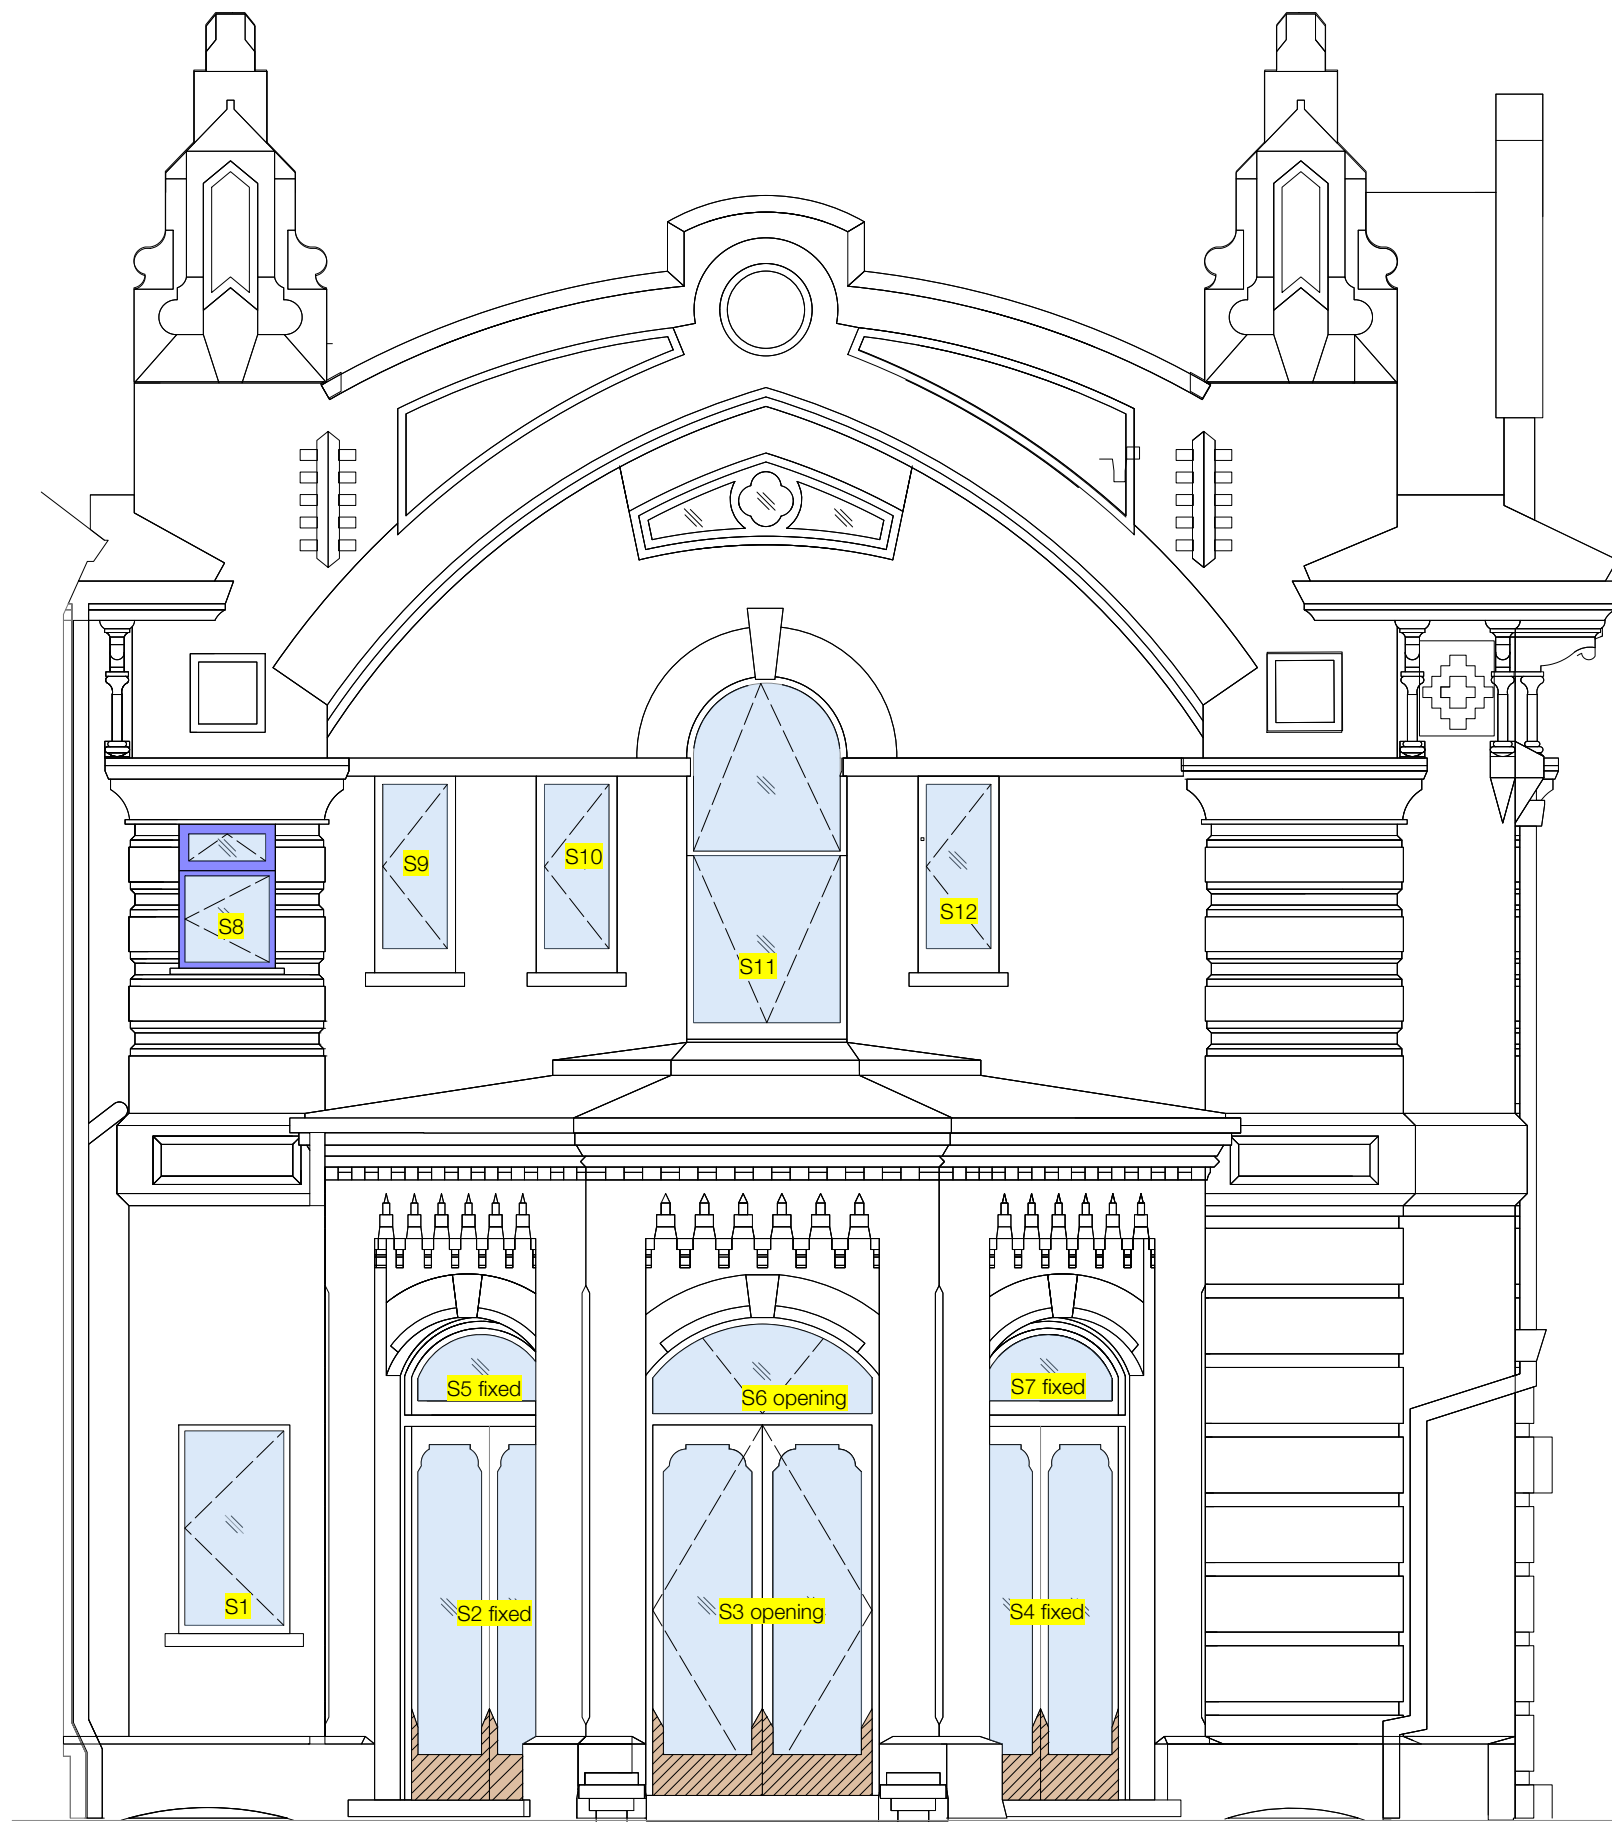
SOUTH ELEVATION

KEY The existing windows are timber construction, painted white & in good condition, except for those requiring repair identified in the KEY. All windows to be retrofitted with HISTOmono, painted white. Sash weights & ironmongery to match existing

S2, S3, S4 & E2 Brown hatch denotes approximate areas of the existing rotten timber french door frames to be cut out and refitted with new timber scarfed in to match in all details

S8 Steel crittal style casement window to be fitted with HISTOmono & painted white

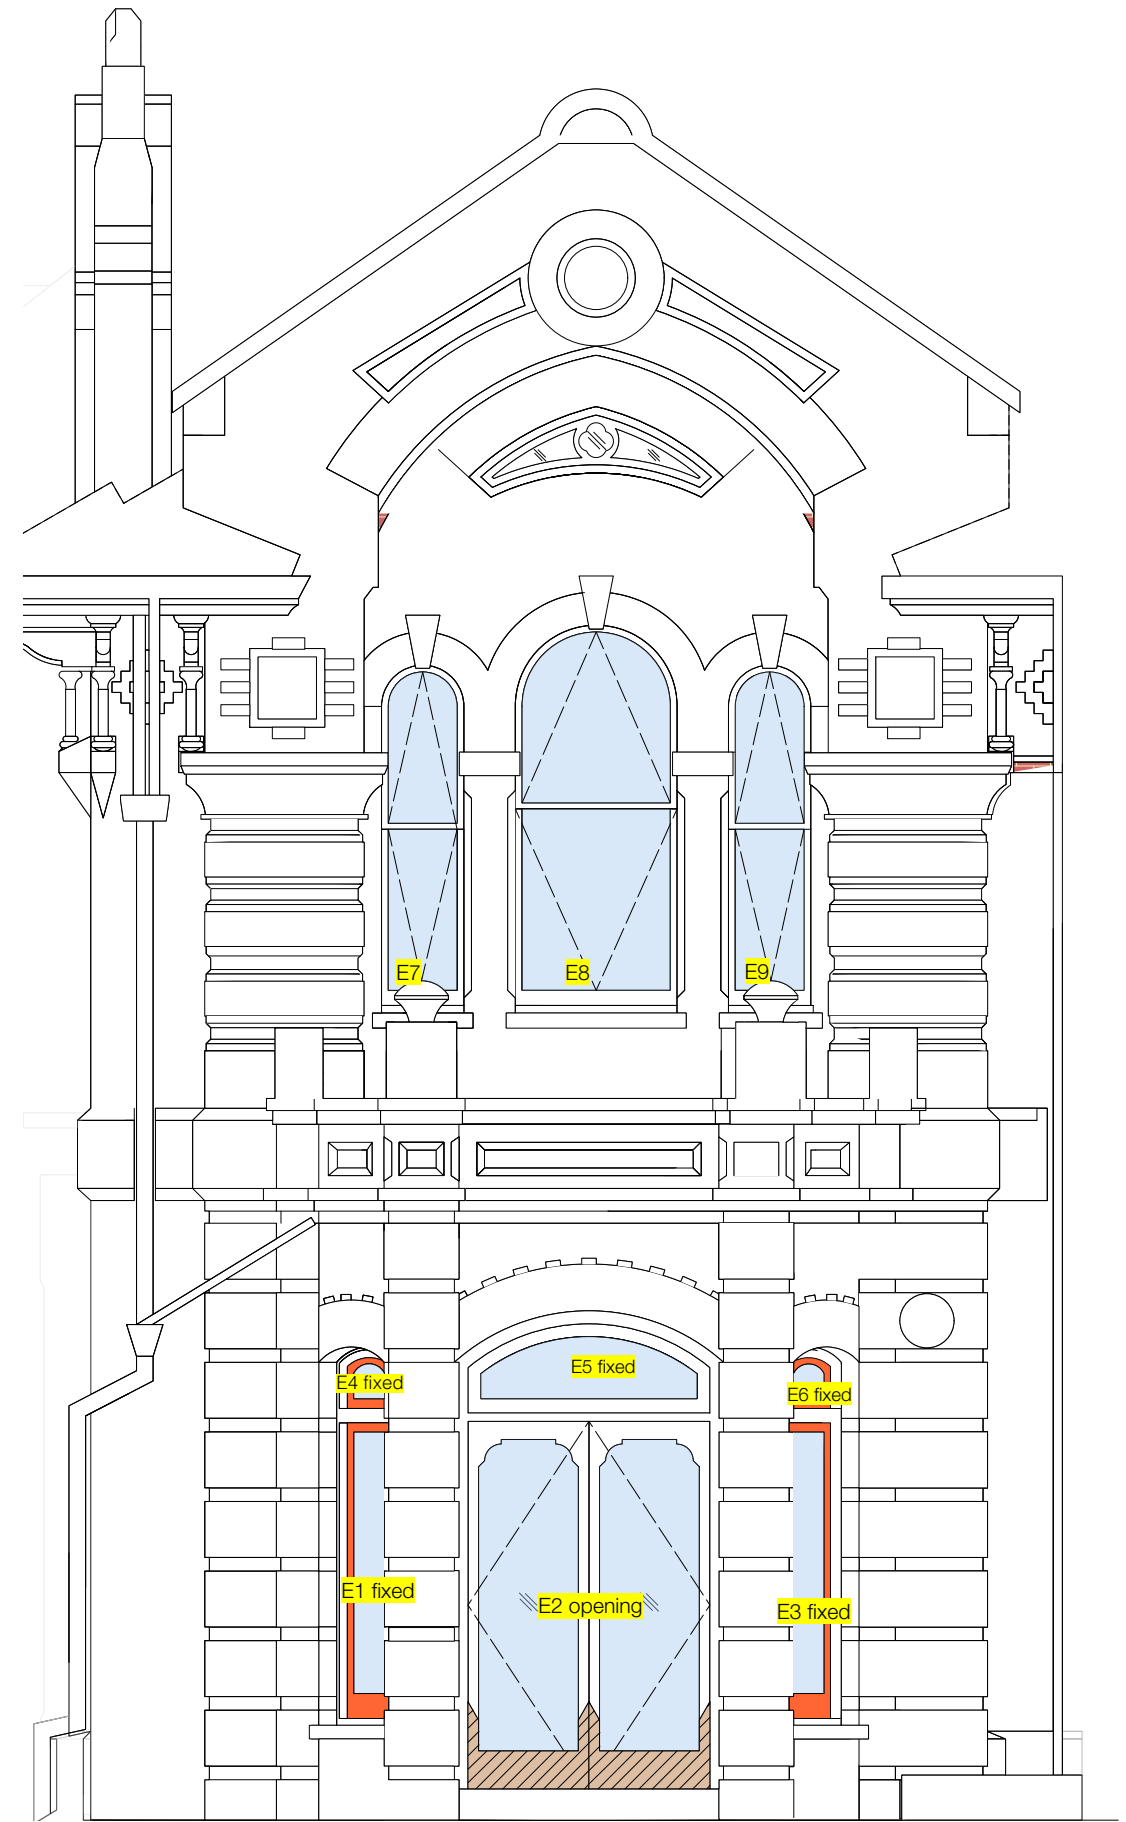
EAST ELEVATION

EAST elevation timber windows E1, E3, E4 & E6 are in good condition and will NOT be reglazed
