Condition 25- Bird Boxes
Swift and Starling Boxes

Condition 25- Bird Boxes
Black Redstart Boxes

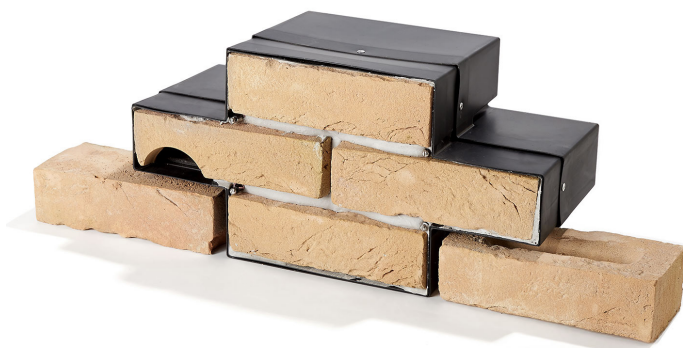
2 3x Swift boxes Located on the north facade of Block B2. Swift box, stretcher bond brick fronted.

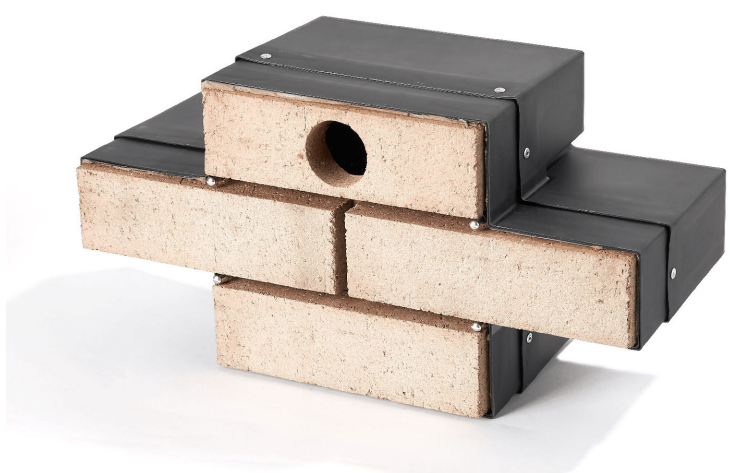
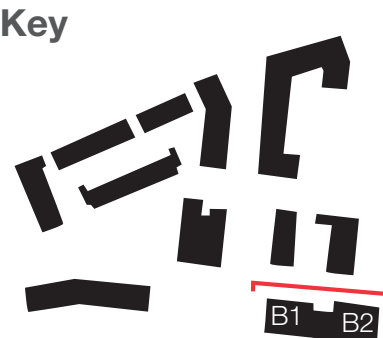
3 3x Starling boxes Located on the north facade of Block B1. Starling bird box, stretcher bond brick fronted.

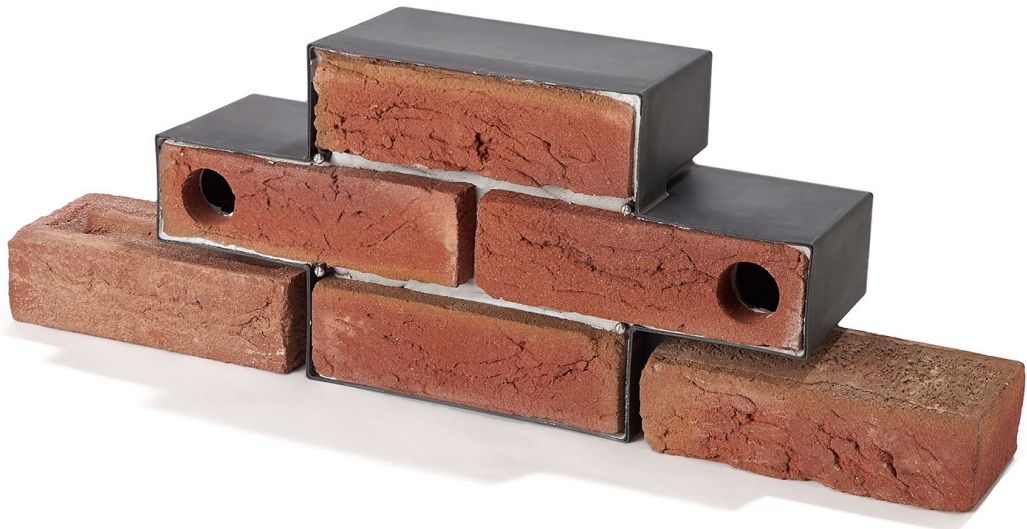
- 4 3 x Black redstart boxes- Located on the roof of block B1. Laid into the side of the stair overrun brickwork.
- Bird Brick Houses - Sparrow terrace box stretcher bond brick fronted, suitable for black redstarts.

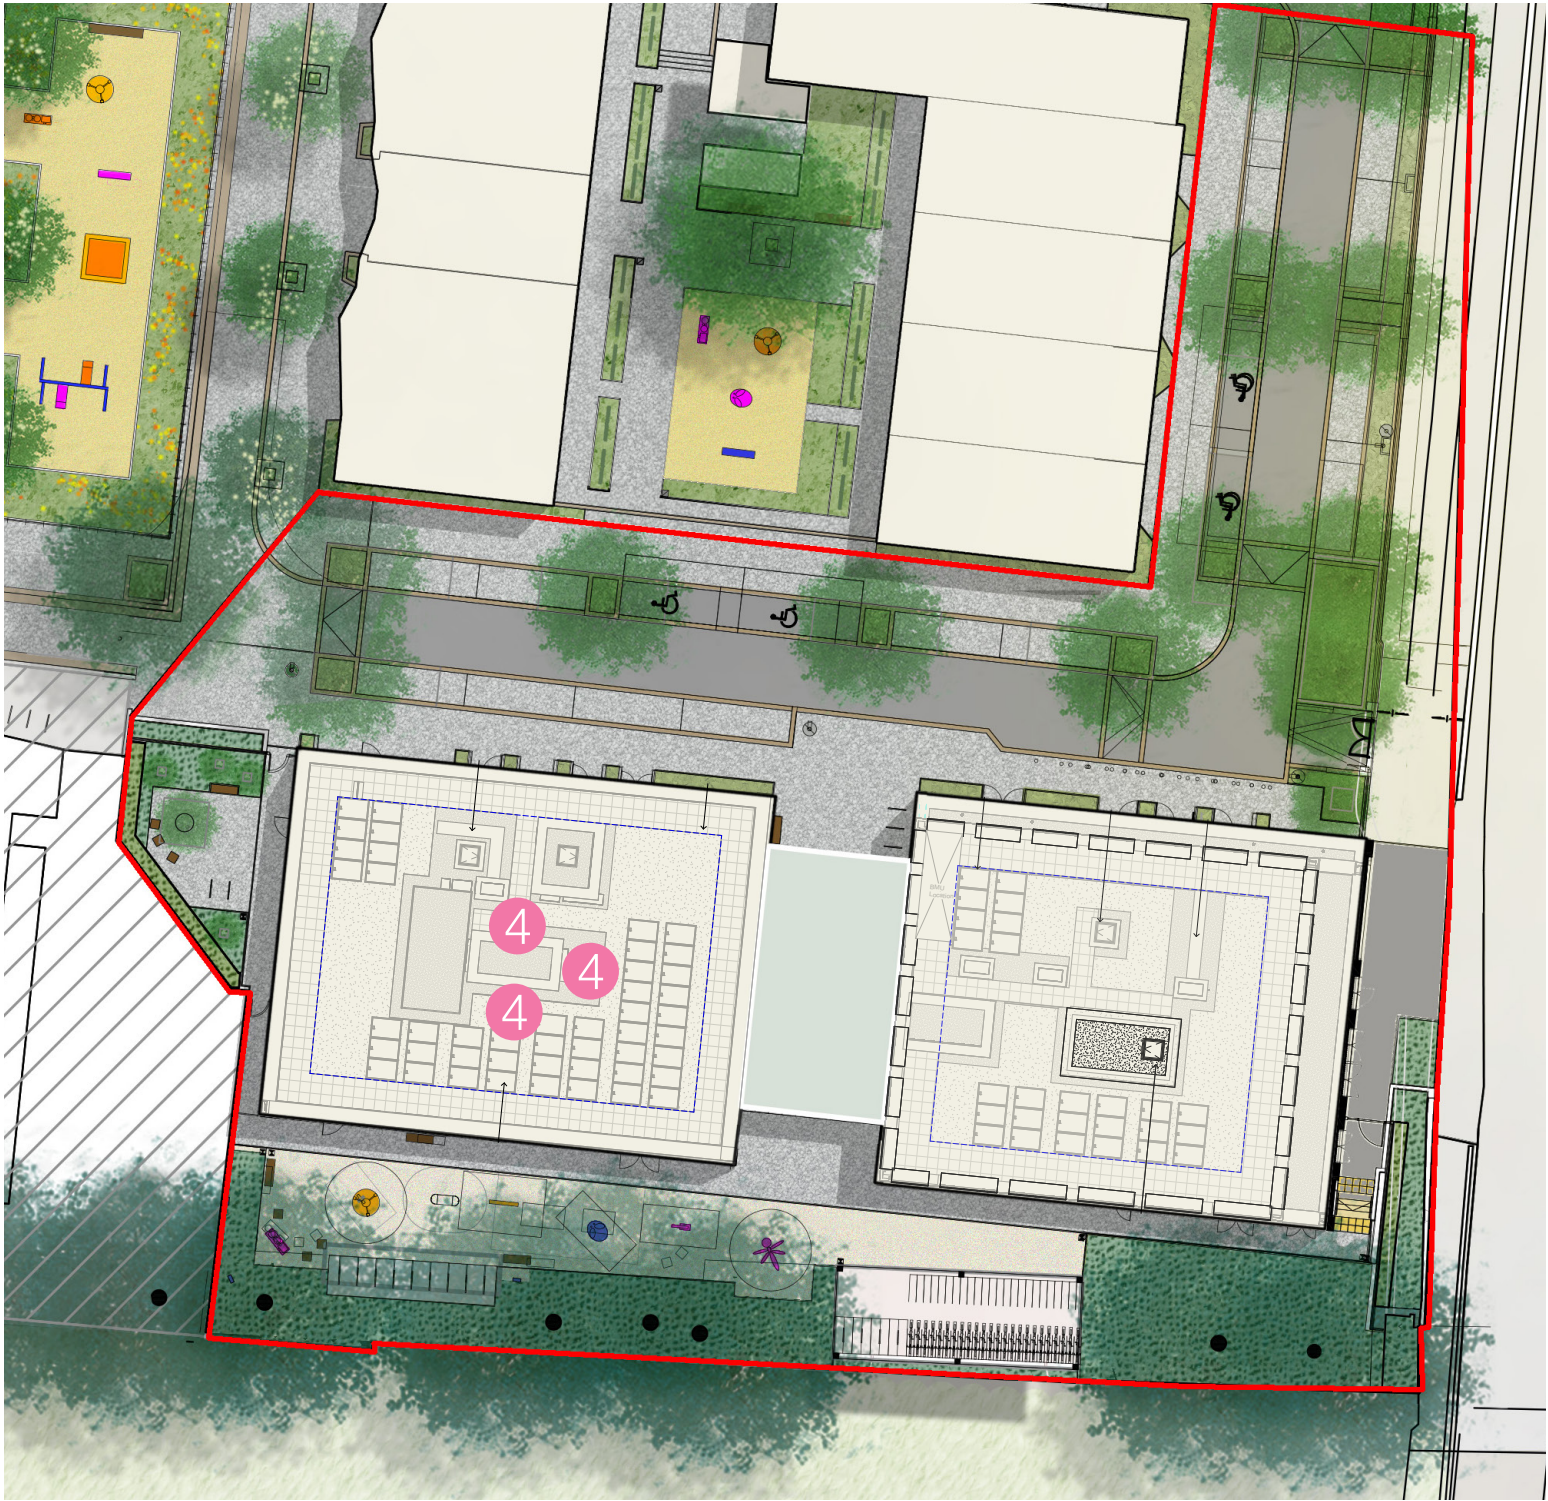
- Red Line Boundary
- X Location of black redstart nesting box
