NENE VALLEY
FIRE & ACOUSTIC LTD.

FIRE STOPPING SURVEY

Site Address:	117J Rowley Way Camden NW8 0SQ
Customer:	Camden
Date:	18 Aug 2021

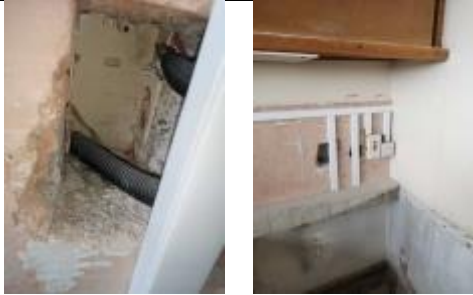
Seal Id	8	
Location	Floor 6 117j kitchen

Description of works	<p>Very deep aperture present to perimeter wall with redundant sockets.</p> <p>Further investigation required to check does not breach compartment wall to adjacent flat.</p>

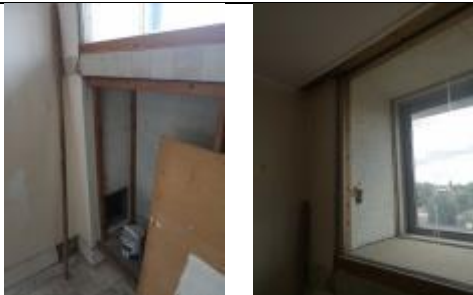
Seal Id	7	
Location	Floor 6 117j kitchen

Description of works	<p>Riser present to corner of kitchen. Top floor flat so no need to fire stop penetrations to above if breach externally with no hidden voids.</p> <p>Would require fire stopping if flat is positioned on below levels.</p>

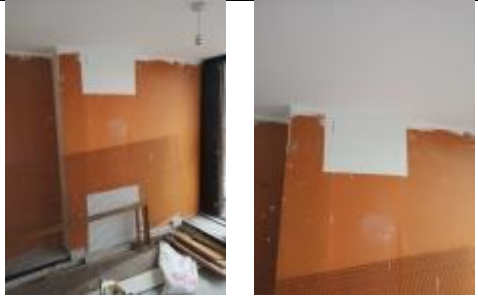
Seal Id	10	
Location	Floor 5 117j lounge

Description of works	Panel present within wall. W/C riser beyond this panel. Recommend to fire stop at slab level if breaches do not exit externally above with no hidden voids.

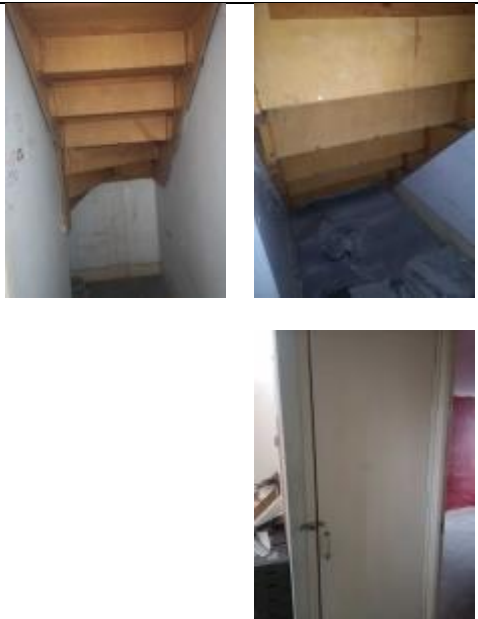
Seal Id	2	
Location	Floor 5 117j understairs cupboard

Description of works	Recommend to protect underside of staircase.

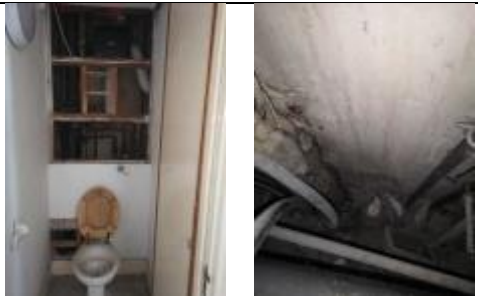
Seal Id	6	
Location	Floor 5 117j w/c

Description of works	Waste pipe enters riser also from adjacent flat, recommend to fire stop breach entry point from next door flat. Shared riser to both flats.
