# Location Plan of Interim Taxi Rank

Section of Grade II listed railing to be reinstated and repaired. These are E/27 and E/28.

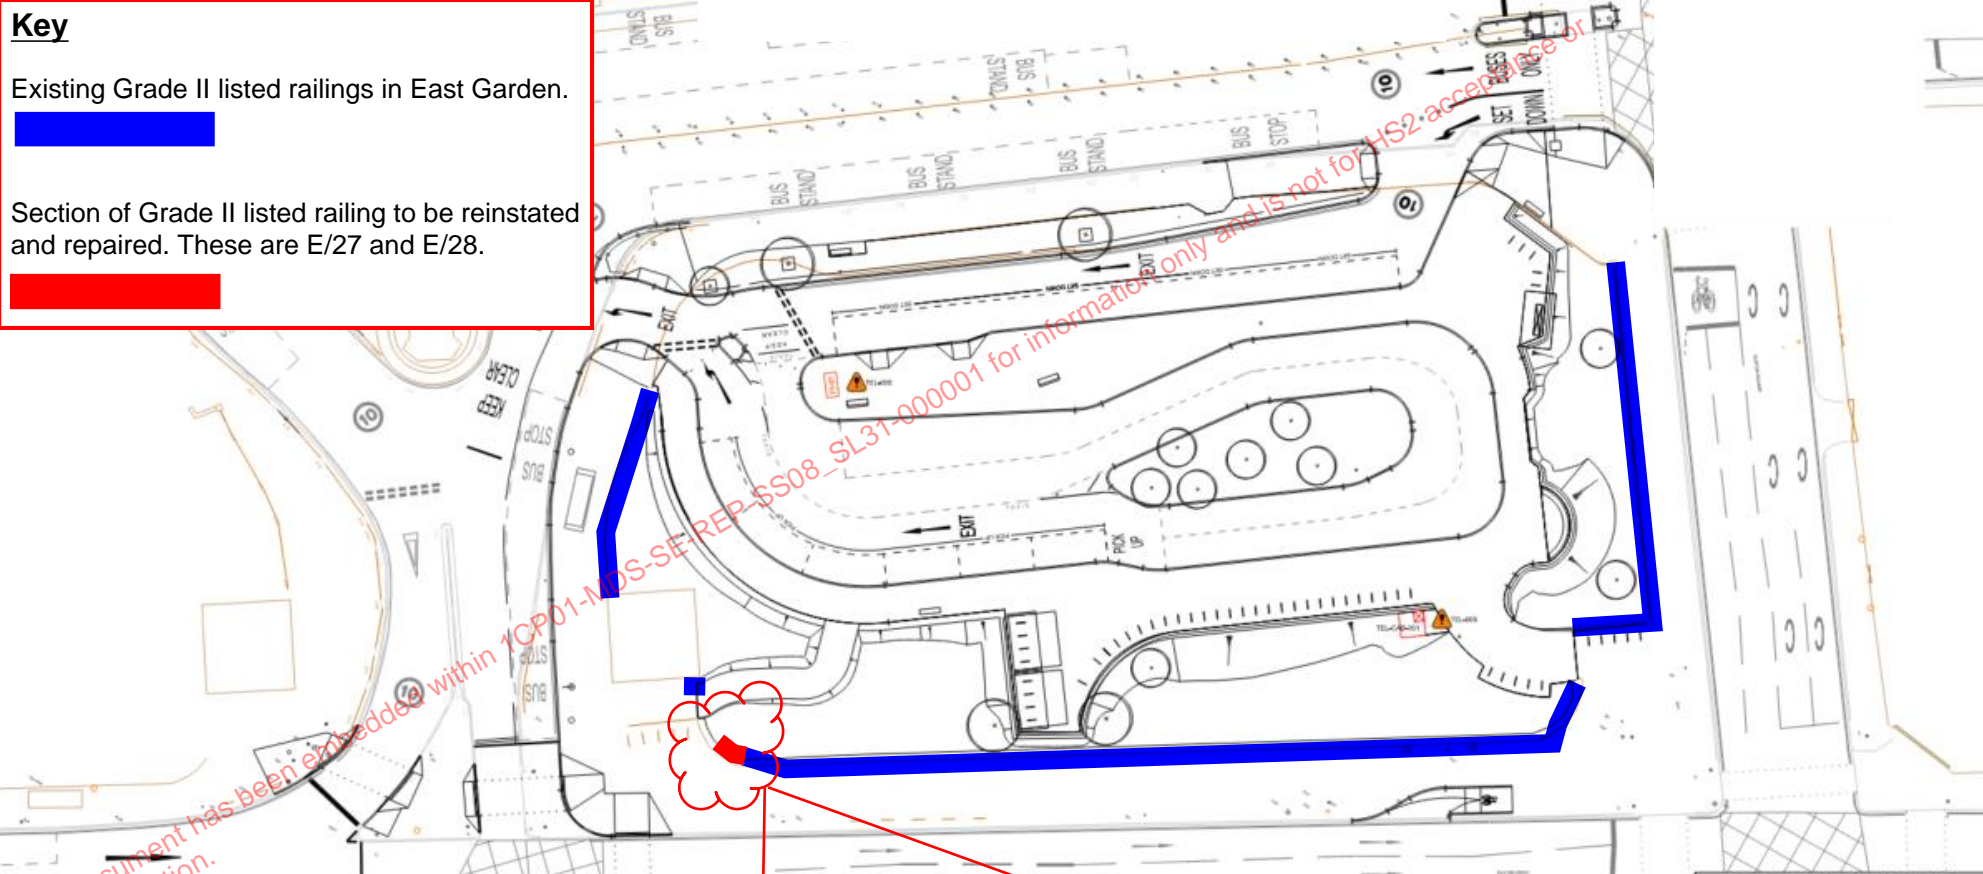
Existing Grade II listed railings in East Garden.
