| Provider Details | | Client Details | | Risk Address | |
|---|---|---|---|---|---|
| | | Client Name: | Sedgwick | Address: | 13 Weech Road |

File 6686348 Level Reading 16 [91132253].xls.XLS

LEVEL MONITORING - RELATIVE MOVEMENT SKETCH

# LEVEL MONITORING - RELATIVE SURVEY READINGS

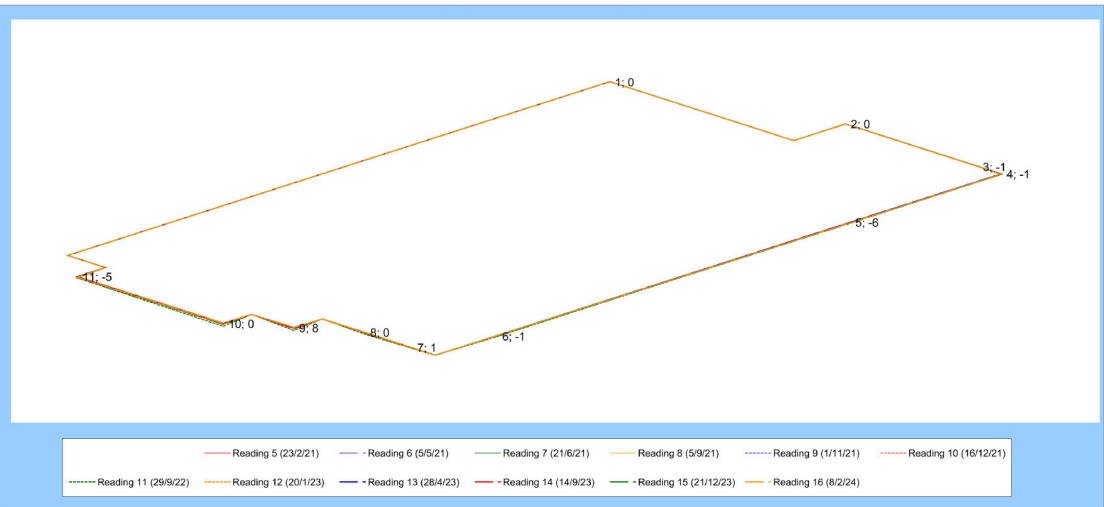
Notes:  
Vertical distorted scale 1: 5  
Point labels give level difference of last reading from original datum in mm.

- It was not possible to install all stations within a common brickcourse. Therefore initial readings cannot be interpreted as Distortion Data.
- Readings have been made relative to level station 1. It has an assumed value of 10.0000m. Secondary TBM is a manhole in the road. If this is not appropriate, please advise if a deep datum is required?
- Further reads to be taken in Mar 24

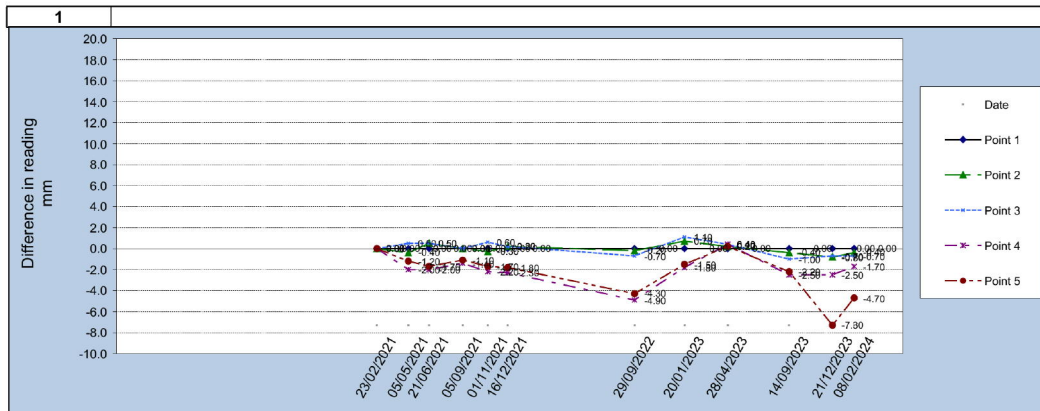
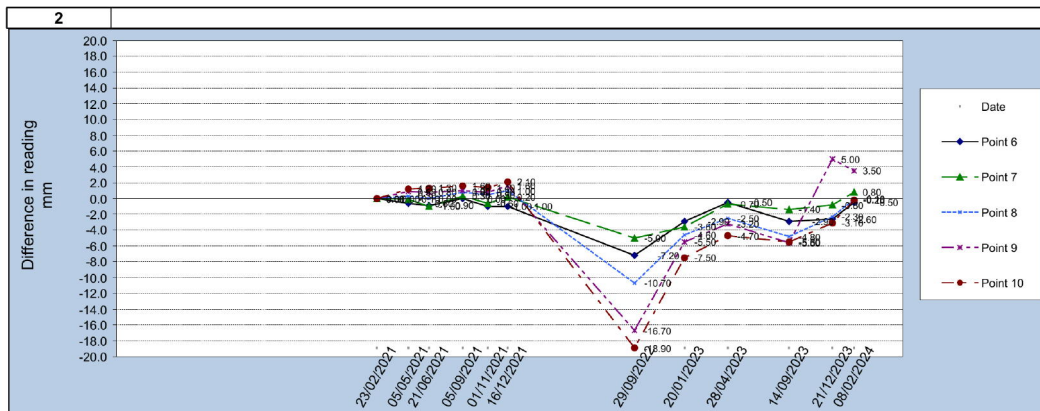
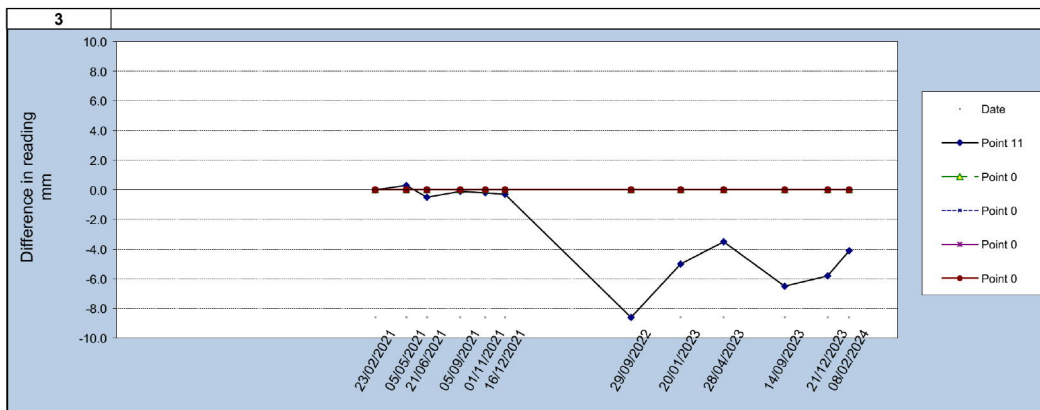
Chart Scale 1:1000
