Crack and Level Monitoring

Date of Issue: 02/02/2024

Address: 69 Canfield Gardens, LONDON, NW6 3EA

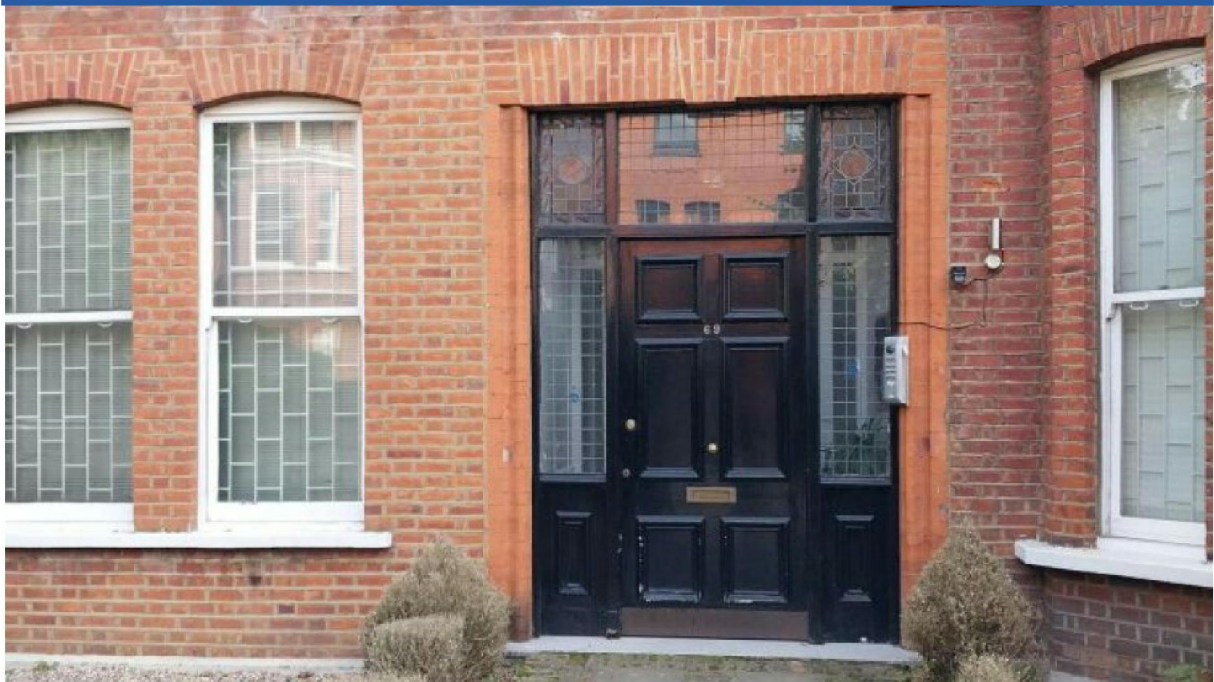
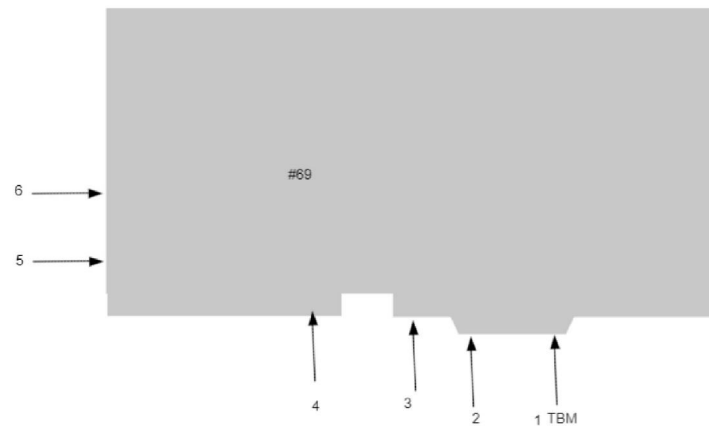
Front Elevation

○ - Area of damage

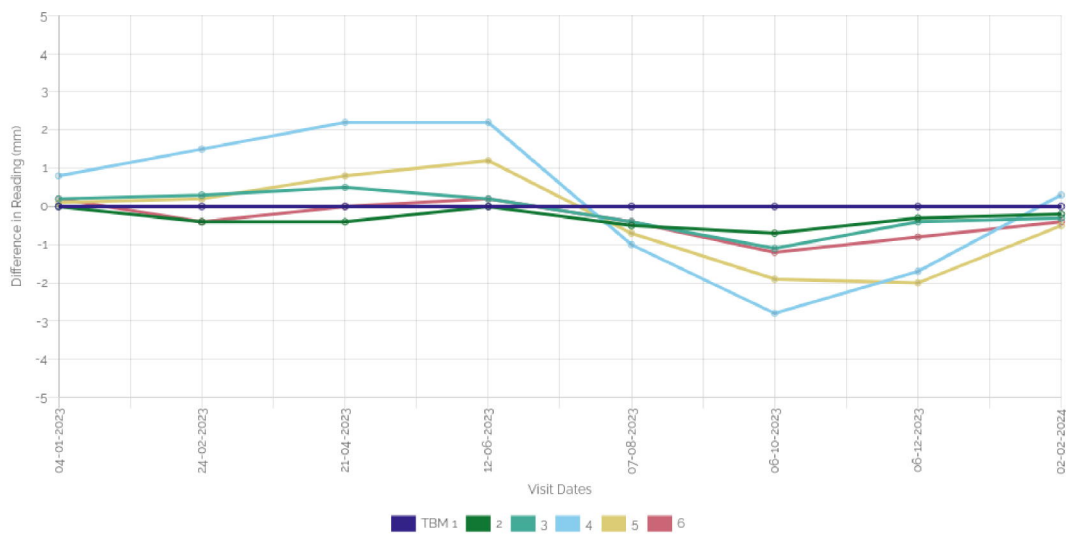
Level Readings Chart (Points TBM 1 - 6)

| | Visit 1 | Visit 2 | Visit 3 | Visit 4 | Visit 5 | Visit 6 | Visit 7 | Visit 8 |
|---|---|---|---|---|---|---|---|---|
| 4 | +0.8 | +1.5 | +2.2 | +2.2 | -1 | -2.8 | -1.7 | +0.3 |
| 5 | +0.1 | +0.2 | +0.8 | +1.2 | -0.7 | -1.9 | -2 | -0.5 |

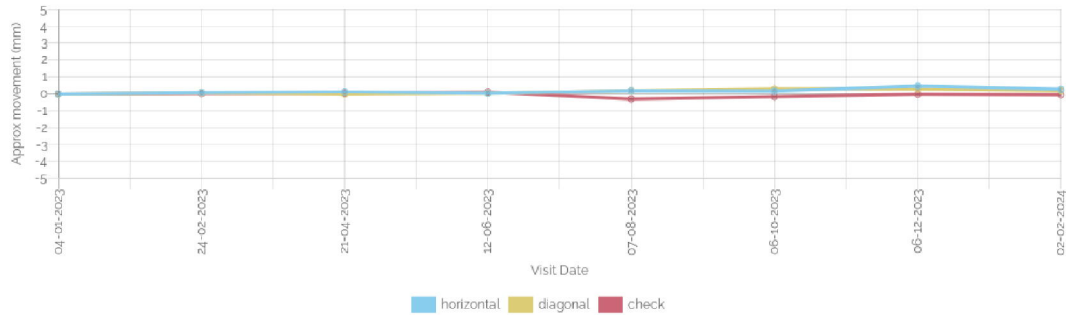
Ext lhs below 1st window - Crack Readings Differences (Displayed in Millimetres)

| | Visit 1 | Visit 2 | Visit 3 | Visit 4 | Visit 5 | Visit 6 | Visit 7 | Visit 8 |
|---|---|---|---|---|---|---|---|---|
| H | 0 | 0.08 | 0.12 | 0.04 | 0.18 | 0.16 | 0.47 | 0.27 |
| D | -0.09 | -0.03 | -0.1 | -0.05 | 0.09 | 0.2 | 0.21 | 0.09 |
| C | 0.08 | 0.1 | 0.12 | 0.19 | -0.22 | -0.09 | 0.06 | 0.03 |

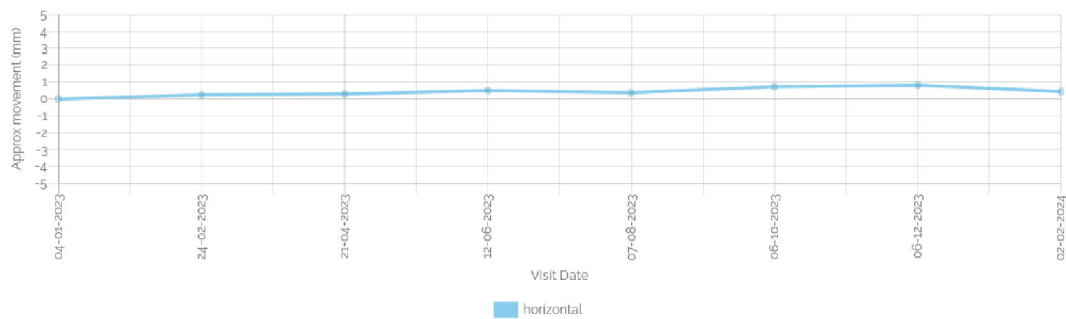
Ext lhs above 1st window - Crack Readings Differences (Displayed in Millimetres)

| | Visit 1 | Visit 2 | Visit 3 | Visit 4 | Visit 5 | Visit 6 | Visit 7 | Visit 8 |
|---|---|---|---|---|---|---|---|---|
| H | -0.02 | 0.22 | 0.28 | 0.48 | 0.35 | 0.7 | 0.79 | 0.41 |
