+85.11 AOD  
COURTHOUSE FFL 01

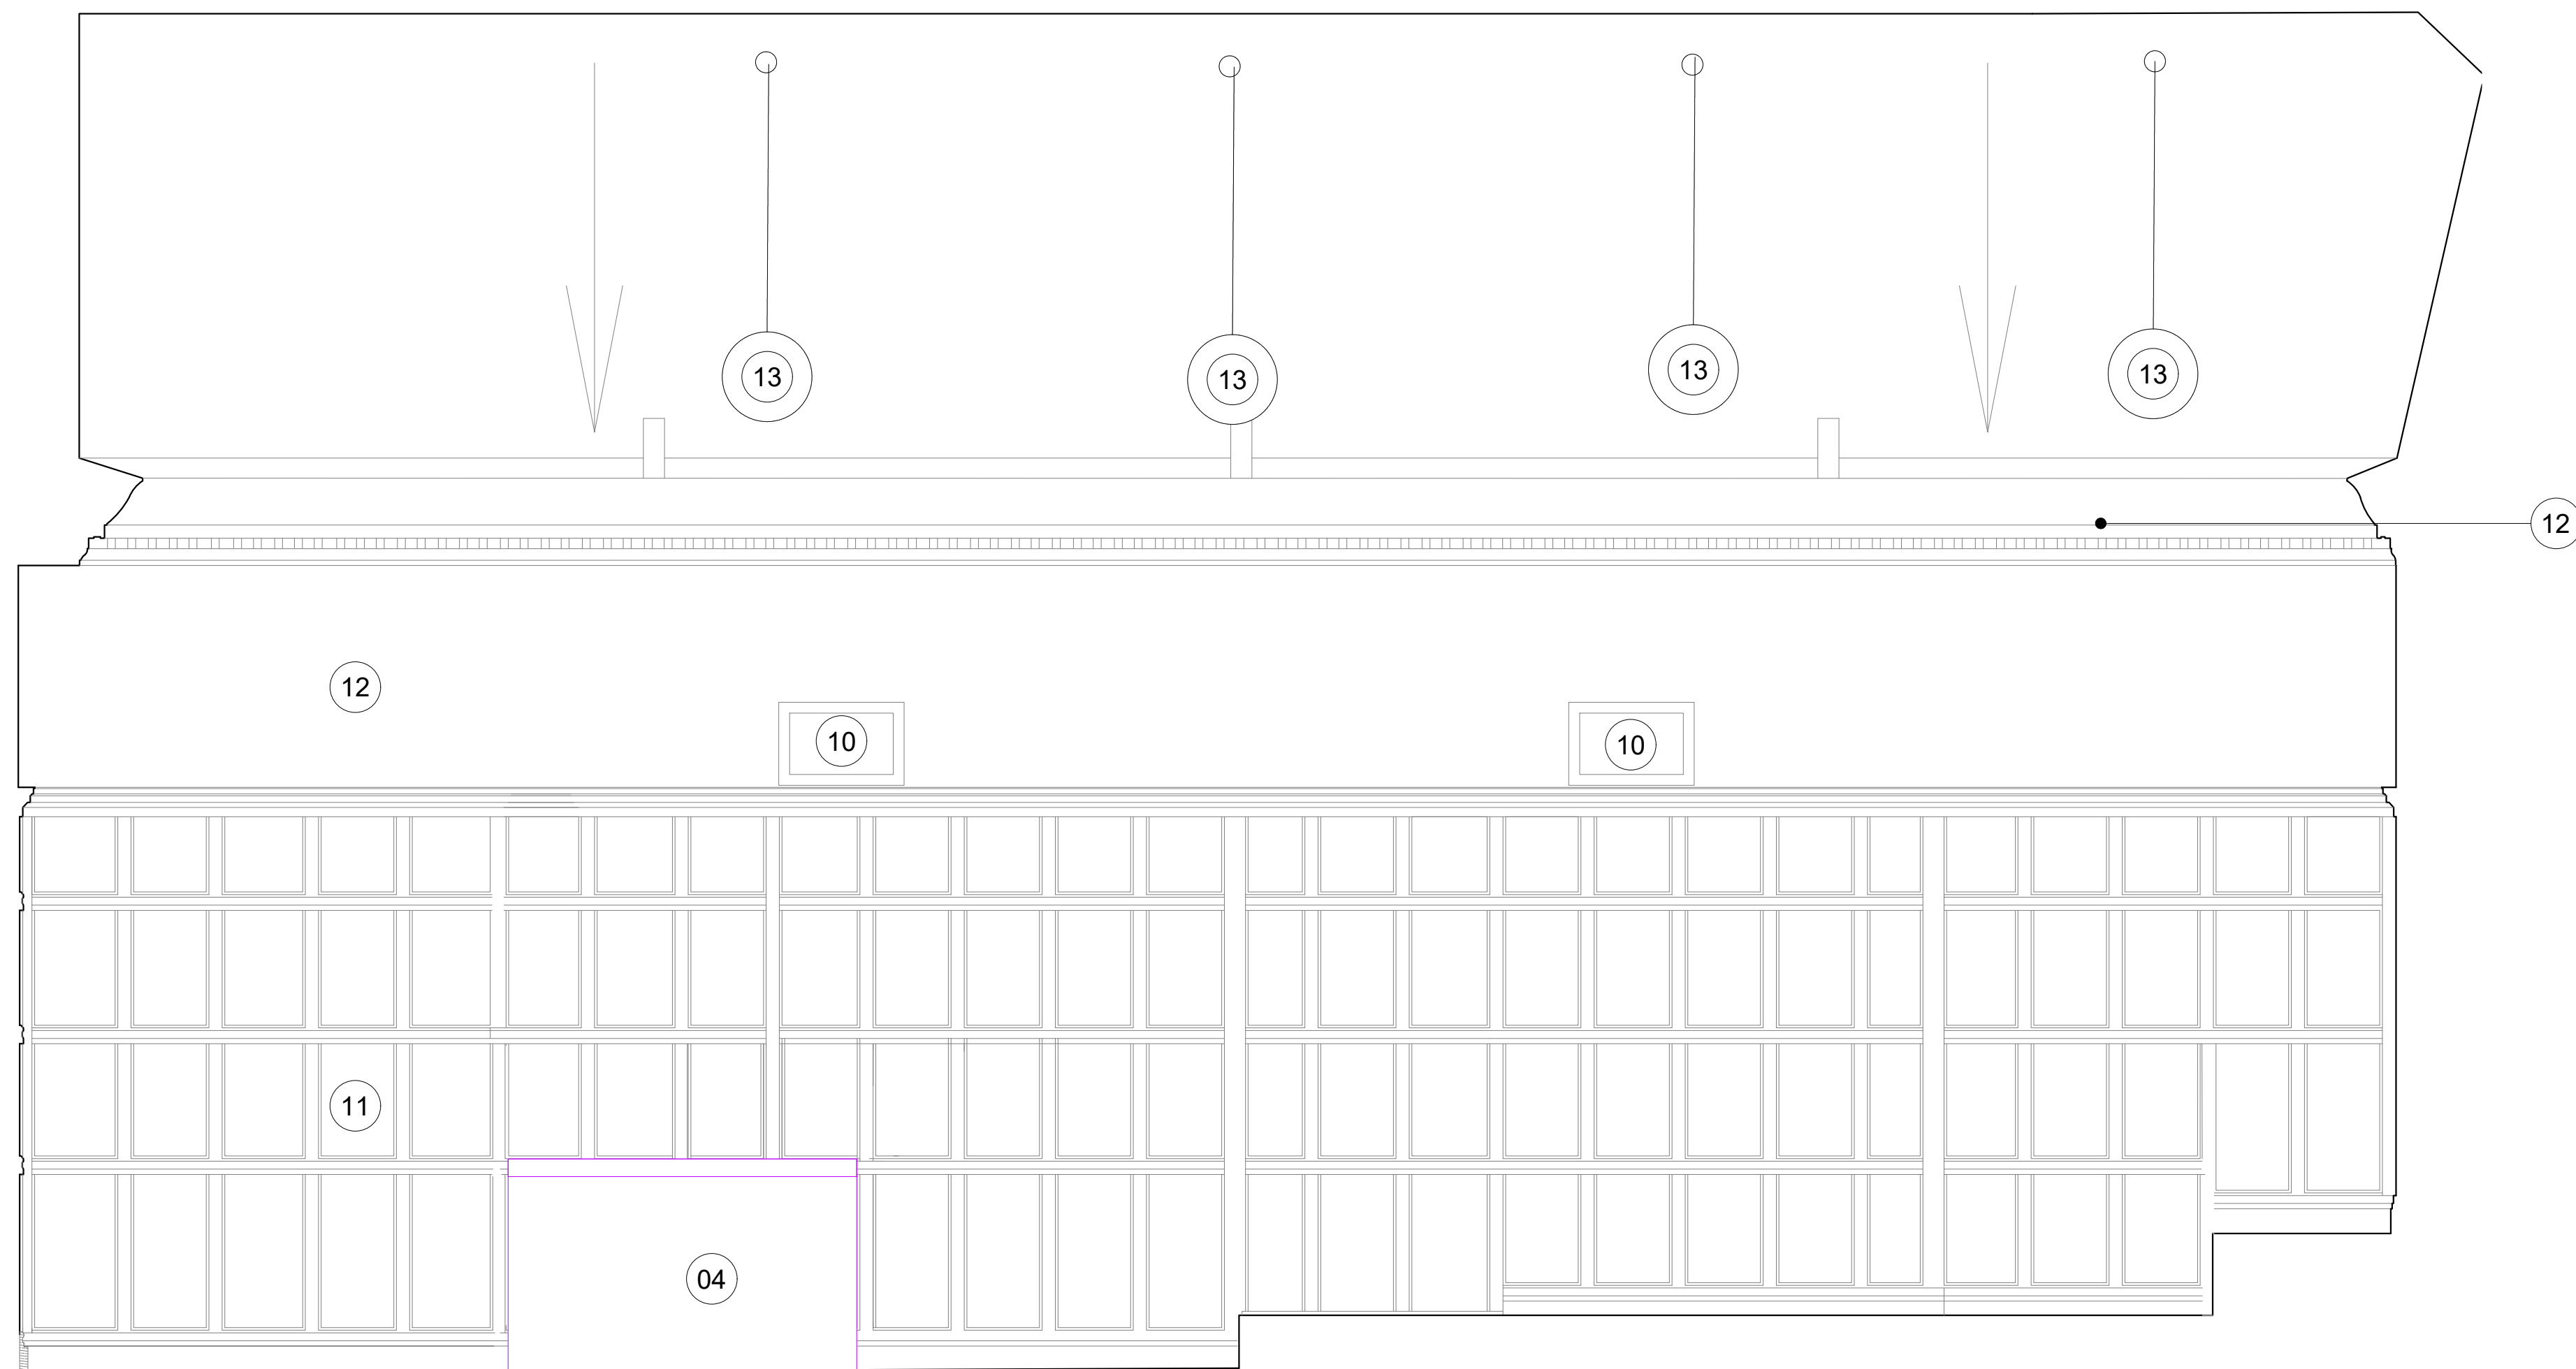
1. New opening with downstand above. Walls to be made good.
2. Stone floor inlay to highlight former podium area.
3. Existing timber floor retained, made good and re-finished.
4. New joinery for FCU covers (heating)
5. Existing joinery screen made removable to provide access in raised access floor void
6. New worktop joinery.
7. Existing opening sealed with recess to indicate historic building form.
8. Fresh air supply grille integrated within existing raised access floor.
9. Fresh air supply integrated within new joinery.
10. Existing vents made good, and draught proofed.
11. Existing paneling made good and re-finished
12. Existing walls, cornices made good and re-decorated.
13. New luminaires. Existing supply routes re-used.

Existing joinery re-used to adjust wall paneling to accommodate new office layout.
-

Existing joinery wall paneling made good and re-finished
-

Extent of existing raised access floor retained. Raised access floor to be used to house services routes and equipment.
-

New timber floor finish to be laid on to exiting substrate. Detail subject to strip-out works.
-

Extent of new joinery.

All walls, ceilings to be made good and re-decorated. New fixtures and fittings to be installed, using existing supply where possible.

All modern door to be replaced.
