Hampstead Police Station

Proposed Courtroom Elevation 03

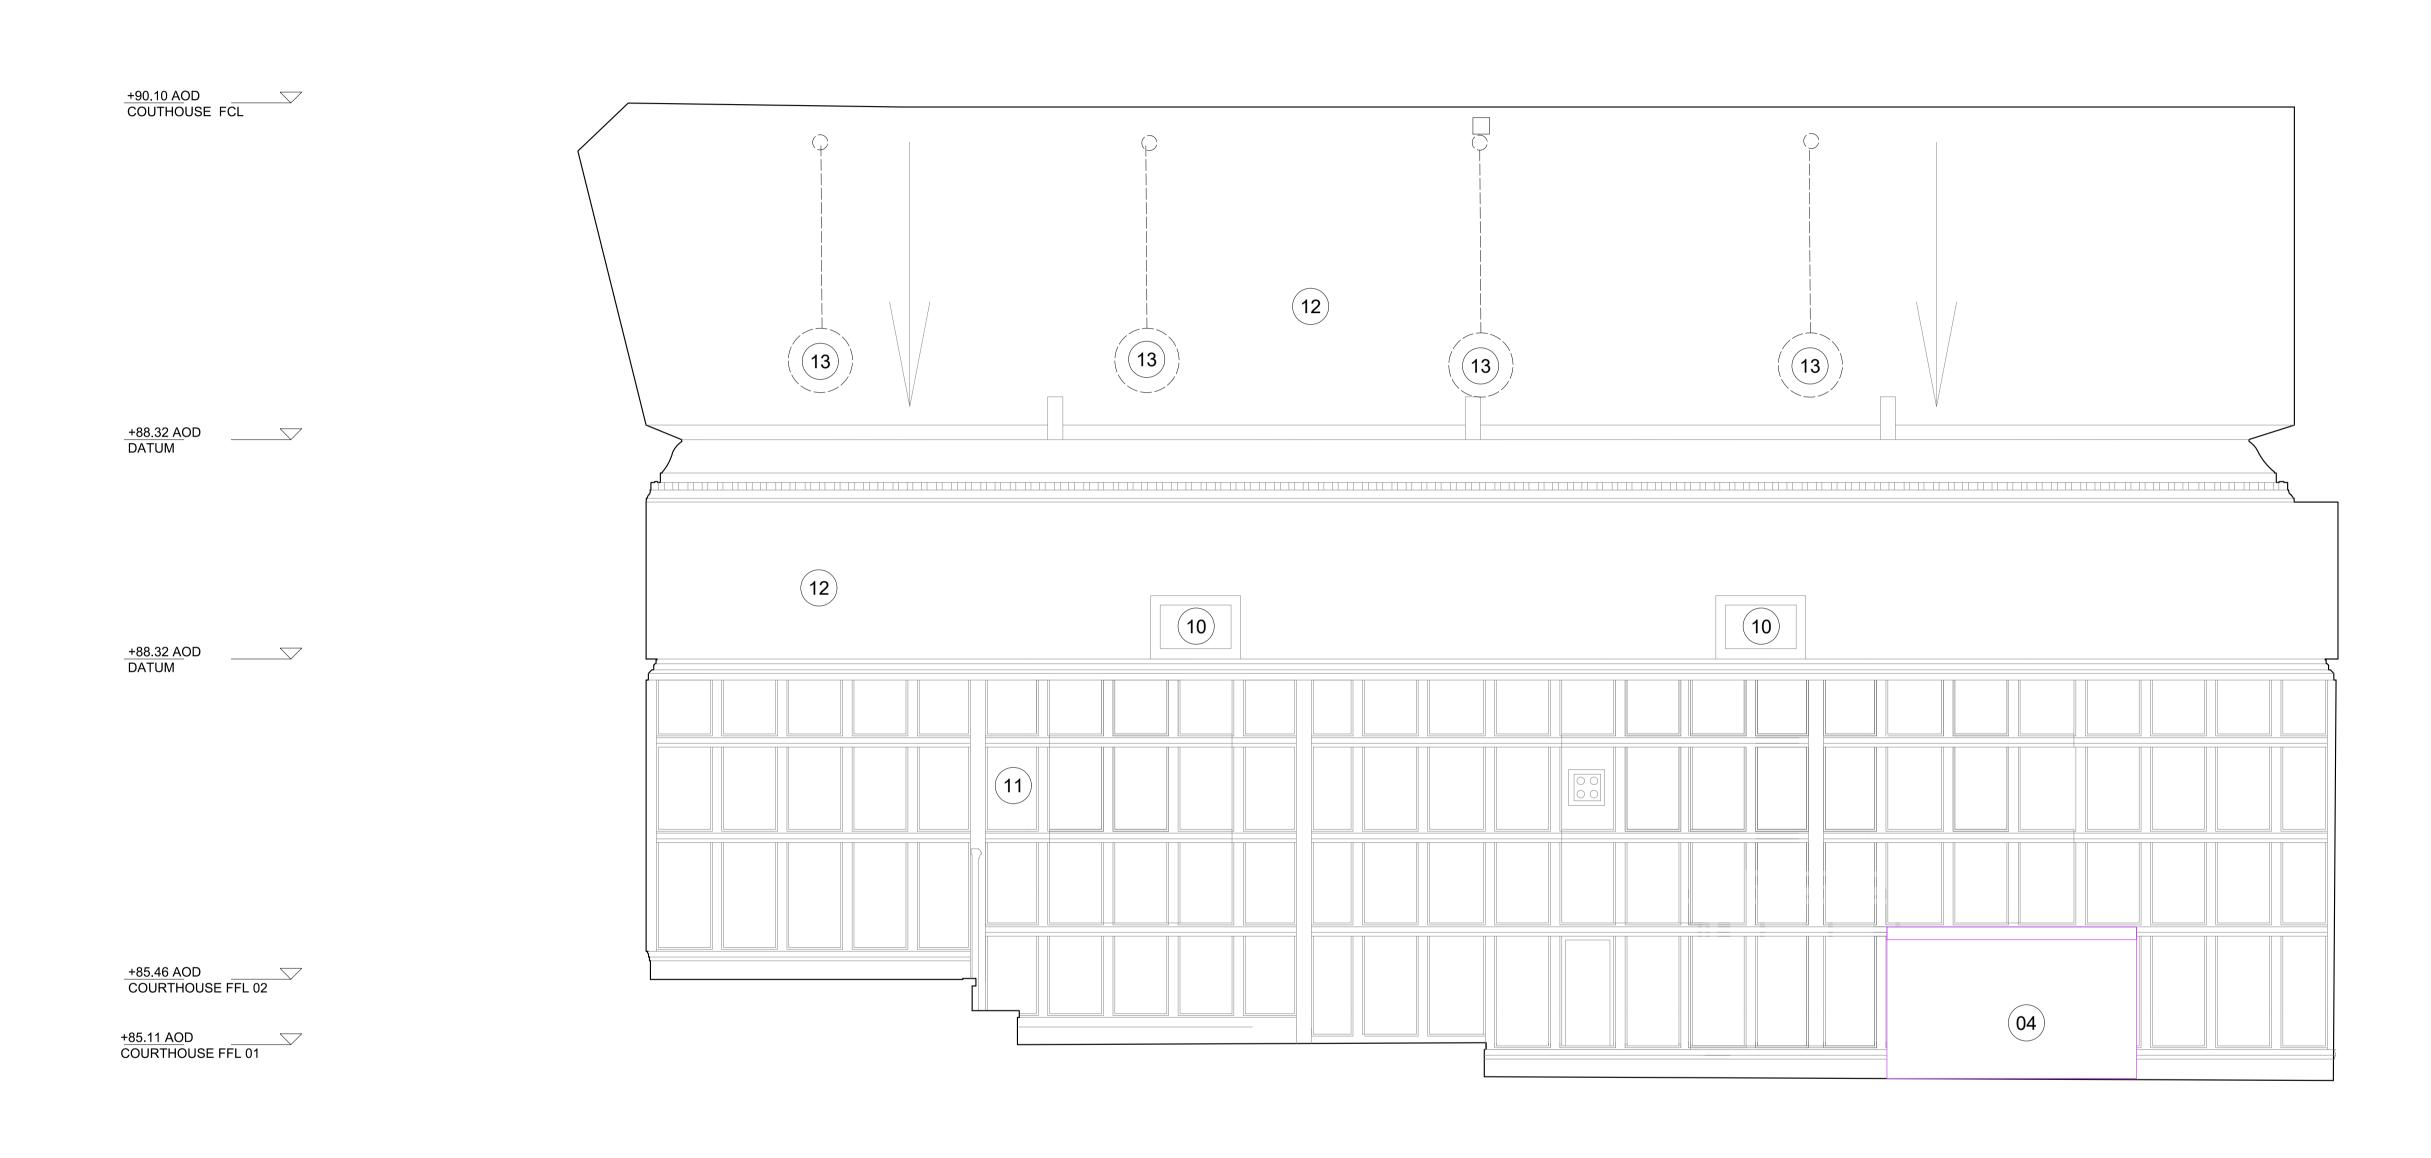
Existing joinery re-used to adjust wall paneling to accommodate new office layout.

Extent of existing raised access floor retained. Raised access floor to be used to

New timber floor finish to be laid on to exiting substrate. Detail subject to strip-out

Existing joinery wall paneling made good and re-finished

house services routes and equipment.

Extent of new joinery.
