Project 13 Belsize Crescent, NW3 5QU	Sheet Number GA 400		
	Client	Revision		
	Ms Nguyen & Mr Lehmann	A		
	Sheet Title	DWG By:	Control By:	
	Proposed Section A	XX	×	XX
10	Date	Scale		
es	16/02/23	1:100@A3

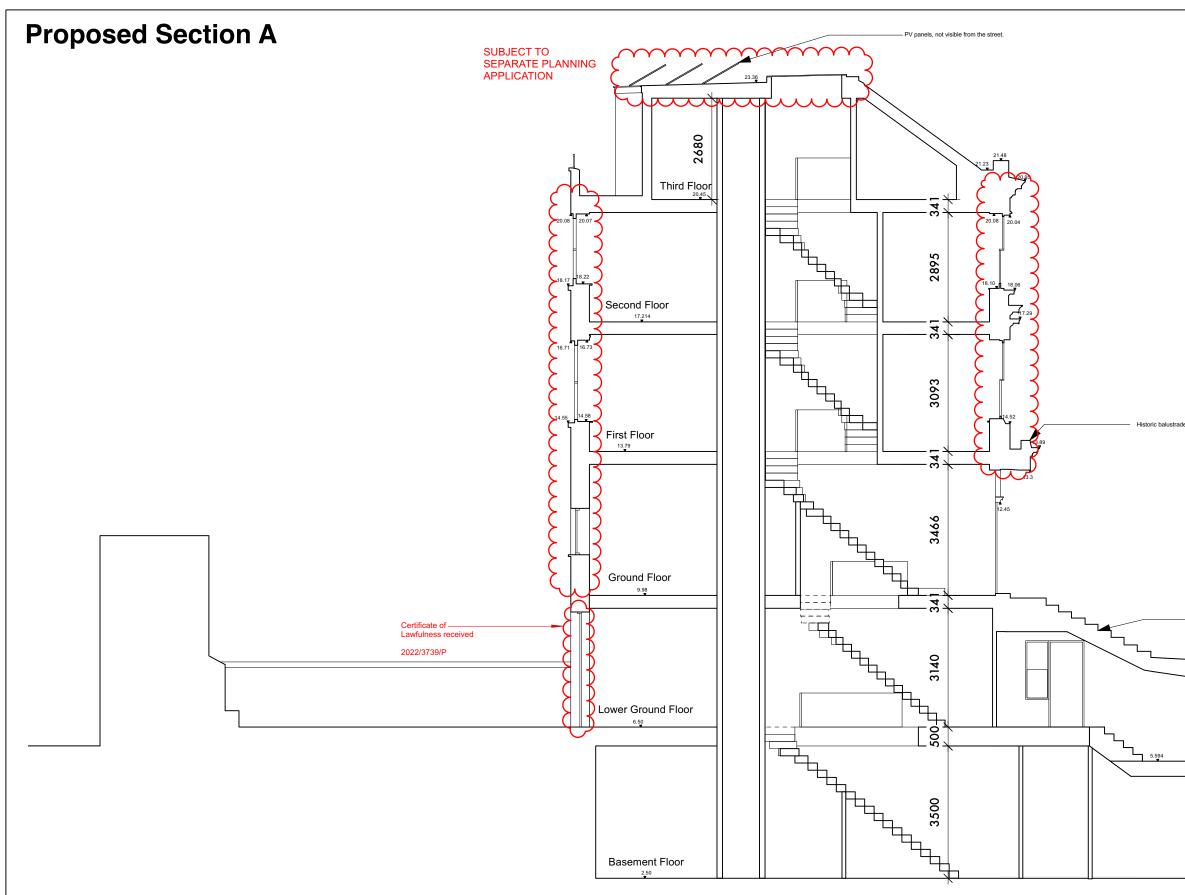
Historic balustrades restored to match neighbour

Stair material to be replaced to match neight

Note: 1. Windows will be replaced with double/triple (tbc) glazed units to match orginal timber framed windows on the terrace. 2. Historic balustrades to be restored on ground and first floor level front elevations and staircase to match with neighbours
