Tavis House

Demolition Second Floor Plan

Stage 0-3

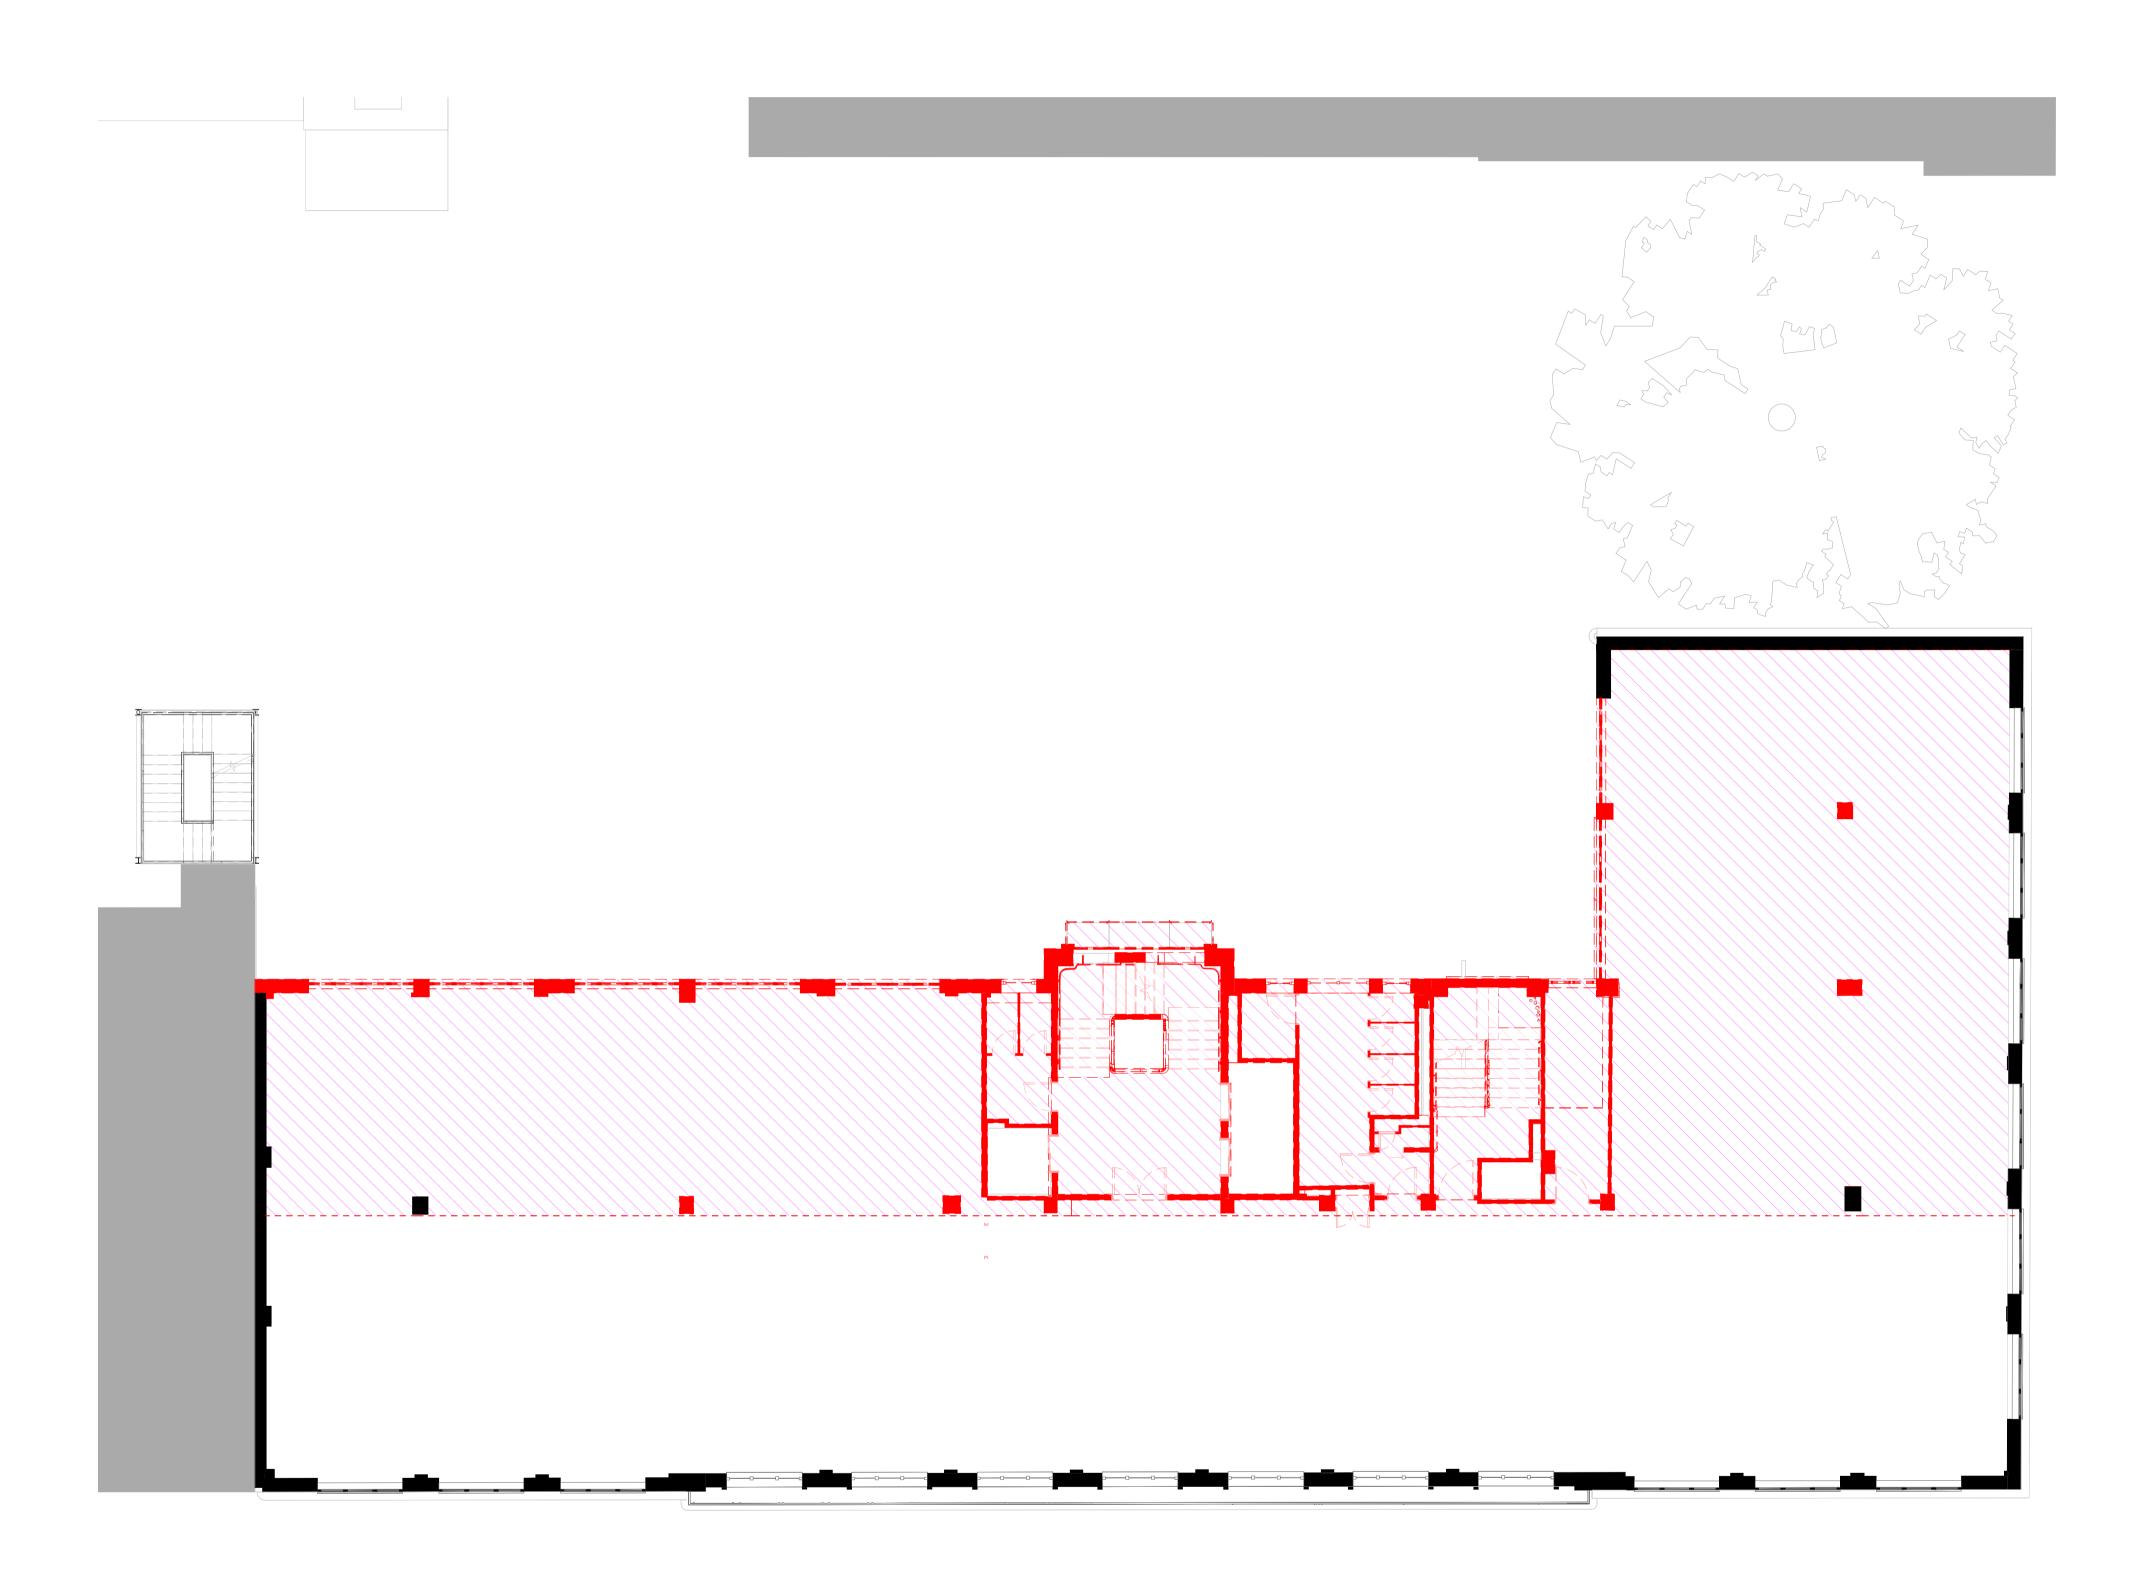
An internal strip out will be carried out prior to the demolition works to remove any previous tenant fit

These demolition drawings do not show any of the strip out, to accurately show the demolition of the facade and structure.

A party wall survey will be carried out prior to the demolition works to clarify the exact position of the structural boundary walls.
