**161 ARLINGTON ROAD  
LONDON NW1 7ET**

DESK STUDY REPORT

Project Ref	S 2930
Rev	--
Issue Date	January 2024

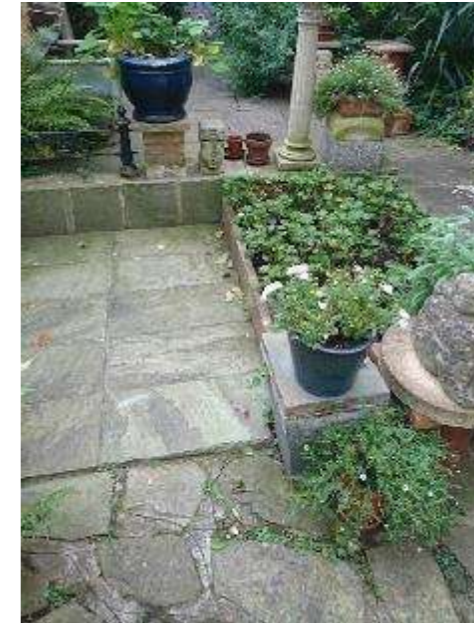
Figure 1: Existing Rear Garden Finishes

The existing rear extension is to be extended full width and by approximately 1.3m into the rear garden to form a lightwell to the basement rooms.

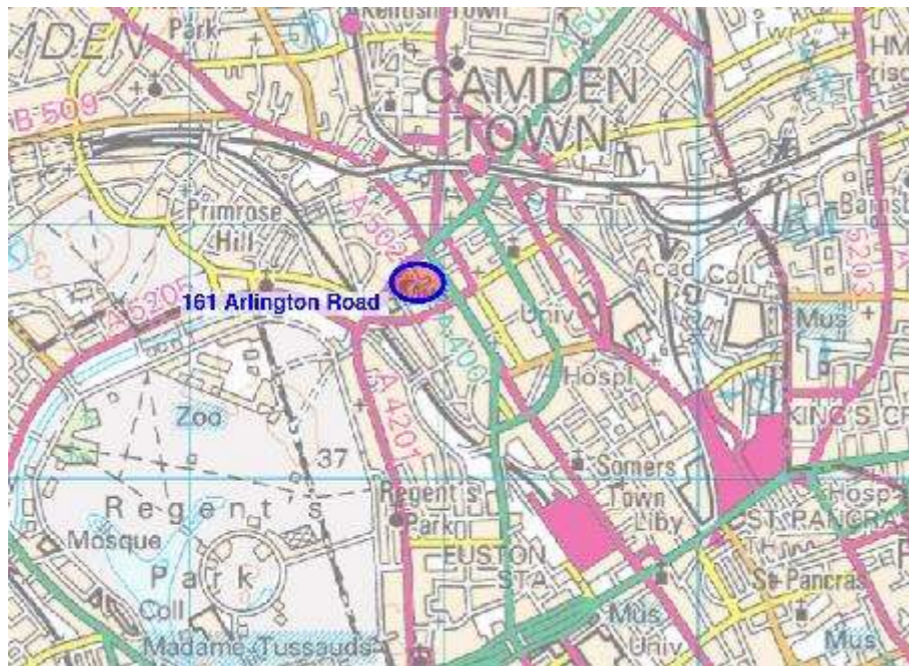
Figure 2: Site Location

The property at 161 Arlington Road lies on the west side of Arlington Road just south of the junction of with Parkway. It is approximately 160m southwest of Camden Town tube station and approximately 330m northeast of Regent's Park.

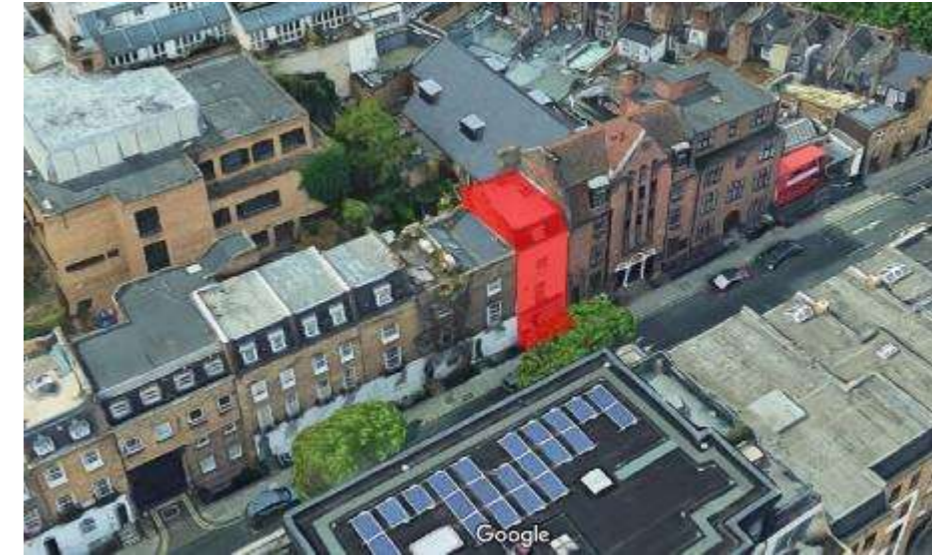
Figure 3: Aerial View Showing Site

The following aerial photograph shows the location of the property, with Parkway on the right-hand side of the photo (See Figures 4 and 5 in Appendix A).

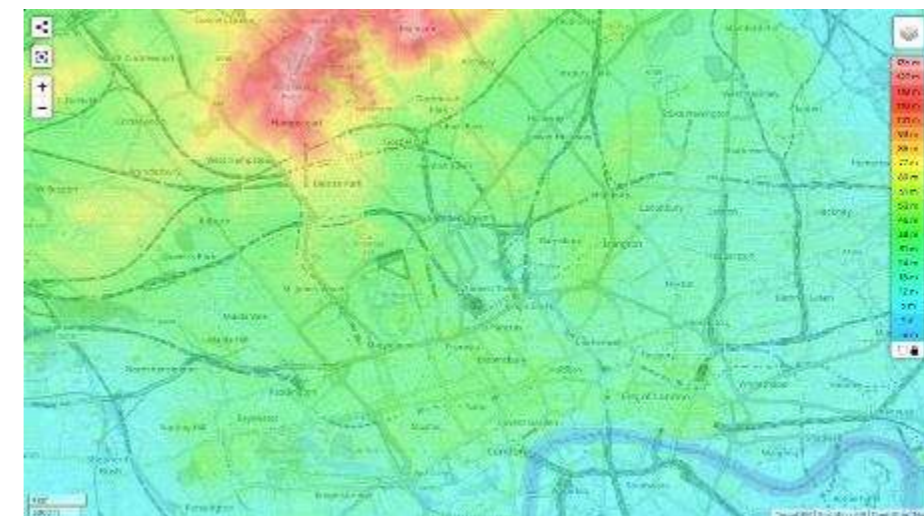
Figure 4: Site Topography (See Appendix for full map)

Reference to the OS map and topography map indicates that the site lies on the eastern slope of the high ground from Hampstead to Primrose Hill with a fall to the north-east. Ordnance Survey levels gives the street level adjacent the site to be 29.4mOD.

From OS data the slope falls to the northeast, with an average slope in the area of the site of 1.4 degrees, defined as a 'very gentle slope'. This is significantly less than the slope of 7degrees as set by Arup in the CGHHS as maximum angle for slope stability in London Clay where groundwater is close to the surface.

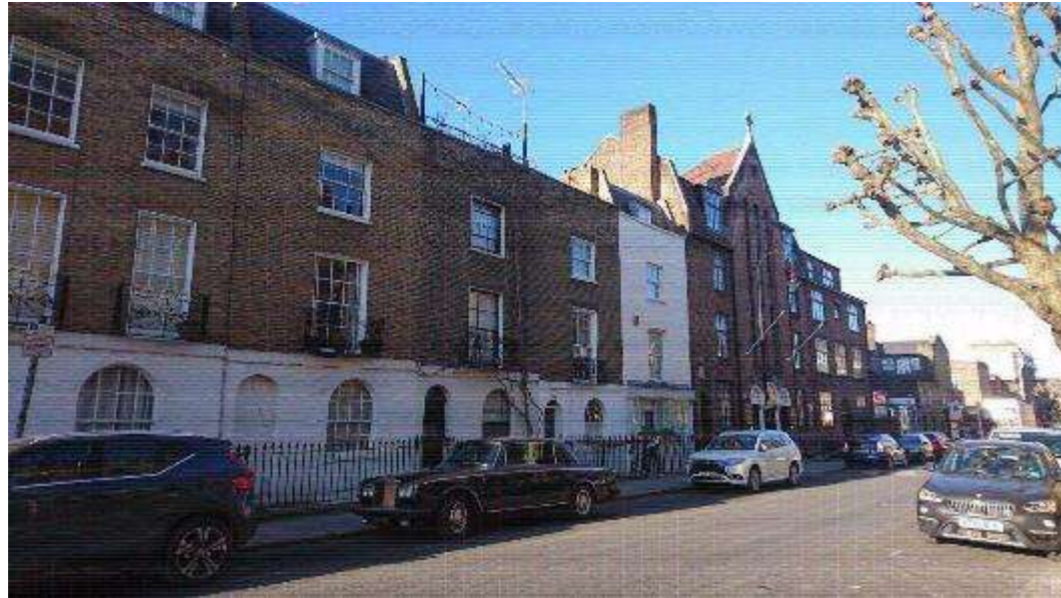
Figure 7: Arlington Road Elevation showing No161 (white building)

The original buildings to the terrace, like those built later to the south, were typically three storey over basement, with lightwells to the front and back. The front elevations were of London Stock brick, rendered up to first floor level and exposed above. Unlike the later buildings to the south, the houses at No155-161 only have a single window on each floor - those further south have two windows.

The construction of the buildings was traditional in nature with timber joists spanning front to back between the external masonry walls and the central spine wall, brick at basement and timber stud over. The original roof structure appears to have been a butterfly roof set behind the front parapet wall with a central valley supported by a beam running front to back.

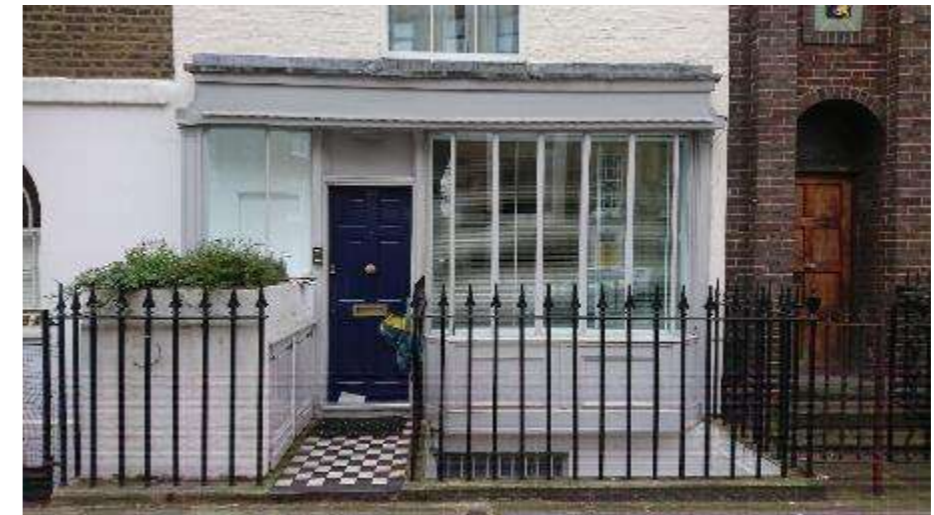
Figure 8: No161 Front ground floor shop-front.

No 161 Arlington is also unusual in that it has a projecting shop window at ground floor (on the right looking from street) and door set off centre, the entrances on Nos157 and 159 are set to the left.

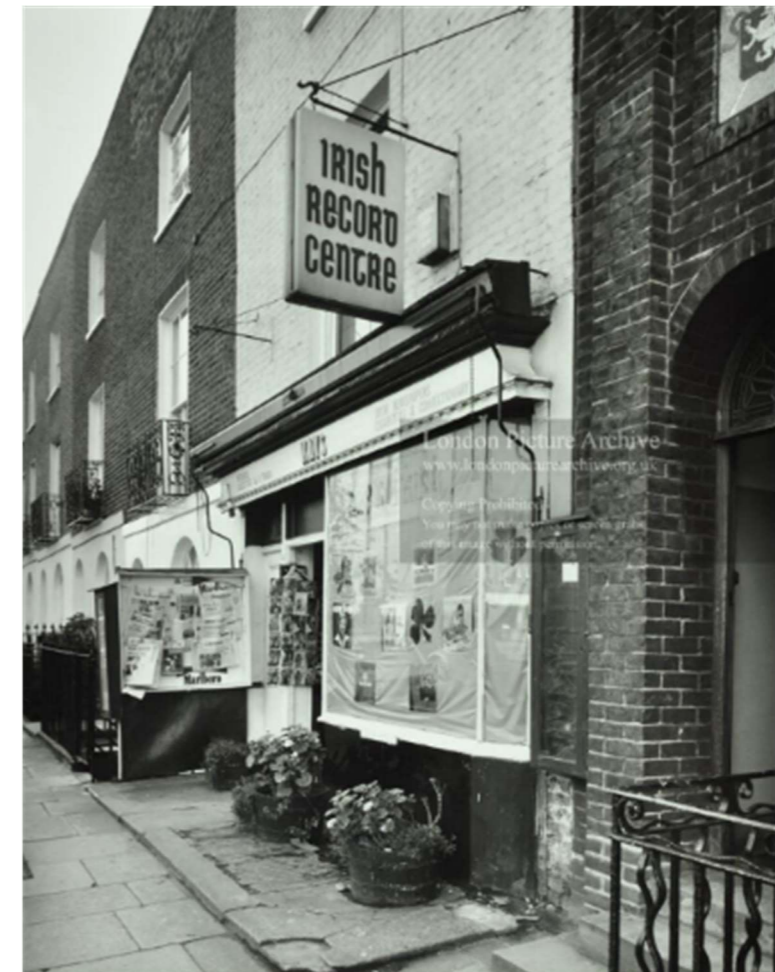
Figure 9: No 161 Shop Front c1977

A historic photograph from The London Picture Archive shows the shop front to No161 Arlington Road in 1977 largely as it exists today, except the separate door to the flat above is present, the front lightwell is covered and the present-day railings at the front are absent.

Planning records indicate the property was converted to a single residential property c1987 (from shop and separate flat over) and in c1992 a rear extension and mansard level were added. It is likely that the alterations from the 1977 photograph were undertaken as part of the 1987 works.

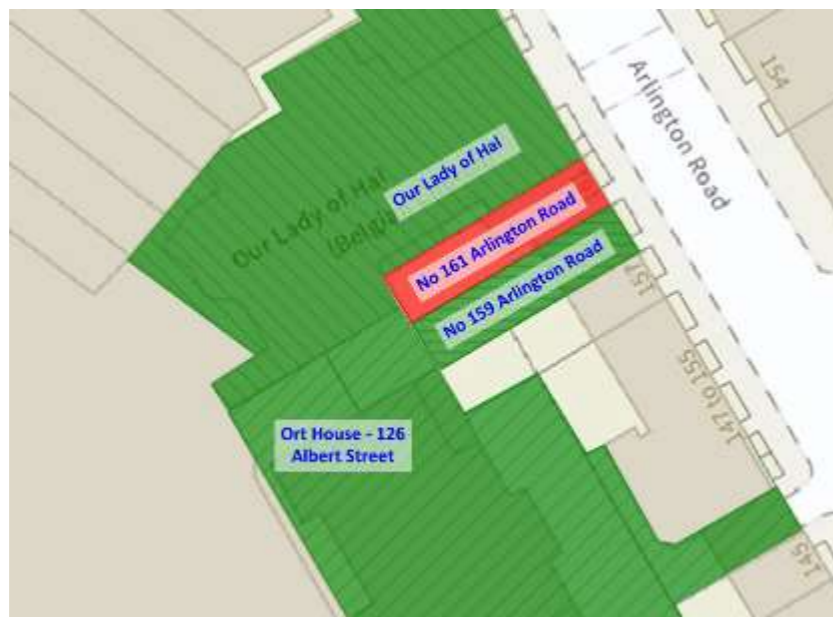
Figure 10: Plan Showing Adjacent Buildings

The following plan shows 161 Arlington Road and the adjacent properties.

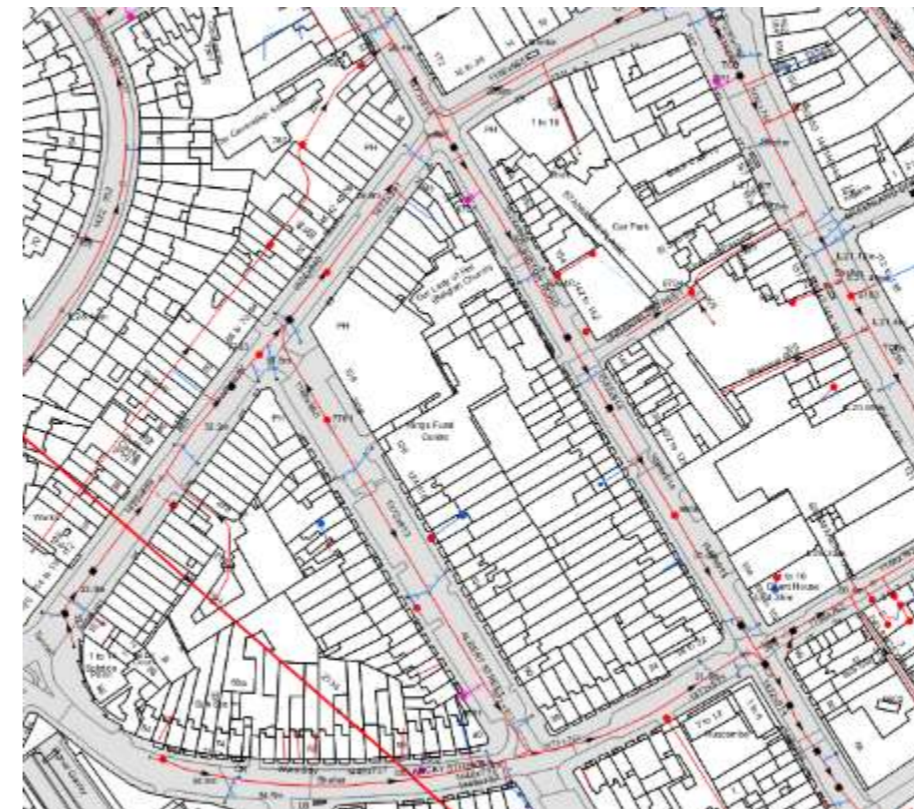
Figure 11: Thames Water Sewers

Thames Water record drawings show an existing Thames Water Authority oval sewer running southwards along Arlington Road. TWA records show the sewer dimensions as 1524x940 with an invert level of 7.2m below street level.

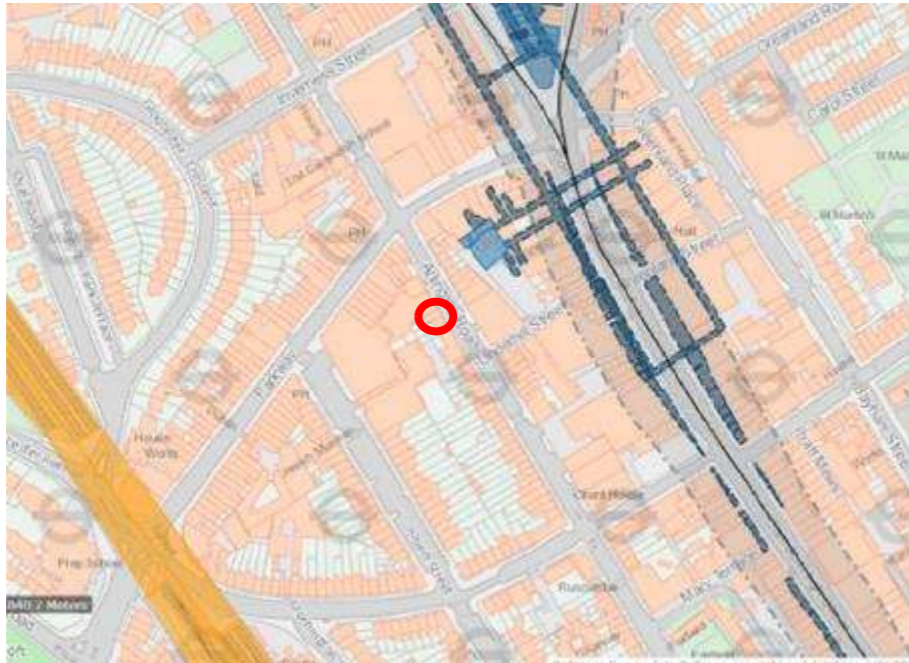
Figure 12: Infrastructure near Arlington Road

The following extracts from TFL's Property Asset map shows the approximate extent of existing railway and tube infrastructure in the vicinity of Arlington Road.

The Northern Line tube tunnels were originally constructed as part of Charing Cross, Euston and Hampstead Railway running from Charing Cross to Golders Green and Highgate during 1902 and 1907. South of Camden Town the tunnels run under Camden High Street, approximately 100m east of the site, and consist of two pairs of tunnels (Edgware and High Barnet branches) with the northbound tunnels set above the southbound tunnels.
