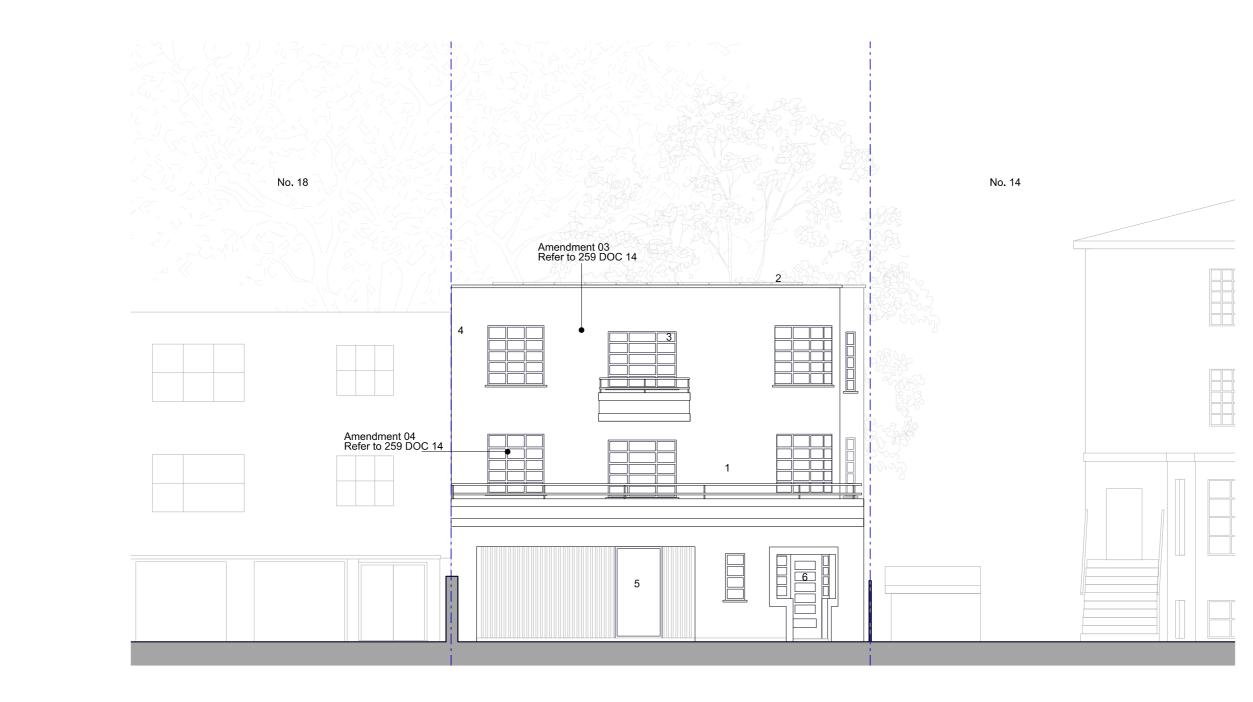
- 1. External insulation and smooth render, restored Art Deco ironwork
 2. Possible glimpse of solar panels on roof
 3. Replace existing windows with high performance Magis 40 windows, to match aesthetic of existing windows.
 4. Gap between buildings closed by insulation
 5. New entrance screen to be covered by condition of approval
 6. Existing entrance to upper floor flats
