**06 Garden Studio**

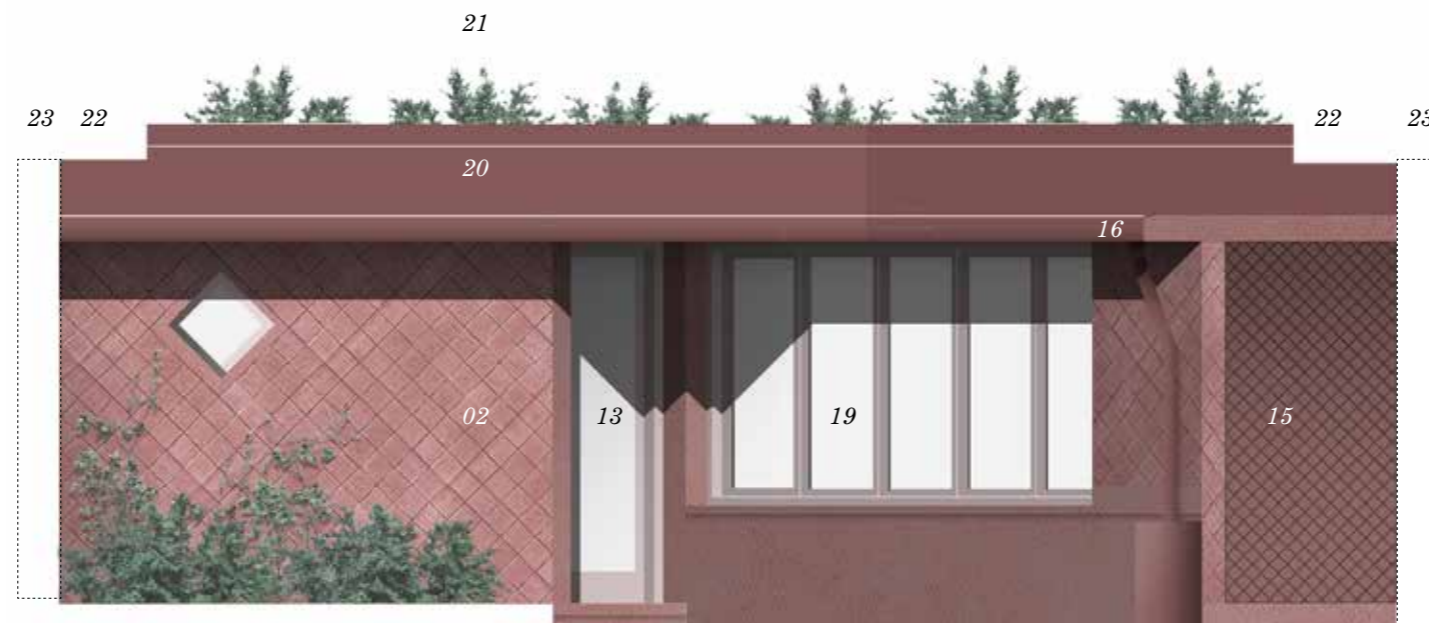
- 01 Stone coping with decorative finial
- 02 Facade constructed of stone bricks
- 03 Stone surround to arched window
- 04 Arched bi-parting framed white window
- 05 Set back to facade (preserving light to adjacent window)
- 06 Stone cill
- 07 Stone parapet / Lintel
- 08 Stone mullion / Stone cill
- 09 Retained window to no.10B
- 10 Planter

- 11 Stone surround and inset to entrance
- 12 Oriel window to study
- 13 Fully glazed entrance door
- 14 Recessed porch with niche

- 15 Bespoke metal doors (colour matched)
- 16 Hoppers and downpipes (colour matched)
- 17 Stone surround to circular window
- 18 Circular opening window
- 19 Sliding / folding white glazed screen
- 20 Bronze copper fascia
- 21 Wildflower roof
- 22 Pebble margin to create buffer from garden wall
- 23 Adjacent garden walls

*Illustration 6.15 (Revision A 13.05.24)  
Proposed South-facing facade materials.*

The studio contains one main façade fronting onto the garden which is made up of the same materials as the main house. The east and west bounding walls rest inside and against the adjacent refurbished garden walls to no. 9 and no.10A-D Lyndhurst Road. The roof is a flat wildflower roof (21). To retain a perceived gap between the outbuilding structure and the garden wall a pebble margin separates the green wildflower roof from the brick wall capping (22)

A garden store is recessed into the east side of the structure and contained by metal powder coated doors.

The materials are illustrated in the adjacent drawing and are all from the same palette as the main building.
