STRUCTURAL REPORT

Ref: 66 Heath Street, London, NW3 1DN

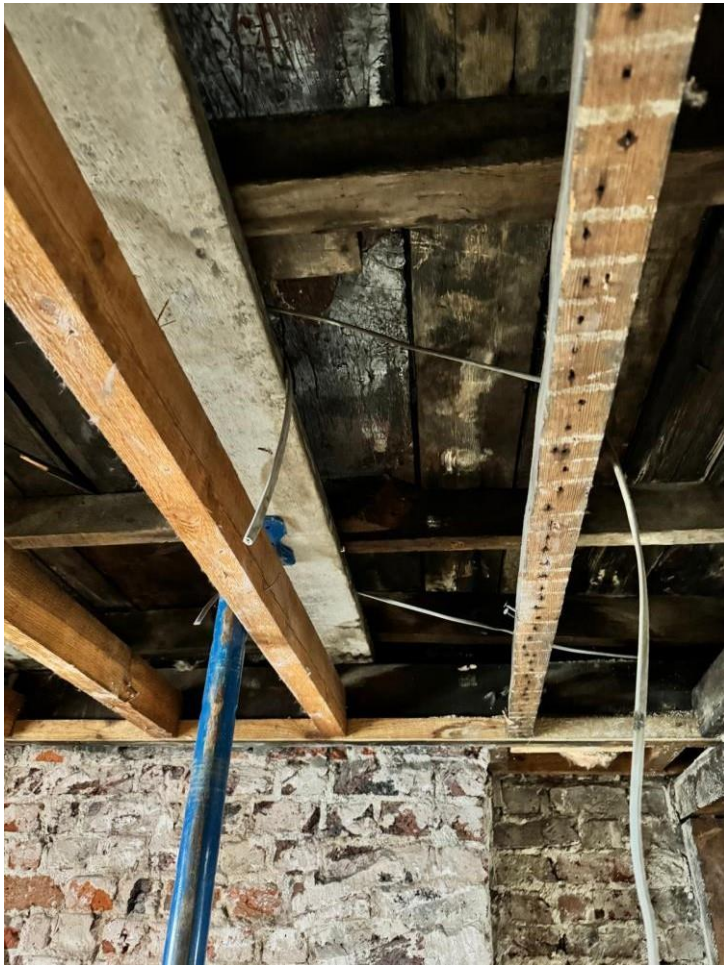
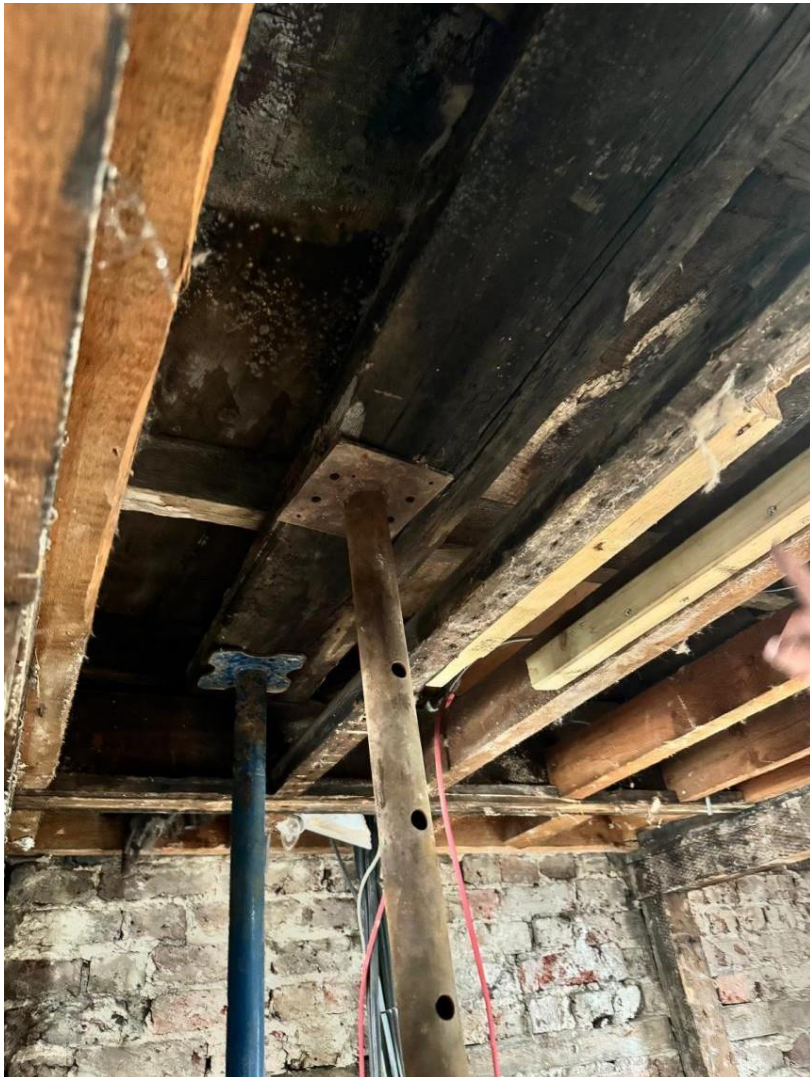
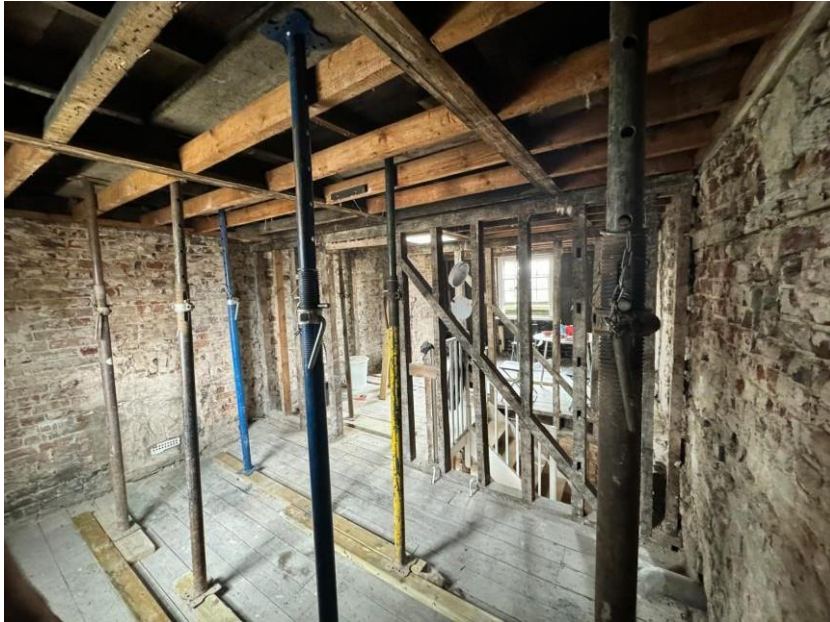
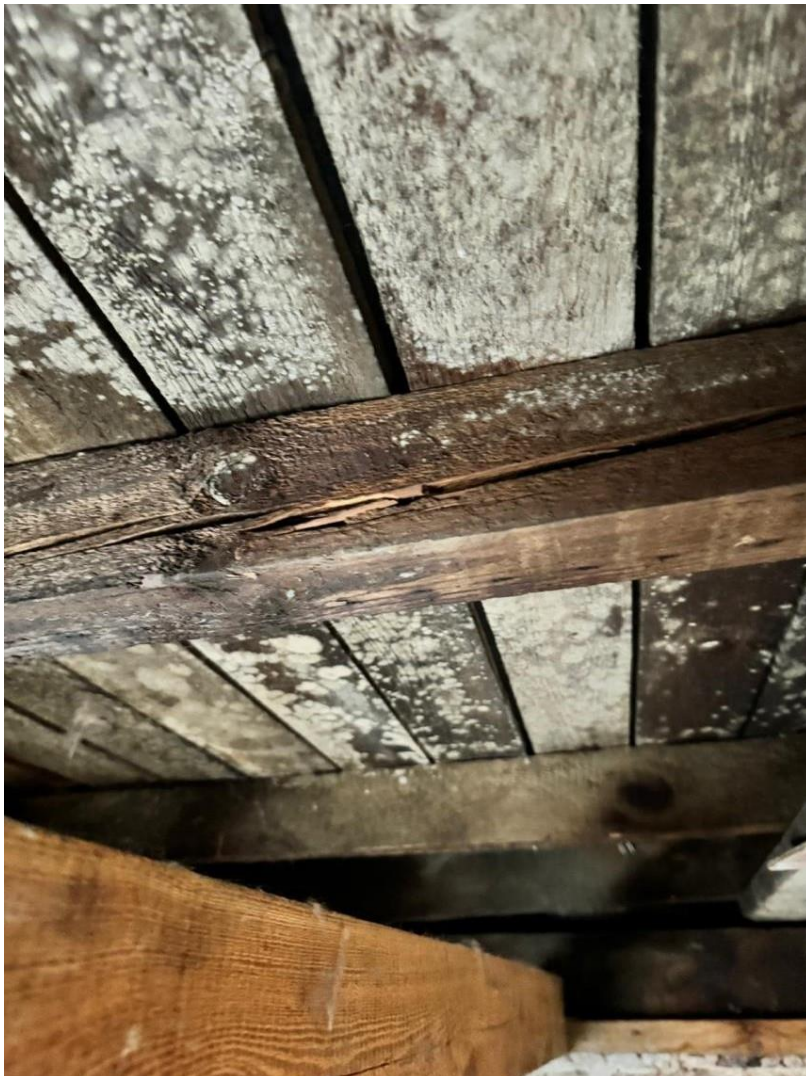
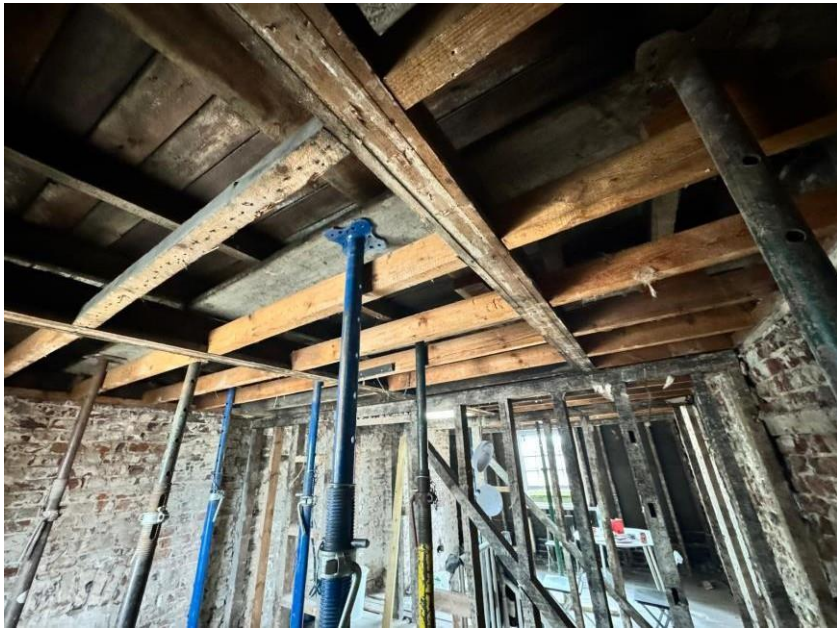
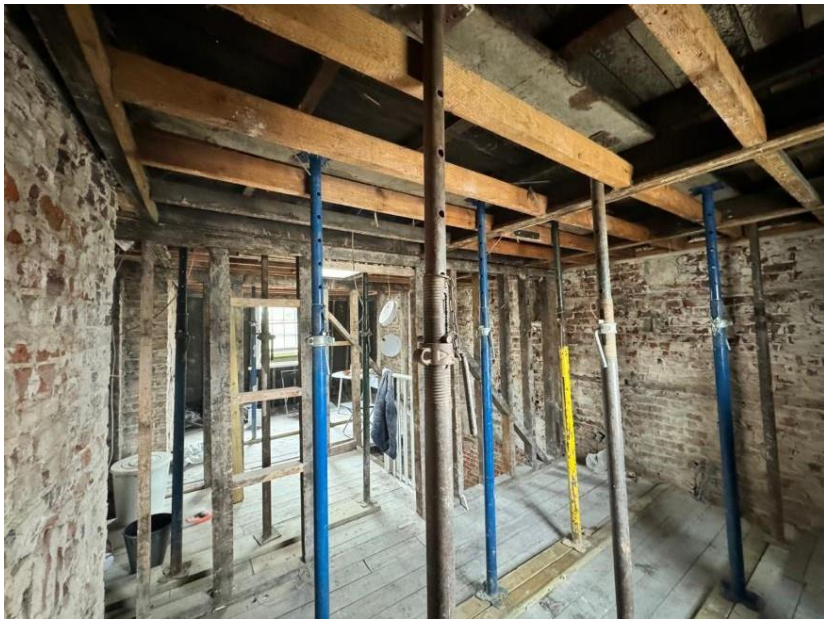
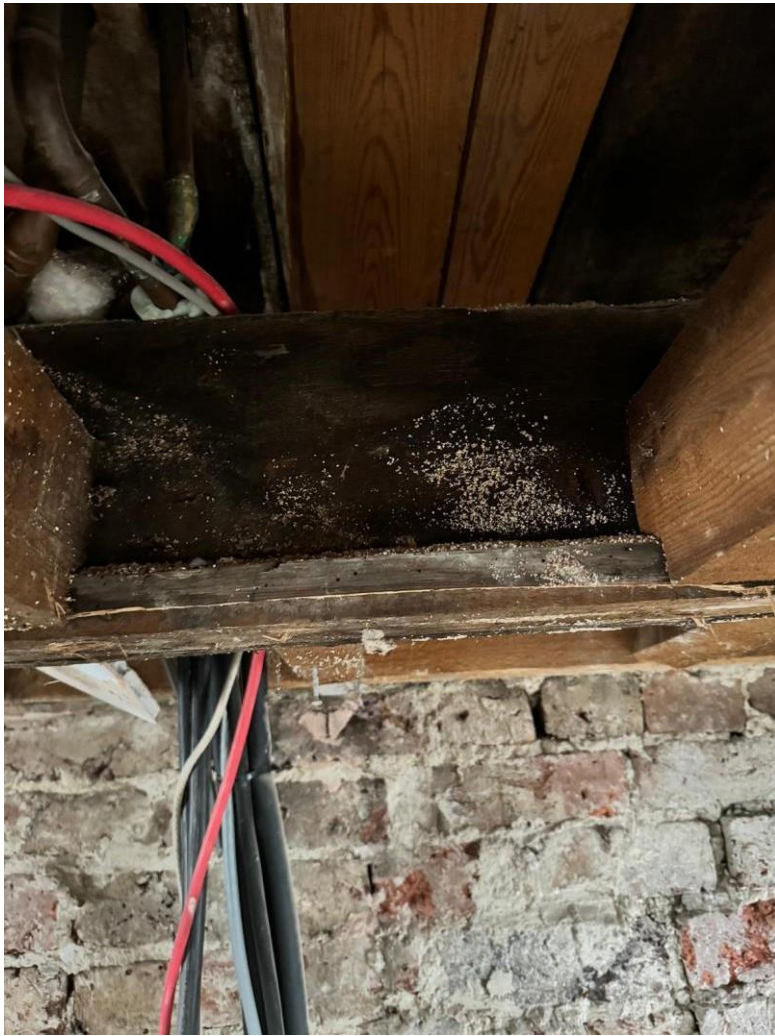
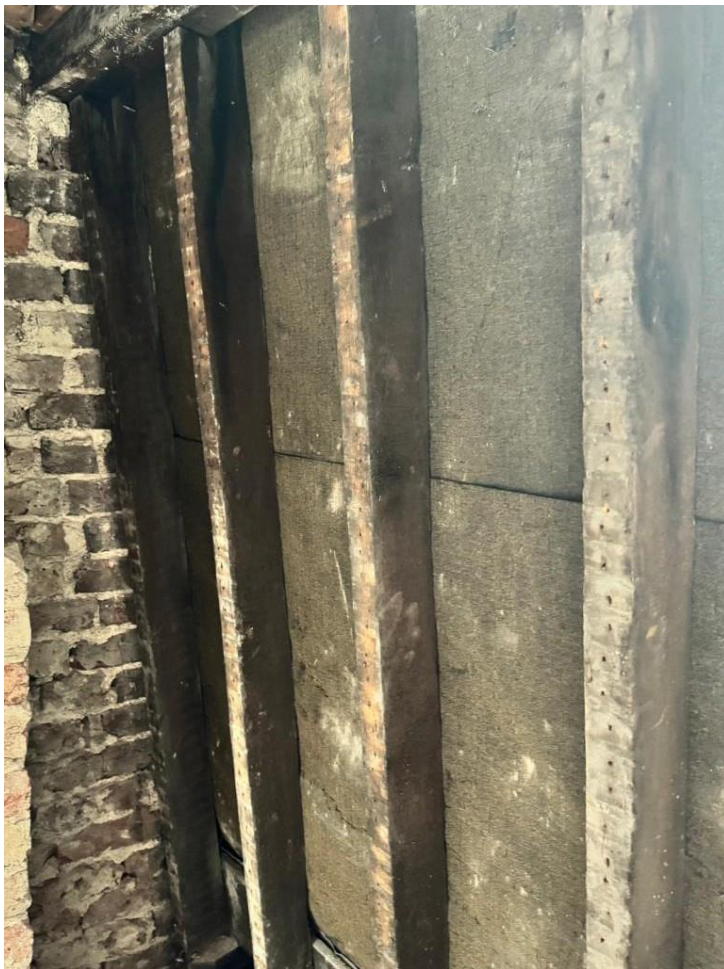
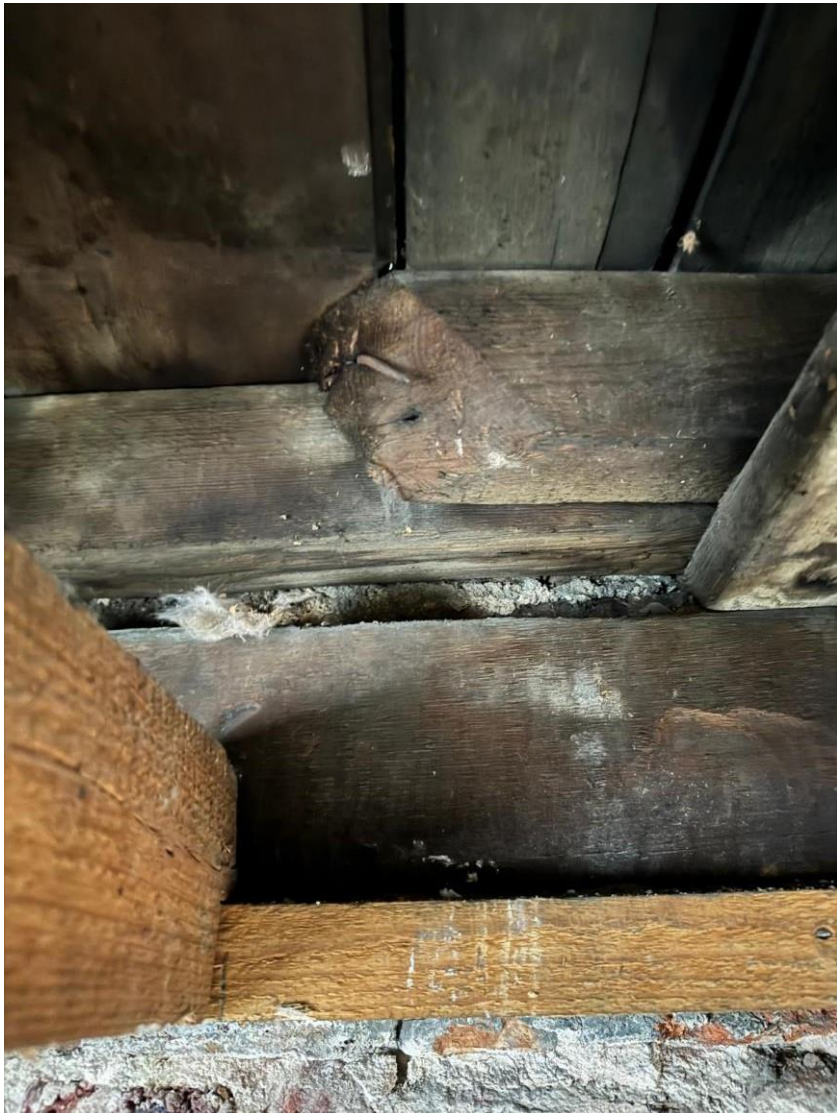
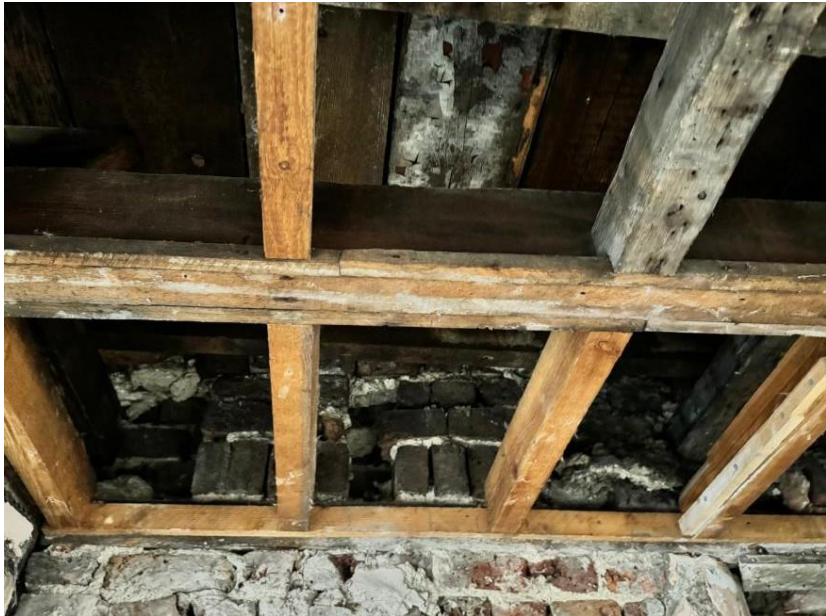
Roof finishes including flashing has not been maintained for a long time and therefore heavy leakage has been noticed.

Ceiling under roof have been flooded for a long time including insulation.

Entire roof finishes, ceiling and isolation is heavily damp and in danger of collapse.

Some of the existing roof timber roof joists appear to be rotten and needs to be replaced on like for like bases.

See attached photographs showing underside of the existing roof.

From our observation we suggest that the roof finishes, flashing, ceiling and insulation would need to be replaced immediately as they are in danger of collapse.
