Tree Protection Plan showing surveyed trees & protection measures

Project Name and Address
**12 SARRE ROAD,
LONDON, NW2 3SL**

Project No 20052	Sheet 1 of 1
Date 2024-07-13 19:55:18	
Scale 1 to 150 at A3

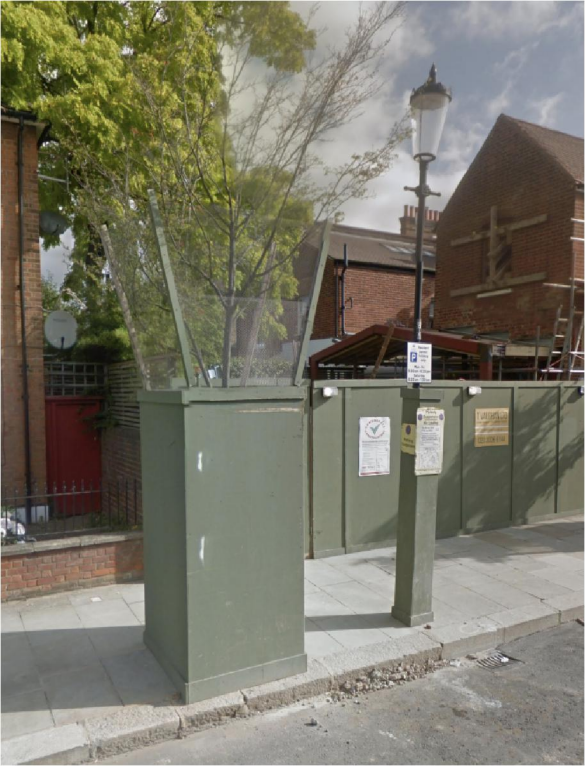
Hoarding Specification

Protective hoarding to be installed prior to main construction phases and to be maintained in place throughout

Hoarding to protect T's 1 & 2

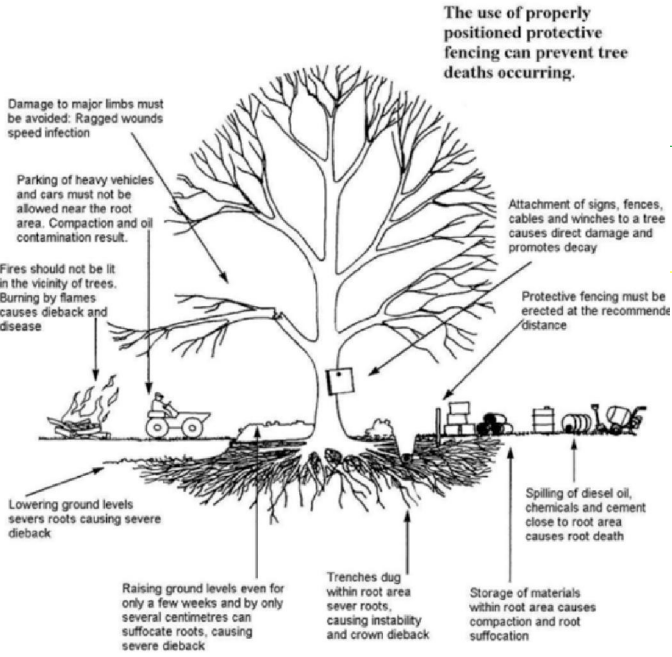
Common causes of Tree Death

Storage of chemicals is prohibited near or around the base of trees

Storage of building materials and machinery prohibited on RPA's unless on existing hard-standing

Washing out of tools and equipment should be done well away from retained trees

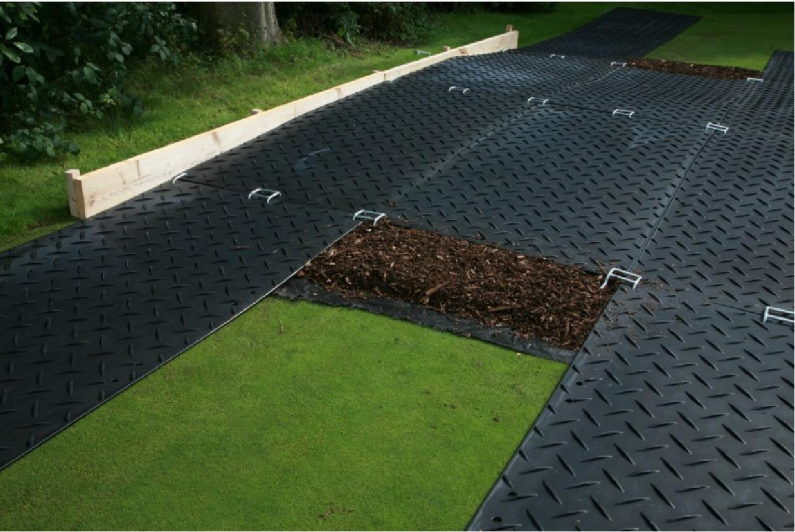
Temporary boarding to be used as ground protection within the RPA's to minimise use of fencing

Temporary Ground Protection
