## ANDREW LISMORE ASSOCIATES: DESIGN AND ACCESS STATEMENT PROPOSED BOUNDARY WALL ALTERATIONS, 82 FAIRHAZEL GARDENS LONDON, NW6 3SU: 05 JULY 2024

#### 1.0. THE PROPERTY

### 2.0 PROPOSALS

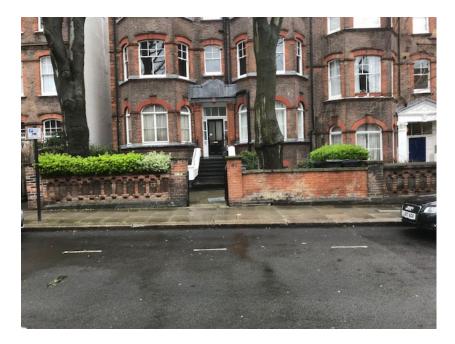
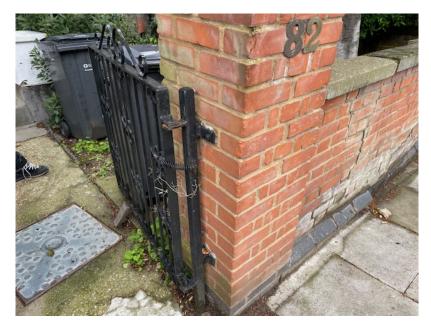
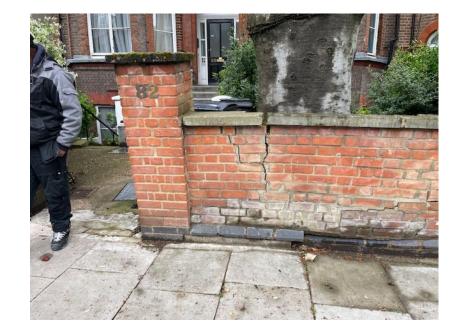
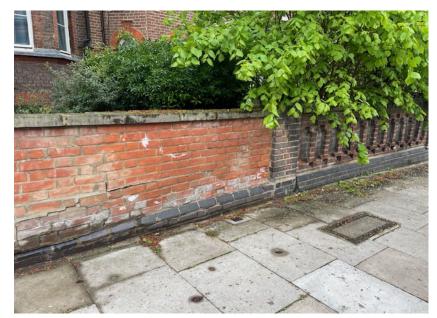
- B. The tree to the right of the property entrance is situated directly behind the front boundary wall. It currently has a girth of approximately 800mm and an above ground root ball of 1000mm in diameter (photographs 5-8). As the tree has grown it has impacted the boundary wall. Currently there is a significant vertical lean towards the public footpath and the brickwork section adjacent to the tree has significant cracking and distortion (Photographs 1-4).

- D. Despite these measures the tree has continued to impact on the boundary wall with significant cracking more than 20mm wide and vertical displacement/leaning towards the public footpath to that renders the wall potentially unstable.

- E. As previous partial rebuilding has not been successful It is proposed to demolish the wall completely up to the boundary pier with No 80 and install a set of prefabricated metal railings and gate post. The existing engineering brick plinth will be retained and made good.

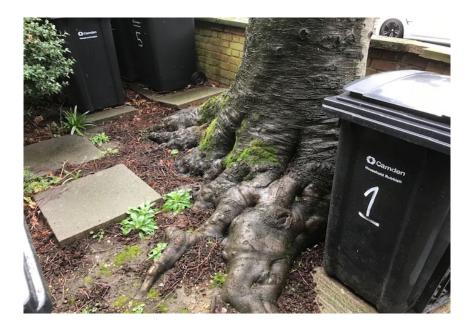
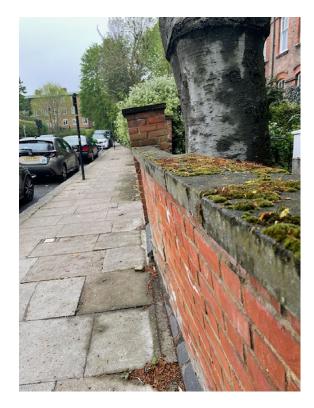
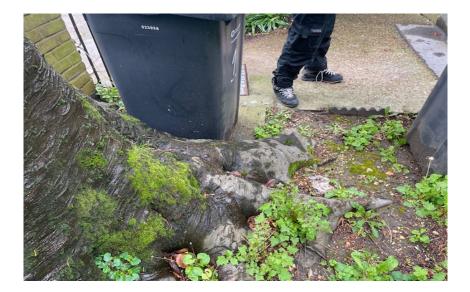
- C. It is evident that Fairhazel Cooperative have carried out repairs to the boundary wall in the past to mitigate earlier tree damage. As recently as 2022 a large section of the wall was rebuilt. To mitigate the impact of the tree the section of wall immediately behind the tree was reduced in thickness and the tree roots bridged where possible with concrete bridging lintols.

- F. The listed status of the tree severely restricts the ability to reduce the impact of the tree on the brickwork boundary wall. Repairing/partially rebuilding is not economically viable as the wall has failed within 2-3 years of major repairs rebuilding a large part of the wall.

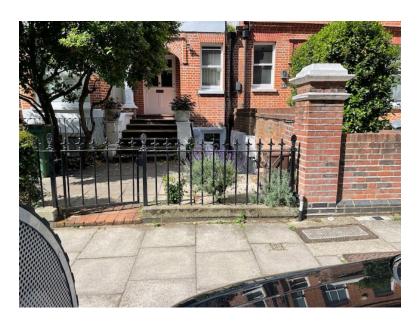
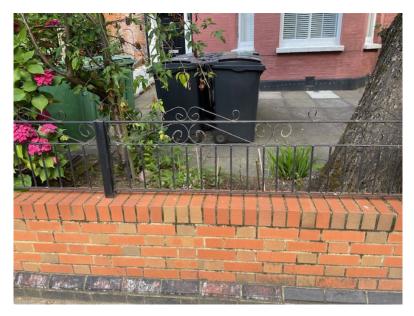
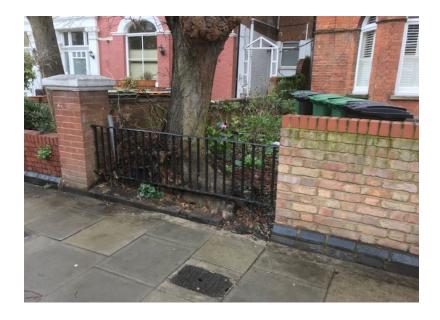
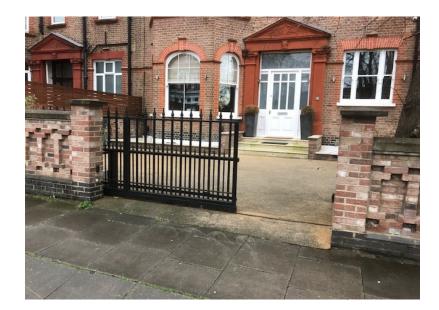
- G. We believe there is precedent for replacing the boundary wall with metal railings. It is evident that several nearby properties have carried out similar boundary wall alterations with the insertion of metal railings or removal of wall sections altogether with the replacement of vehicle access crossovers and access gates (**Photographs 9-12**).
