Existing Front Isometric

Planning

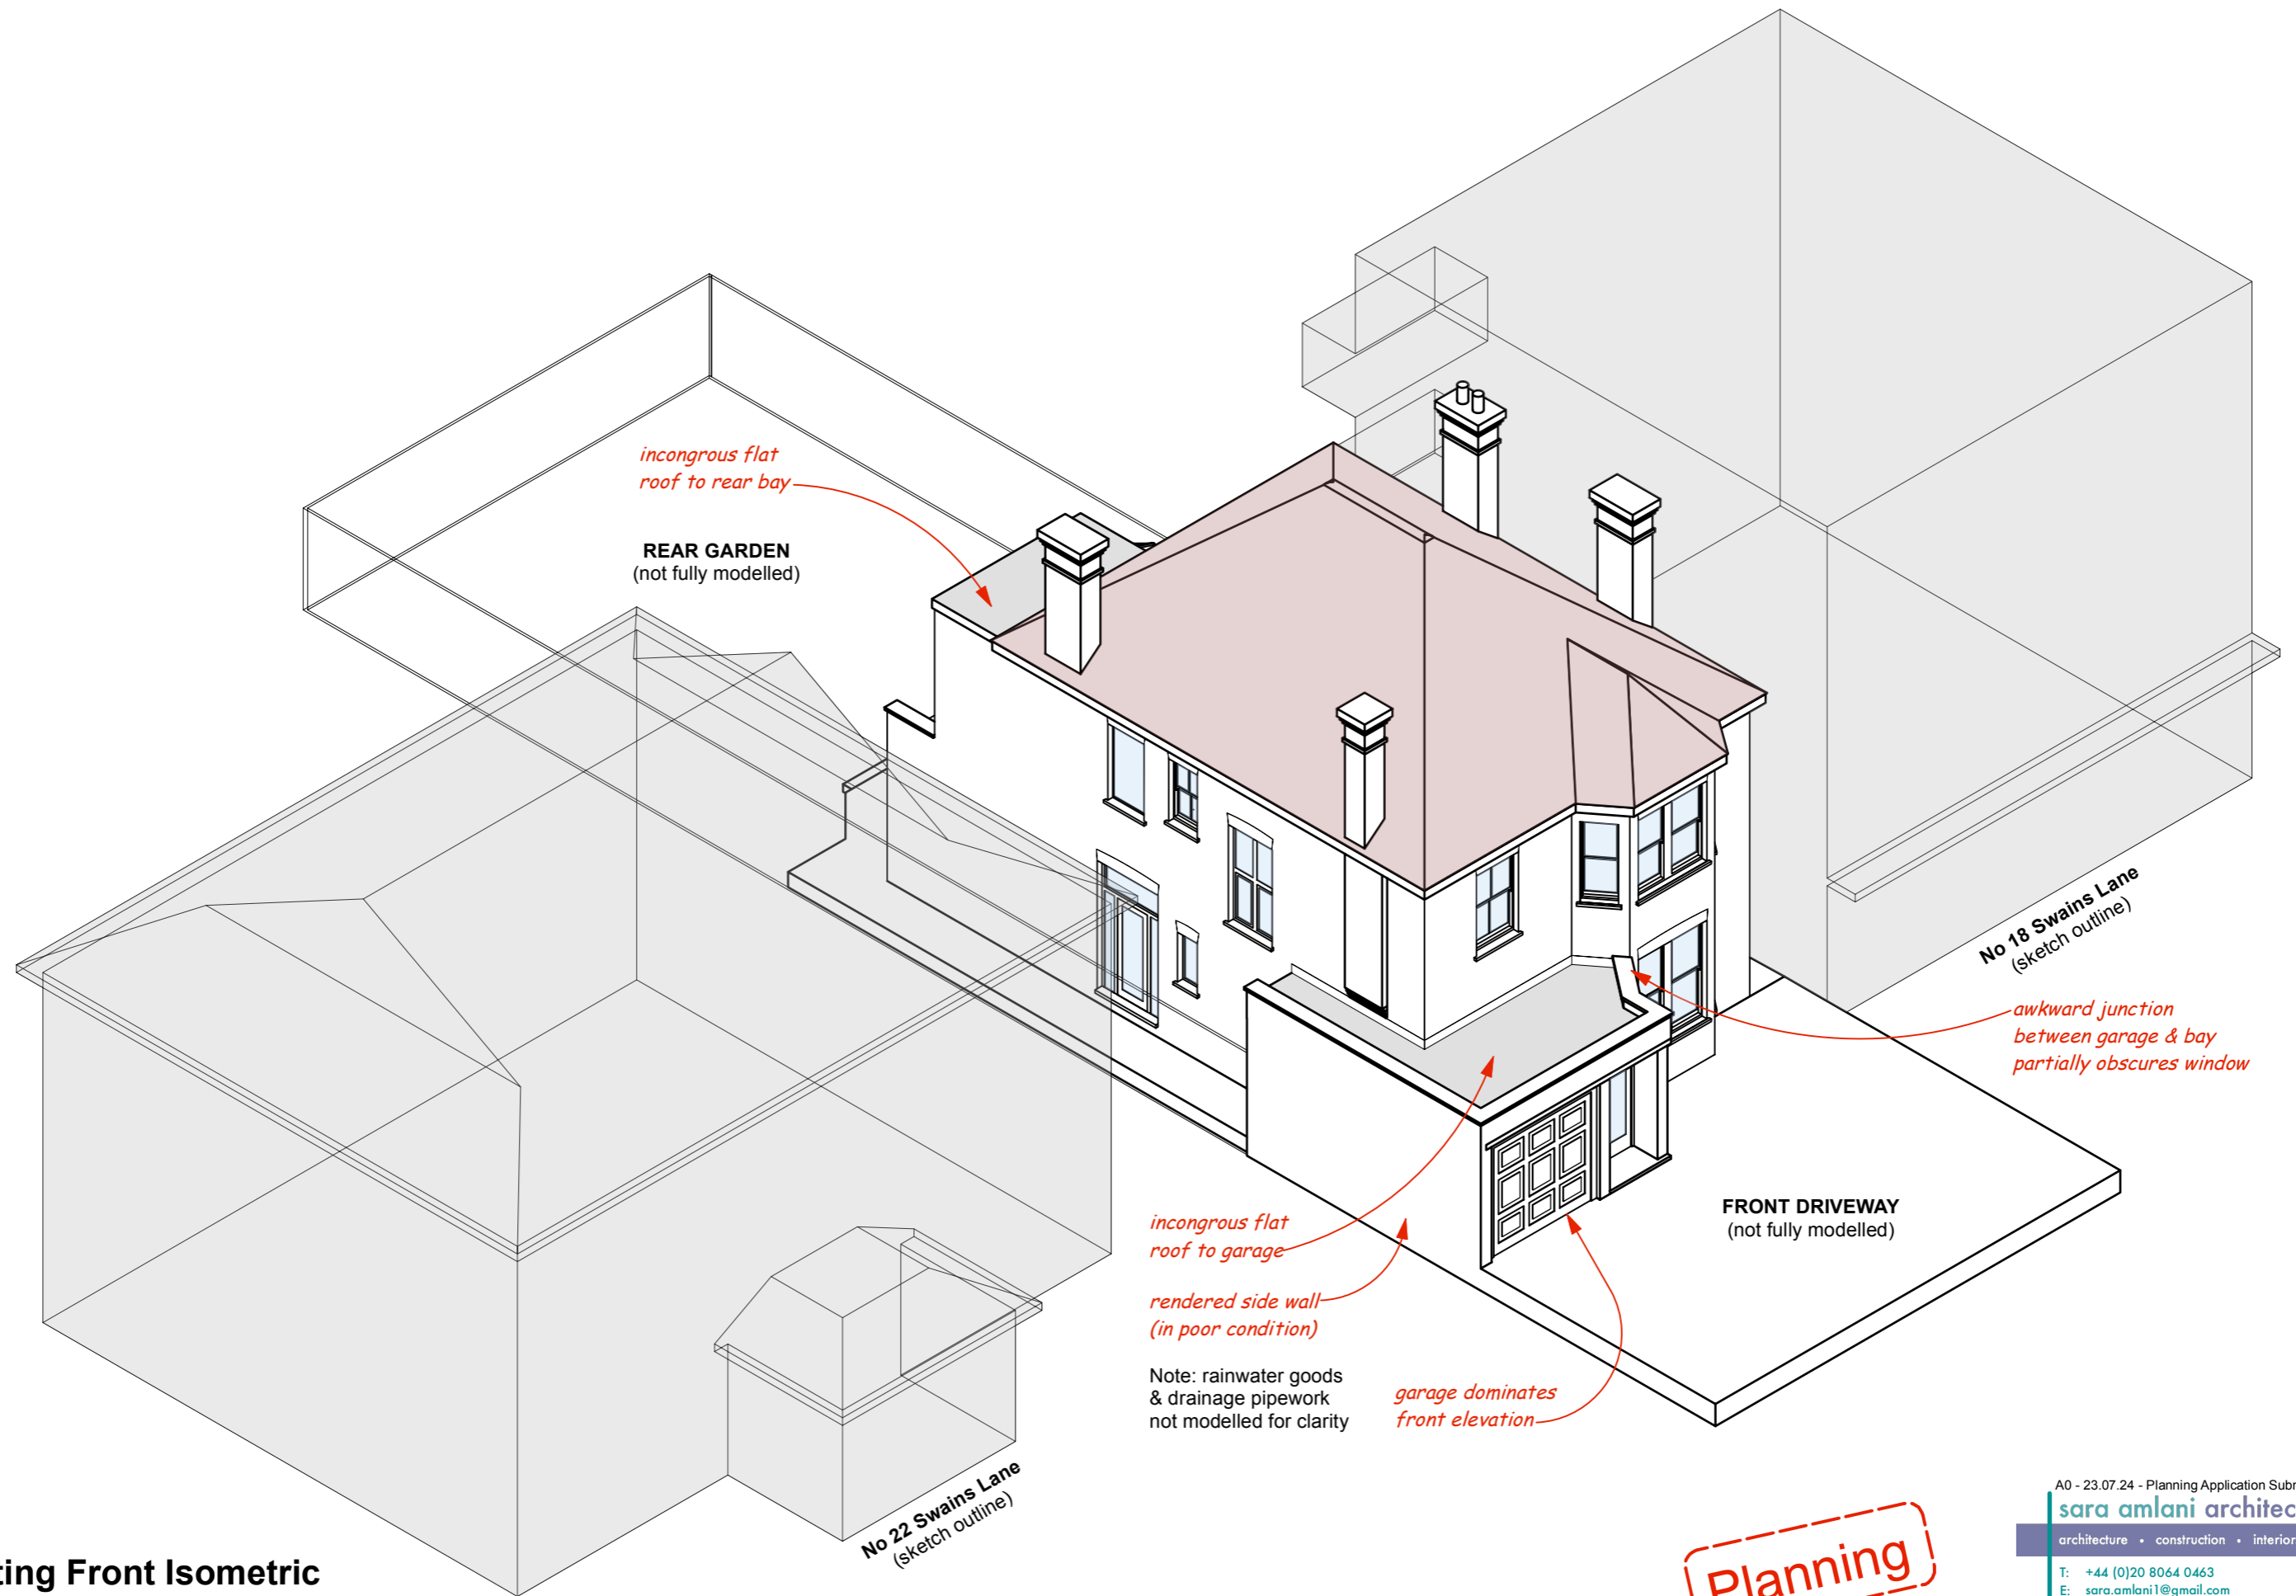
incongruous flat roof to garage

rendered side wall (in poor condition)

garage dominates front elevation

awkward junction between garage & bay partially obscures window

incongruous flat roof to rear bay
