# CRACK MONITORING

## for SMS (LV)

**29 Edis Street, London, NW1 8LE**

Report Date: 17 July 2024

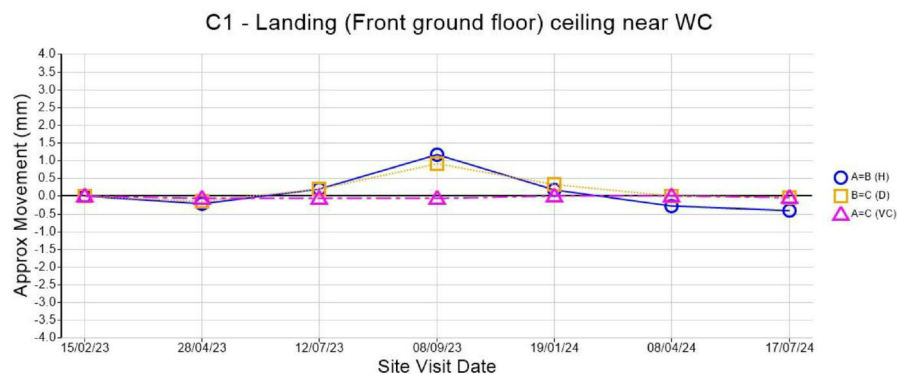
The following graphs display the progressive movement that each Crack Monitoring Station recorded at each separate site visit date to give an overall look at how much the property is moving.
