JAMES DANIEL DEVELOPMENTS (JDD) LTD

ITEMS IN PROGRESS

26 OLD GLOUCESTER STREET

NAME: REBECCA VINEY CLIENT NAME: REBECCA VINEY  
REFERENCE: 26 OLD GLOUCESTER STREET CLIENT TELEPHONE: 07957203569  
DESCRIPTION: ITEMS TO BE DISCUSSED DUE TO ADDITIONAL WORKS BEING UNCOVERED  
ITEMS: 8

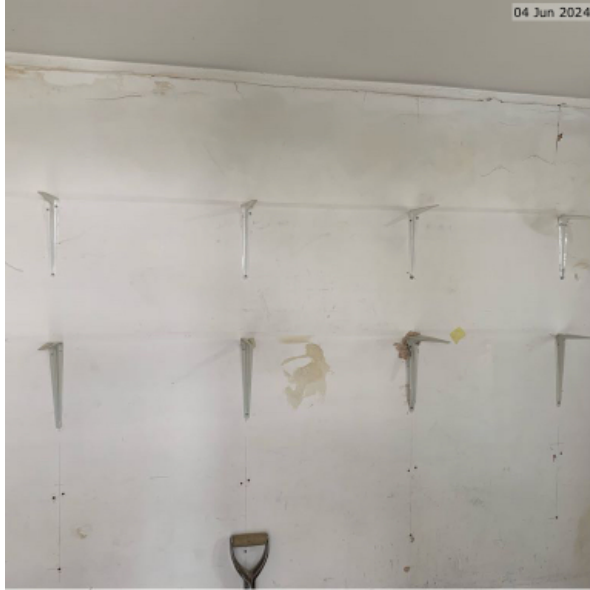
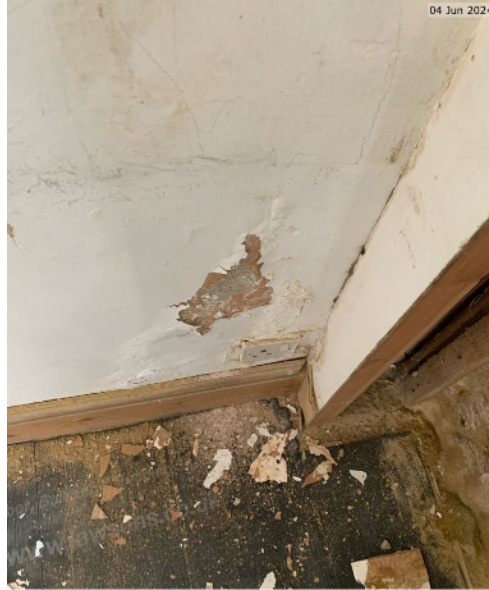
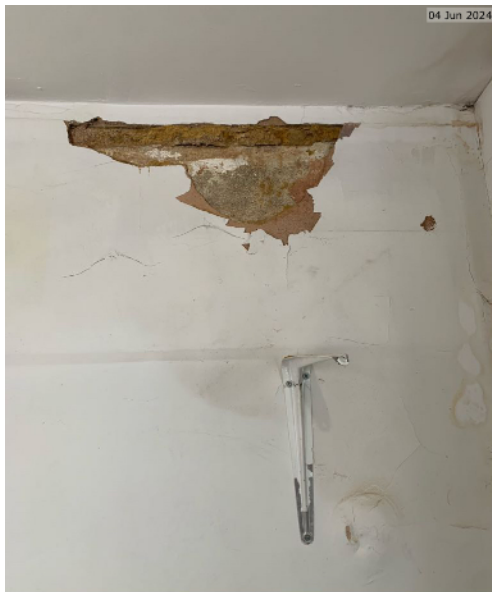
OFFICE LHS WALL

DESCRIPTION: ADDITIONAL DAMP HAS BEEN FOUND ON THE LEFT HAND WALL IN THE OFFICE, WE NEED TO DISCUSS NEXT STEPS AND POSSIBLE SOLUTIONS, NOT INCLUDED WITHIN THE ESTIMATE

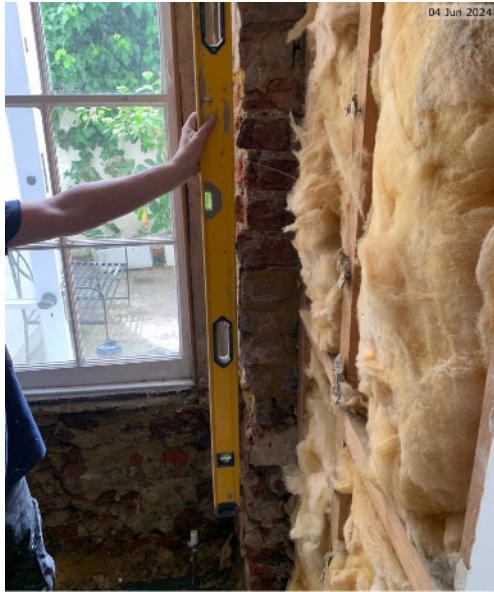
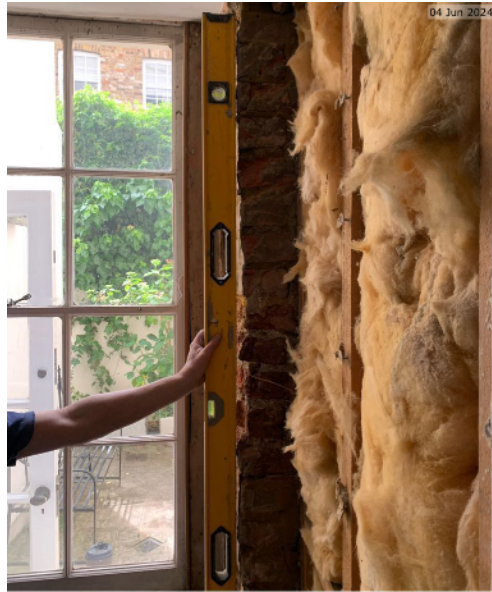
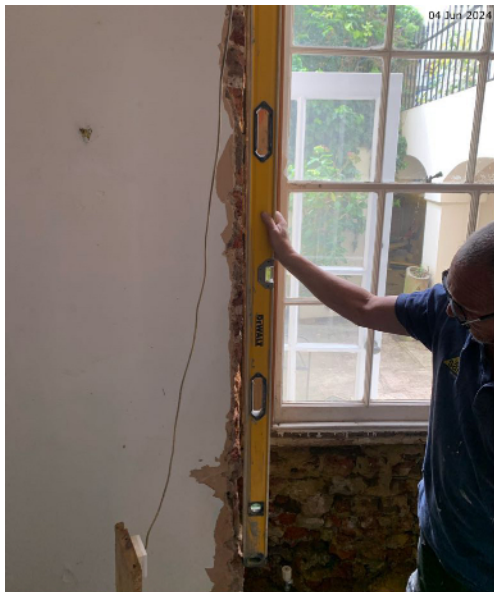
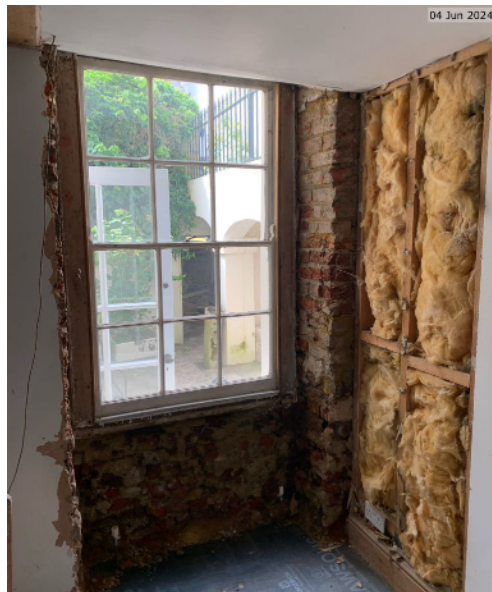
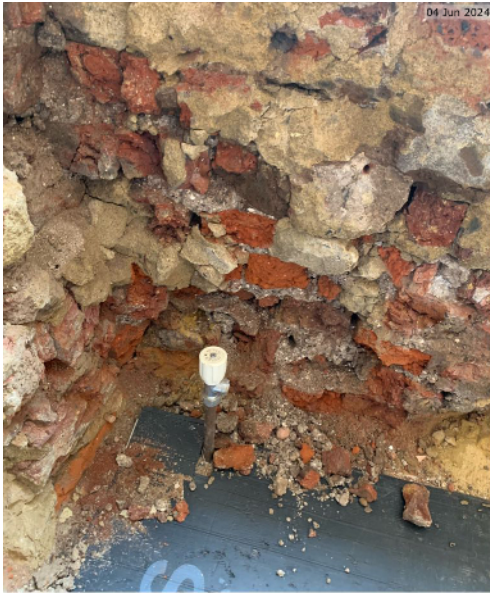
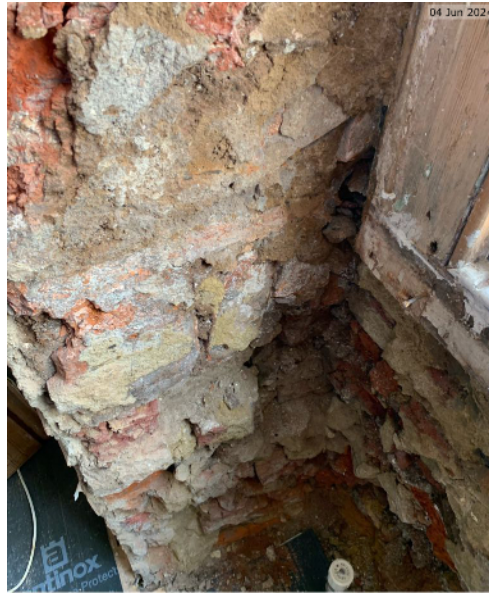
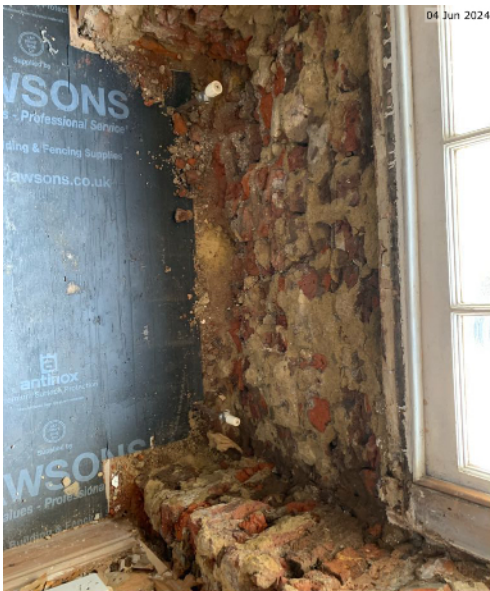
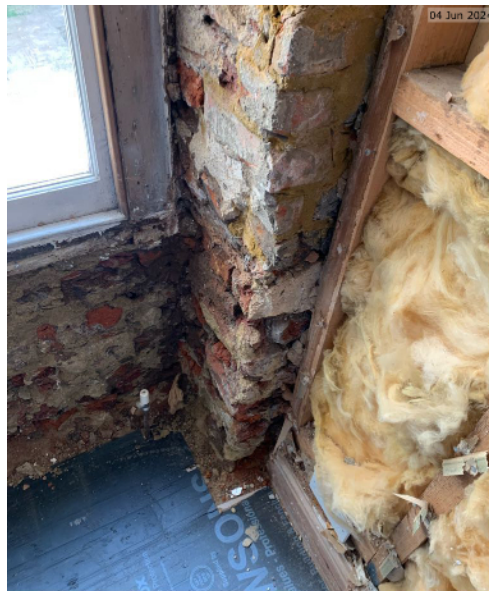
BEDROOM BY STUDY

**DESCRIPTION:** WE NEED TO DISCUSS THE BRICK WORK AS IT IS OUR OPINION SECTIONS NEED TO BE REPLACED DUE TO HEAVY DEGRADATION AND UNEVENNESS. NOT INCLUDED WITHIN THE ESTIMATE.

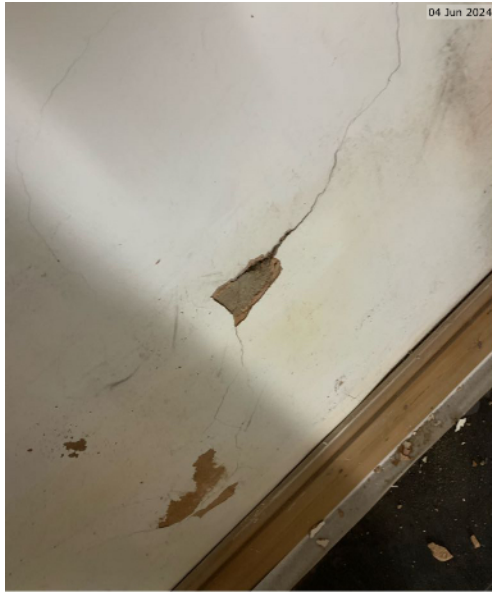
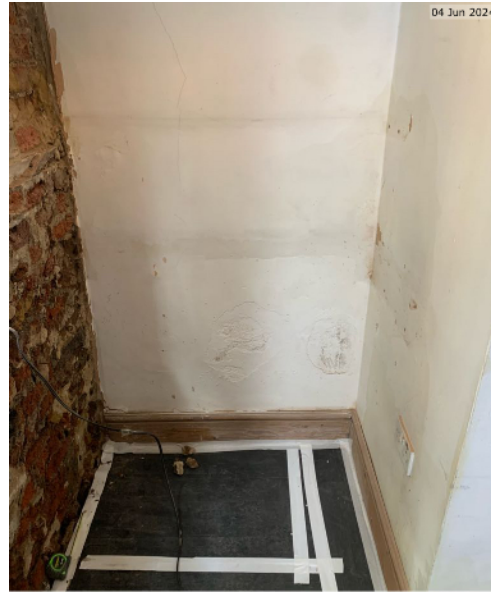
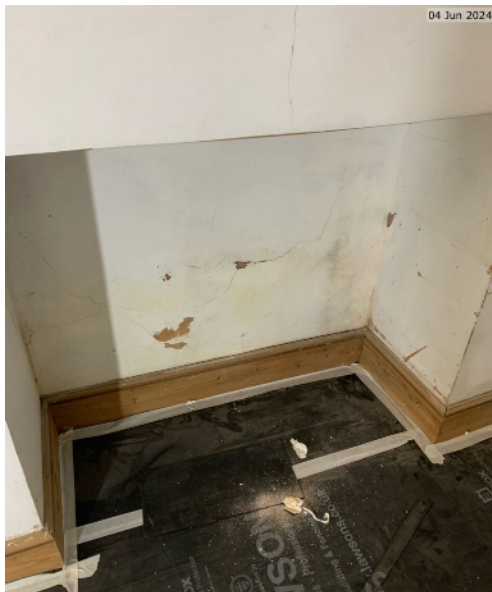
**MAIN BEDROOM**

**DESCRIPTION:** WE HAVE FOUND POSSIBLE ADDITIONAL DAMP NOT RAISED ON INITIAL INSPECTION/ INCLUDED WITHIN THE ESTIMATE. WE NEED TO CARRY OUT FURTHER INVESTIGATIONS AND DISCUSS NEXT STEPS

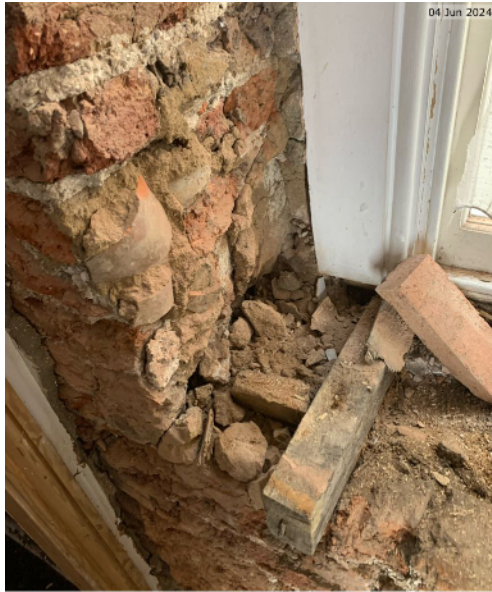
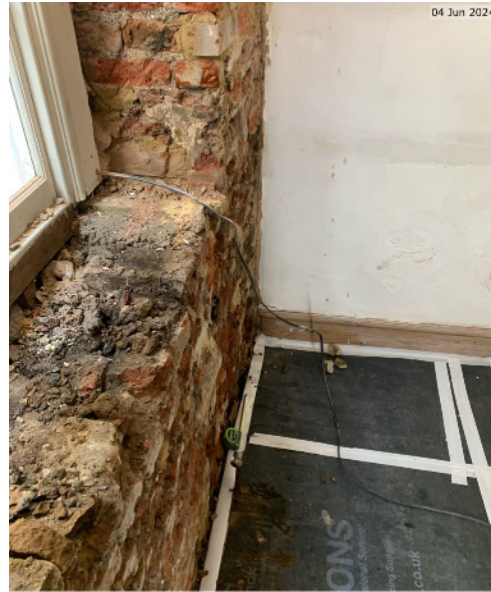
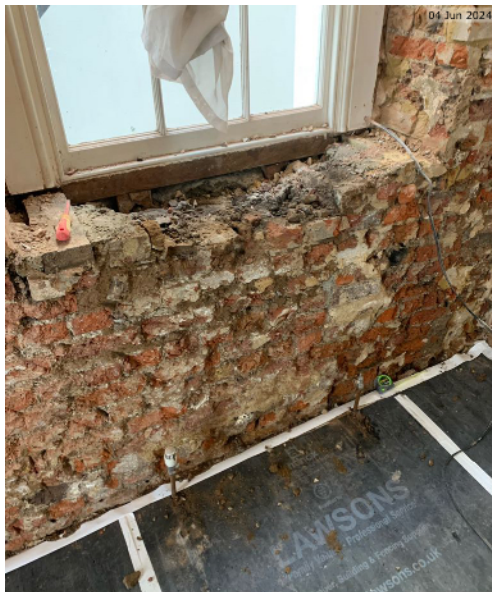
MAIN BEDROOM

DESCRIPTION: THERE ARE BRICK WORK REPAIRS WE NEED TO CARRY OUT TO THE WINDOW OPENING/  
REVEALS NOT INCLUDED WITHIN THE ESTIMATE

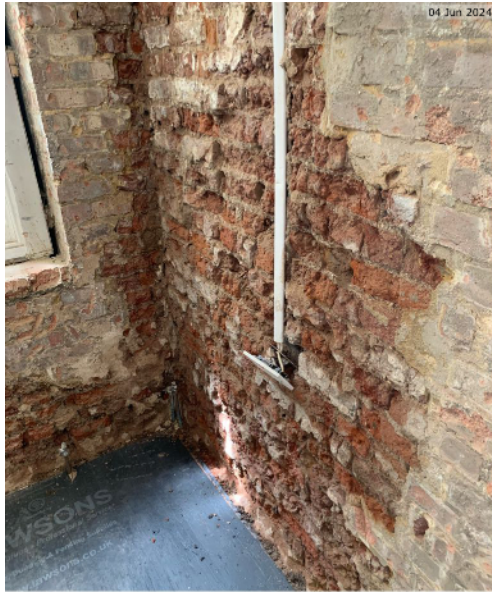
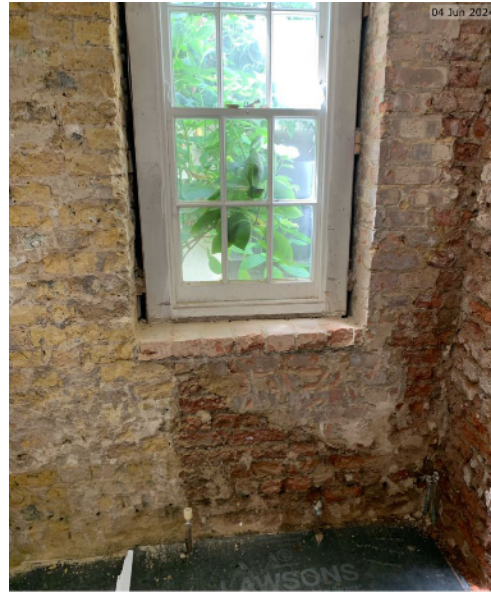
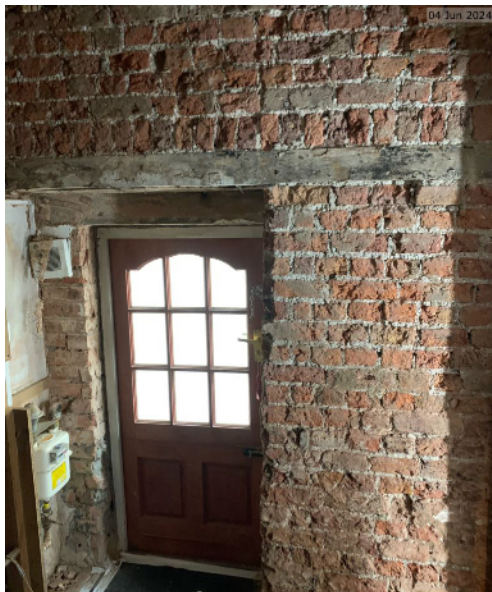
OFFICE, BEDROOM & BATHROOM WALLS

DESCRIPTION: THE WALLS ARE IN AN OK CONDITION THERE IS SOME EVENNESS BUT CURRENTLY SHOULD NOT POSE ANY PROBLEMS. WE ARE GOING TO CHECK PROPERLY BEFORE CONTINUING AS ADDITIONAL MATERIALS MAY BE REQUIRED TO FLATTEN PRIOR TO BEING ABLE TO RENDER CORRECTLY.

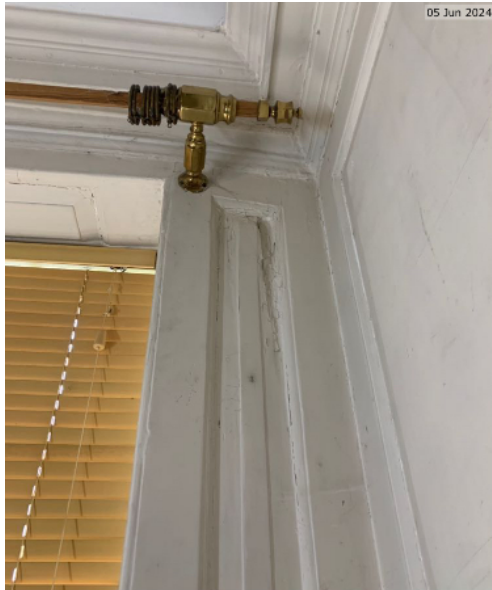
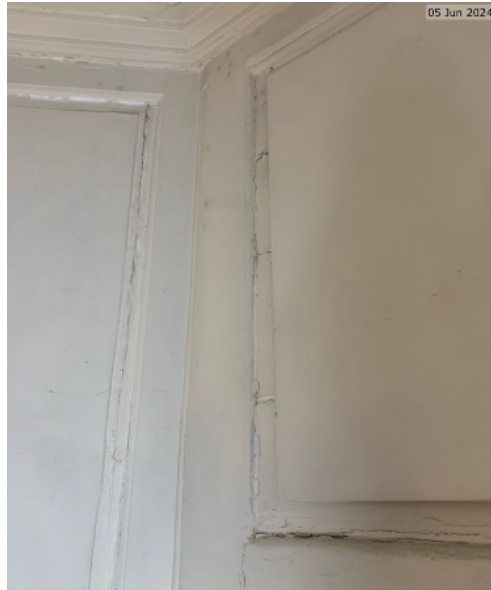
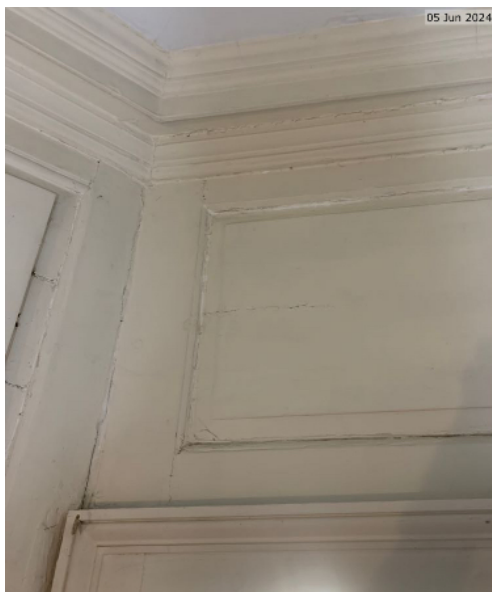
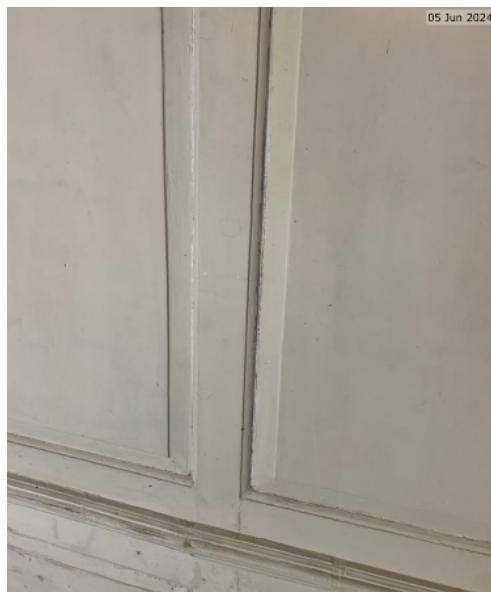
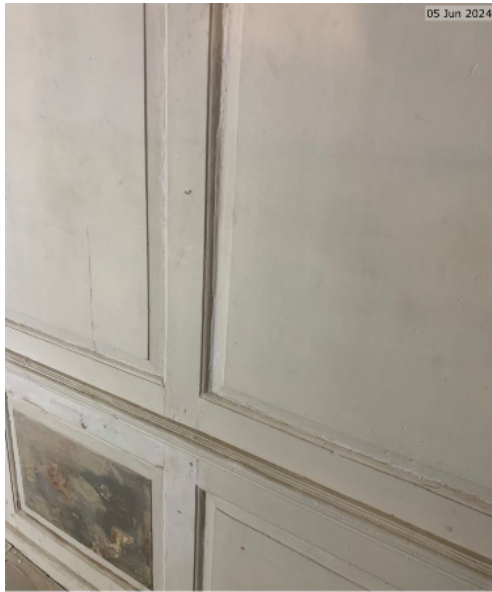
**DESCRIPTION:** THE WOOD PANELLING HAS BEEN SILICONED AND NOT CAULKED. THIS IS WHY THE PAINT WAS CRACKING AND FLACKING. WE NEED TO DISCUSS STEPS MOVING FORWARD AS THIS WILL CAUSE PROBLEMS WITH THE FINISH UNLESS SORTED. NOT INCLUDED WITHIN THE ESTIMATE.

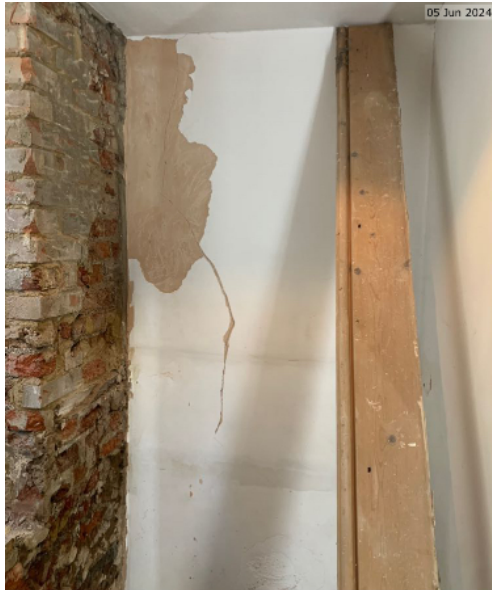
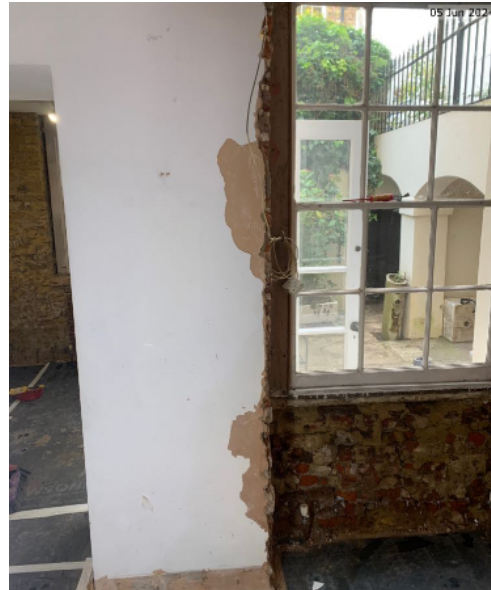
**BLOWN PLASTER**

**DESCRIPTION:** THERE ARE PATCHES/ AREAS OF BLOWN PLASTER IN THE MAIN BEDROOM AND BEDROOM BY THE OFFICE. NEED TO DISCUSS NEXT STEPS AS NOT INCLUDED IN THE ESTIMATE

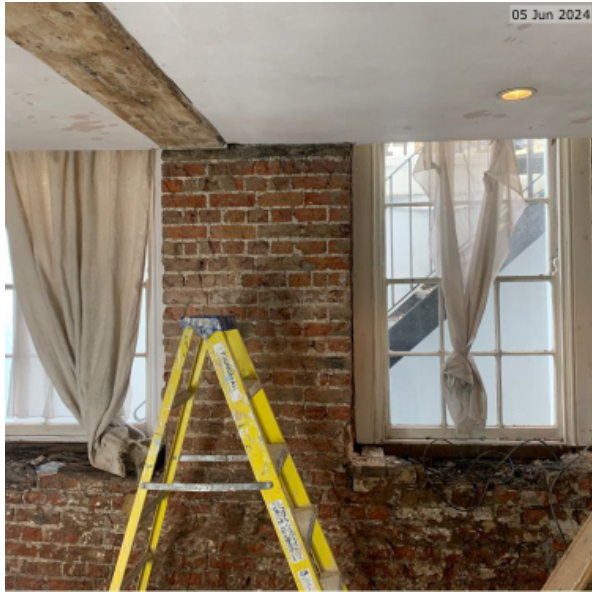
**BEDROOM**

**DESCRIPTION:** THE MAIN BEDROOM WINDOWS HAVE BEEN PAINTED SHUT PREVIOUSLY FROM THE OUTSIDE
