REPORT No: FR230724NW52HR

153 Fortess Rd London, NW5 2HR ENVIRONMENTAL NOISE SURVEY

ODOUR RISK ASSESSEMTN AND MANAGEMNT PLAN

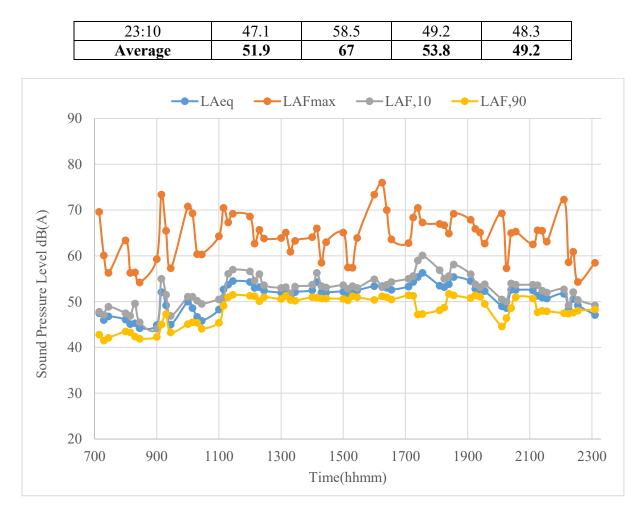
Figure 1: Day Sound Pressure Levels measured at the rear of the site.

Measured residual ($L_{Aeq,1h}$), and background ($L_{AF90,1h}$) levels are 51.9dB, and 49.2dB respectively. Highest L_{AMax} , was 76dB that was observed at 16:25 during measuring background noise levels. A comparison of L_{Aeq} , L_{AMax} , L_{A10} and L_{A90} results for day is given numerically in Table 3, and they are given graphically for day levels in Figure 1.

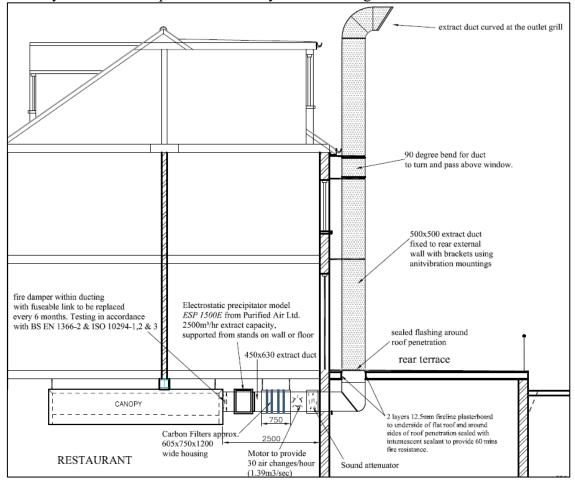
Figure 2: The design of proposed ventilation system for the kitchen.

The first stage of odour control is to use an Electrostatic Precipitator model ESP 1500E unit for oil, grease and smoke removal. More detail for ECP could be found in Appendix C.

The second stage of odour control is to use Carbon Filters 605 x 750 x 1200 from Purified Air Ltd. Carbon filters use panels of activated carbon to remove the malodourous gases within the commercial kitchen extract duct through the process of chemical adsorption.

By installing ESP units before carbon filters, the carbon life span is greatly increased, allowing it to nullify malodours at optimum efficiency for much longer.

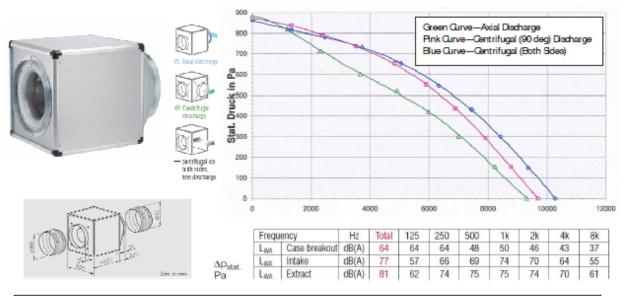
GBW 560/4

GigaBox centrifugal fan 560 mm ø

Self supporting frame construction from aluminium hollow profiles. Double-walled side panels from galvanised sheet steel. Intake cone for ideal airflow, spigot and flexible connector for duct connection. With discharge adapter (square to circular) on the pressure side for low-loss discharge and flexible seeve to reduce vibration transmission. Simple positioning by standard crane hooks. Installation must be carried out with condensation discharge showing downward. Rexible assembly by three possible centrifugal discharge directions via discharge adapter. Outdoor installation is possible using outdoor cover hood and external weather louvres (accessories).

Smooth running backward curved aluminium centrifugal impeller highly efficient and direct driven. Energy efficient with a low noise development. Dynamically balanced together with the motor to DIN ISO 1940 Pt.1 - class 6.3 Motor:

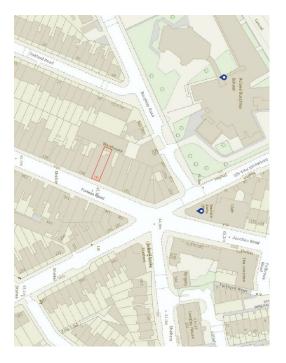
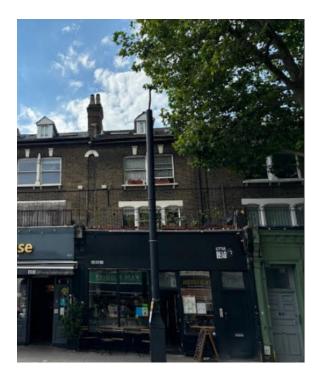
15. Appendix E: Measurement set-up and images of equipment used for environmental noise survey

To undertake a BS4142:2014+A1:2019 assessment, it is necessary to measure the noise levels at the site to determine day noise levels. Day residual noise levels and background noise levels were measured at the rear of the site. The sound level meter was positioned at minimum 3.5 metres away from nearby walls/fences. The sound level meter was mounted onto a tripod at 1.4 metre above the rear terrace of the site as shown in **Appendix E**.
