Scale @ A1	Date	Job Number	Project
As indicated	10/07/24	17056A	IoN/DRI Redevelopment Project
Drawn By	Checked By	Status	256 Grays Inn Road, London, WC1X 8LD
MM	JP	S3	
Drawing No.	Rev	Purpose of Issue	Drawing
BEMP-HBA-P2-ZZ-DR-A-21-1415	P03	For Review & Comment	External Wall Detail - Corners

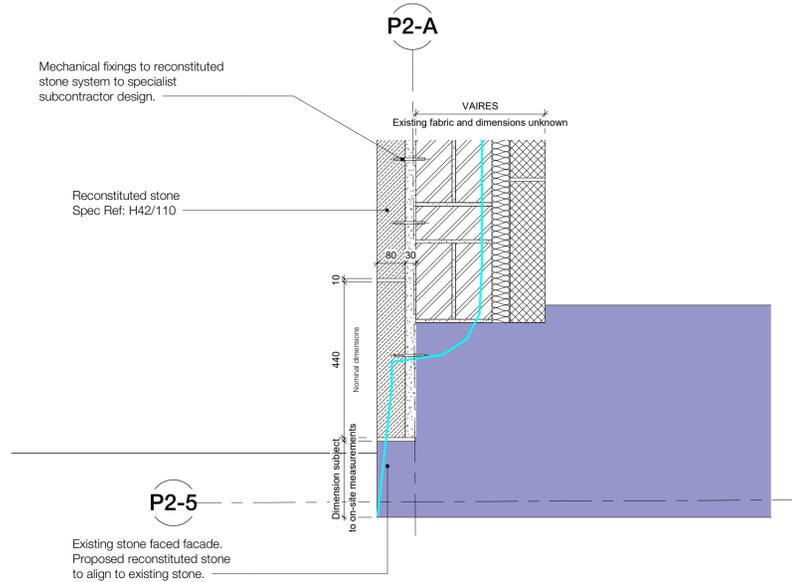
1
Level LG - Plan - Northwest Corner - Proposed Stone to Existing Brick
1 : 10

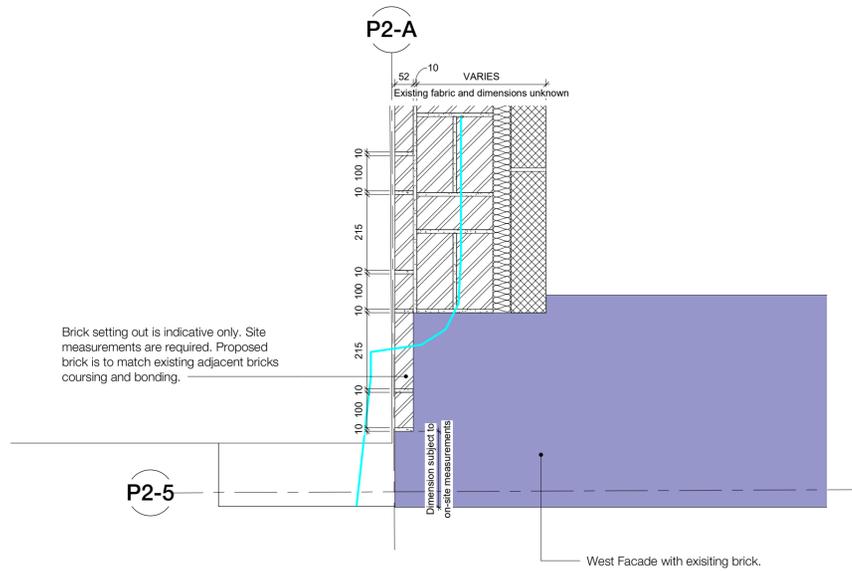
2
Level 00 - Plan - Northwest Corner - Proposed Brick to Existing Brick
1 : 10

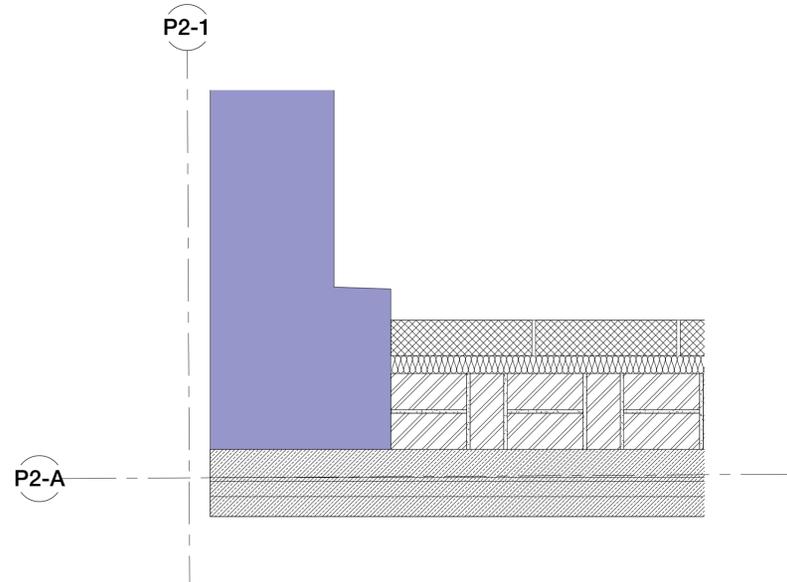
3
Level 00 - Plan - Northeast Corner - Proposed Stone to Existing Brick
1 : 10
