Feature stone course types

IoN/DRI Redevelopment Project  
256 Grays Inn Road, London,  
WC1X 8LD

BEMP-HBA-P2-ZZ-DR-A-21-1416

External Wall Detail - Stone Features

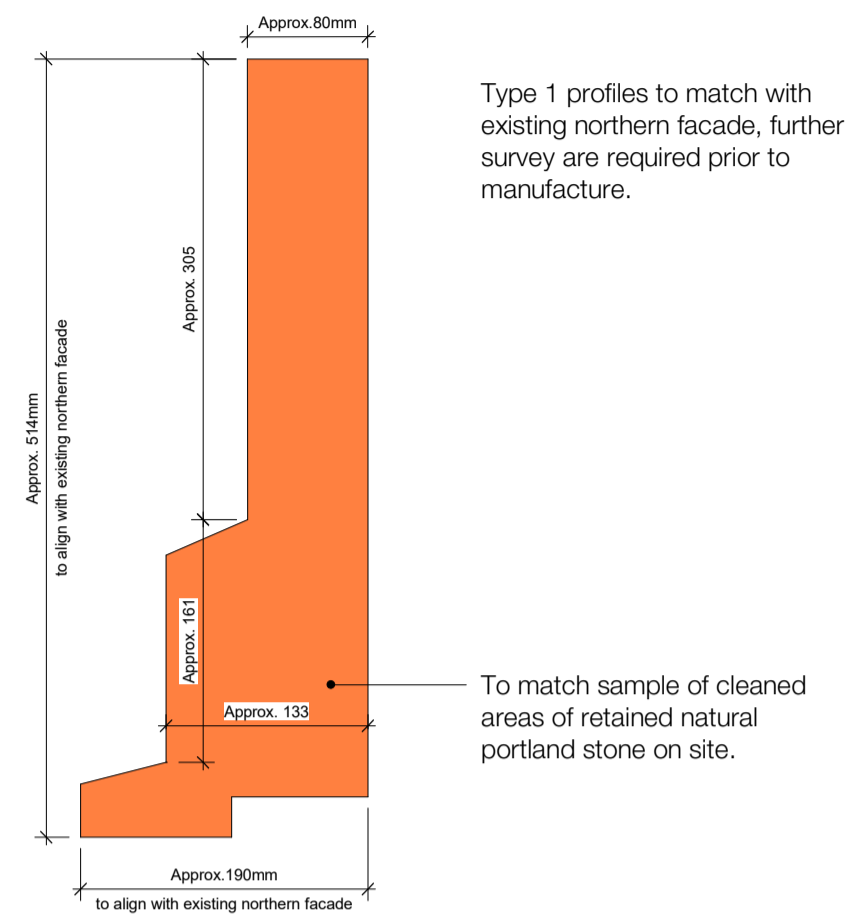
Natural portland stone ornamented stringcourse band - Type 1  
Spec Ref: H51/220

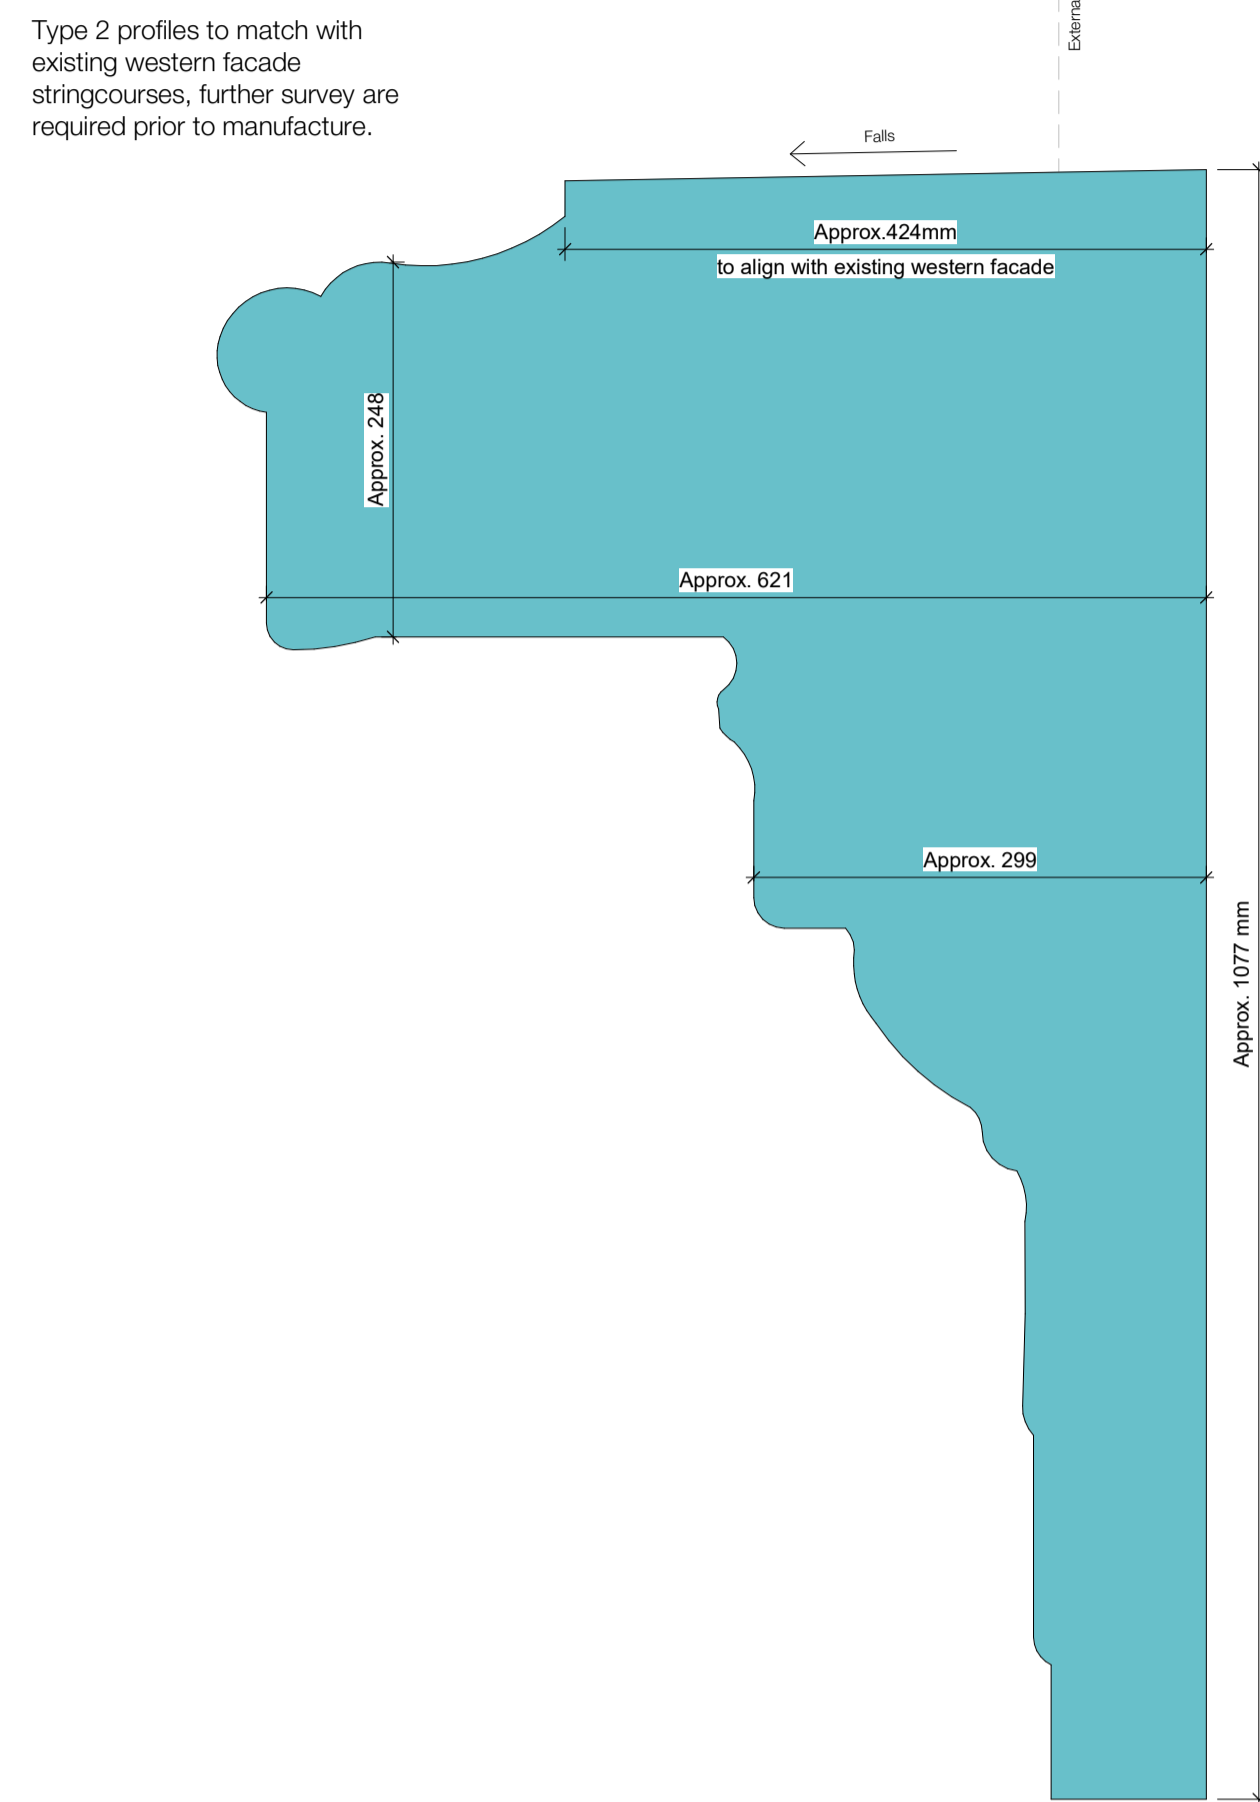
Natural portland stone ornamented stringcourse band - Type 2  
Spec Ref: H51/220

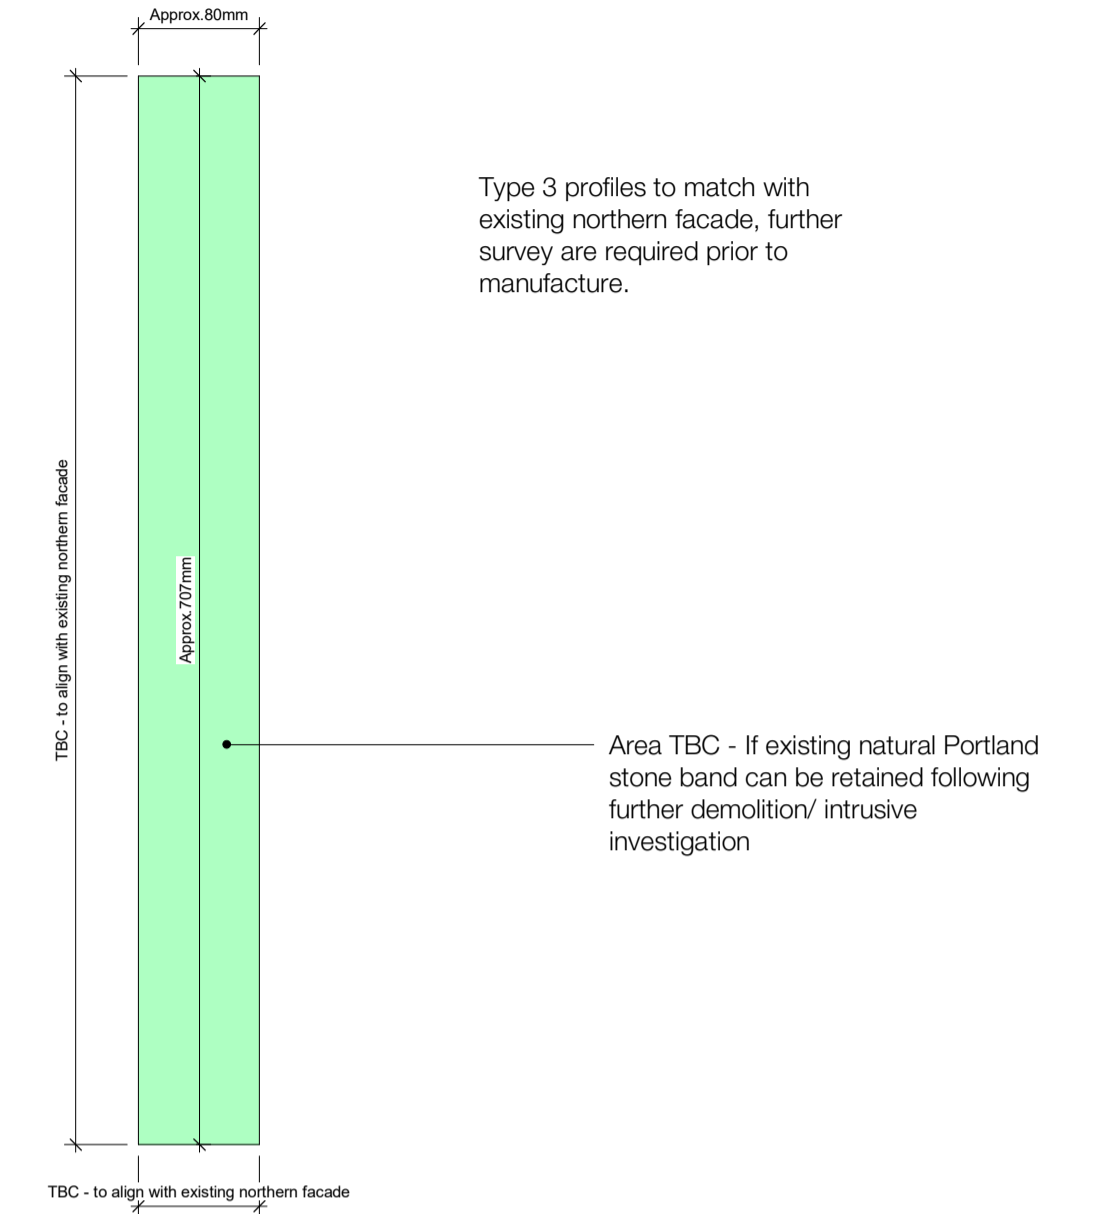
Natural portland stone ornamented stringcourse band - Type 3  
Spec Ref: H51/220

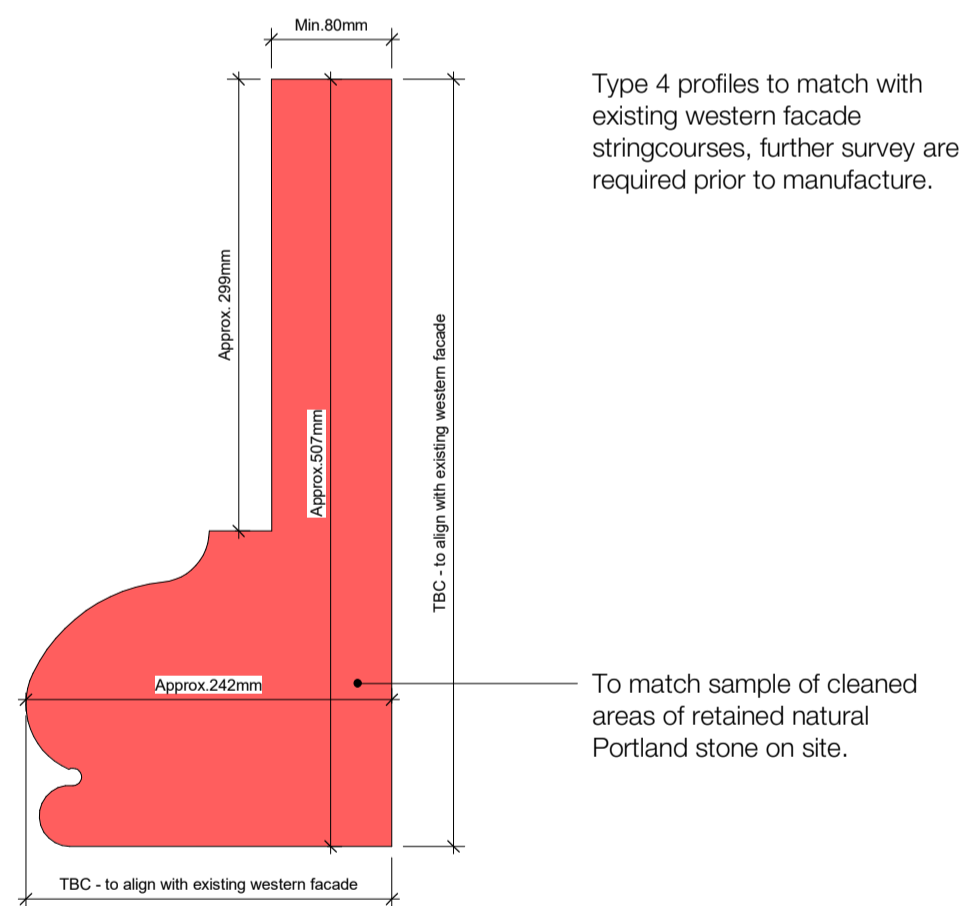
Natural portland stone ornamented stringcourse band - Type 4  
Spec Ref: H51/220

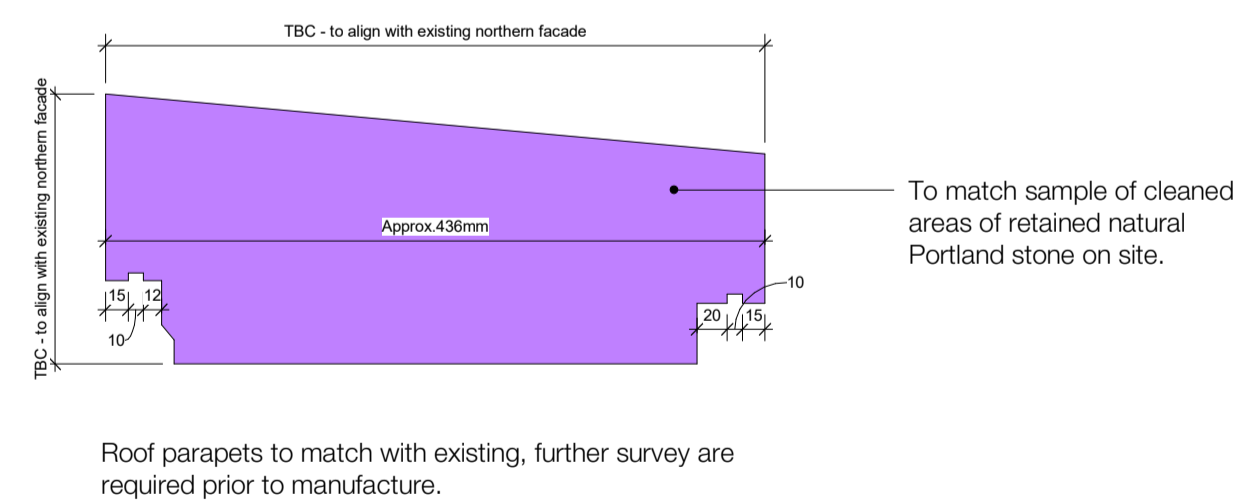
Natural portland coping stone at roof parapet  
Spec Ref: H51/220

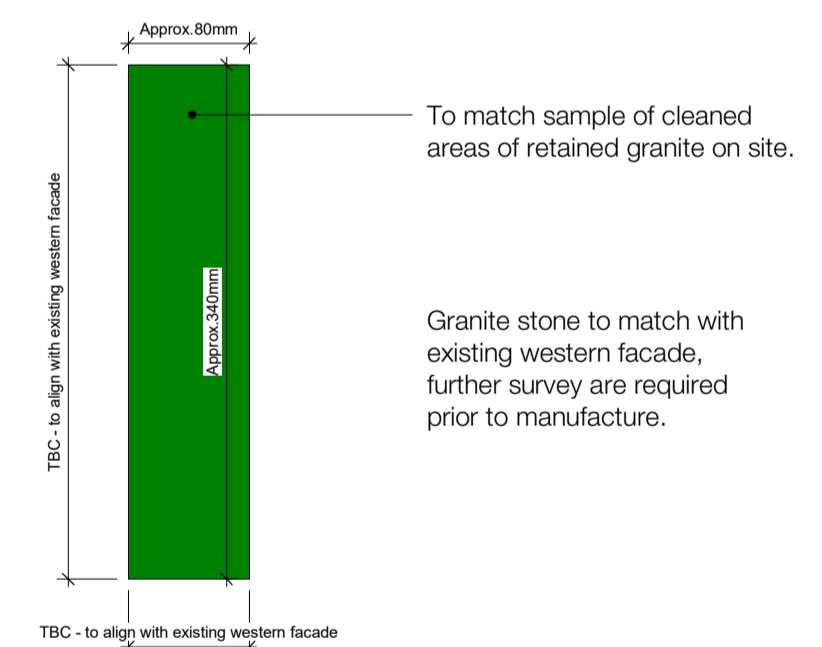
Natural Stone Granite  
Spec Ref: H51/110
