Scale @ A1	Date	Job Number	Project
As indicated	10/07/24	17056A	IoN/DRI Redevelopment Project
Drawn By	Checked By	Status	256 Grays Inn Road, London, WC1X 8LD
MM	JP	S3	
Drawing No.	Rev	Purpose of Issue	Drawing
BEMP-HBA-P2-ZZ-DR-A-31-1412	P03	For Review & Comment	New Window Type 3 (L01/Infill Area/North Facade)

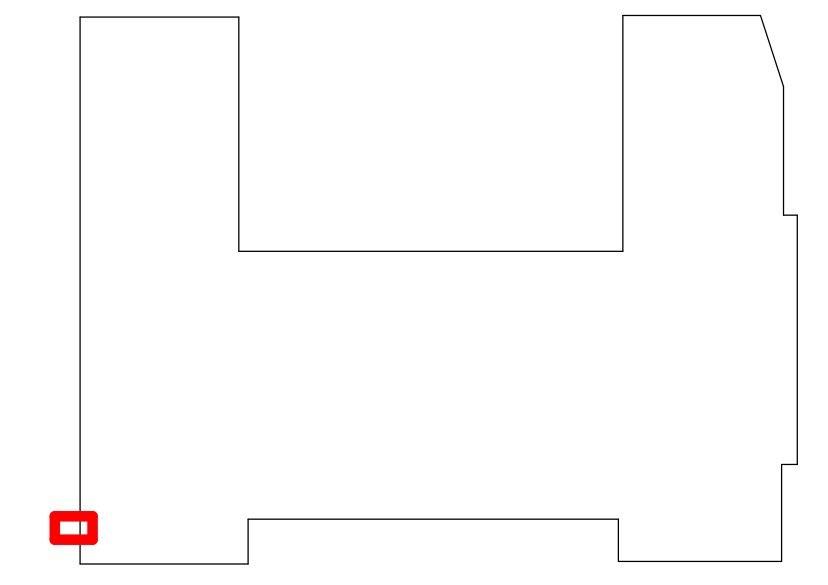
**Level 00 - External Detail Location**  
1 : 500

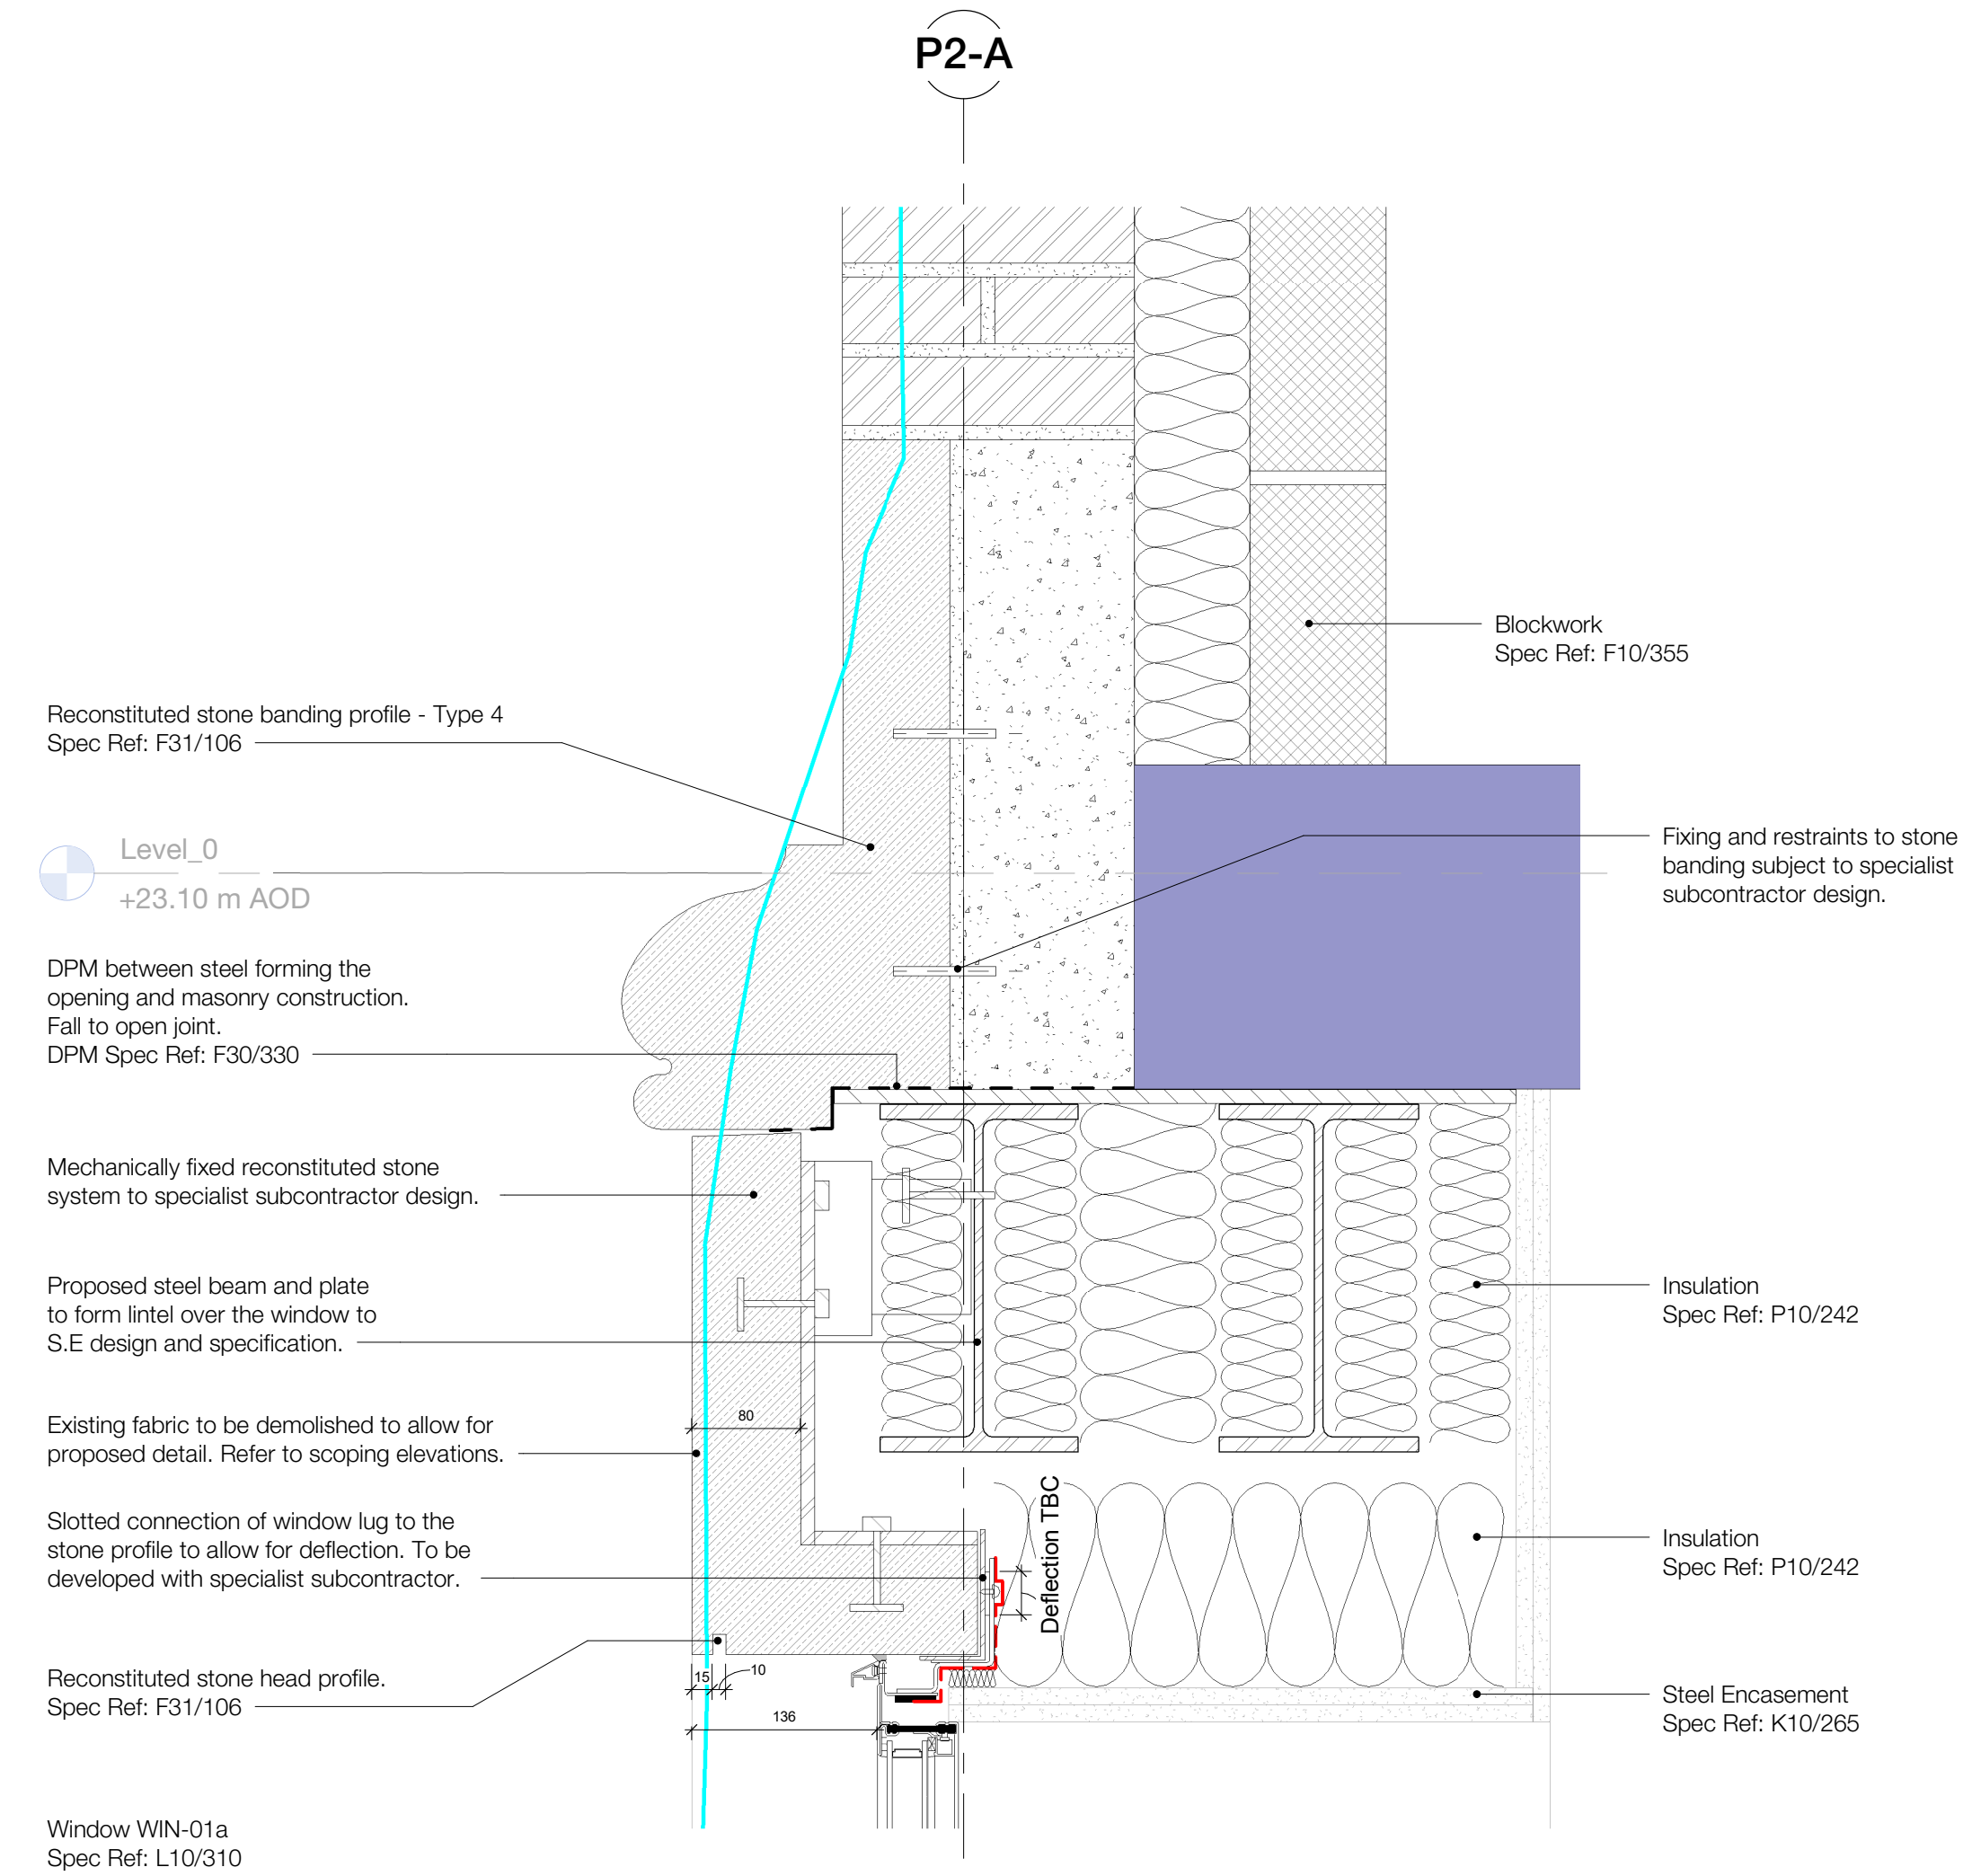
**1**  
1 : 5

**New Opening / Typical fixed window head in stone overlaid (stringcourse band - Type 4)**

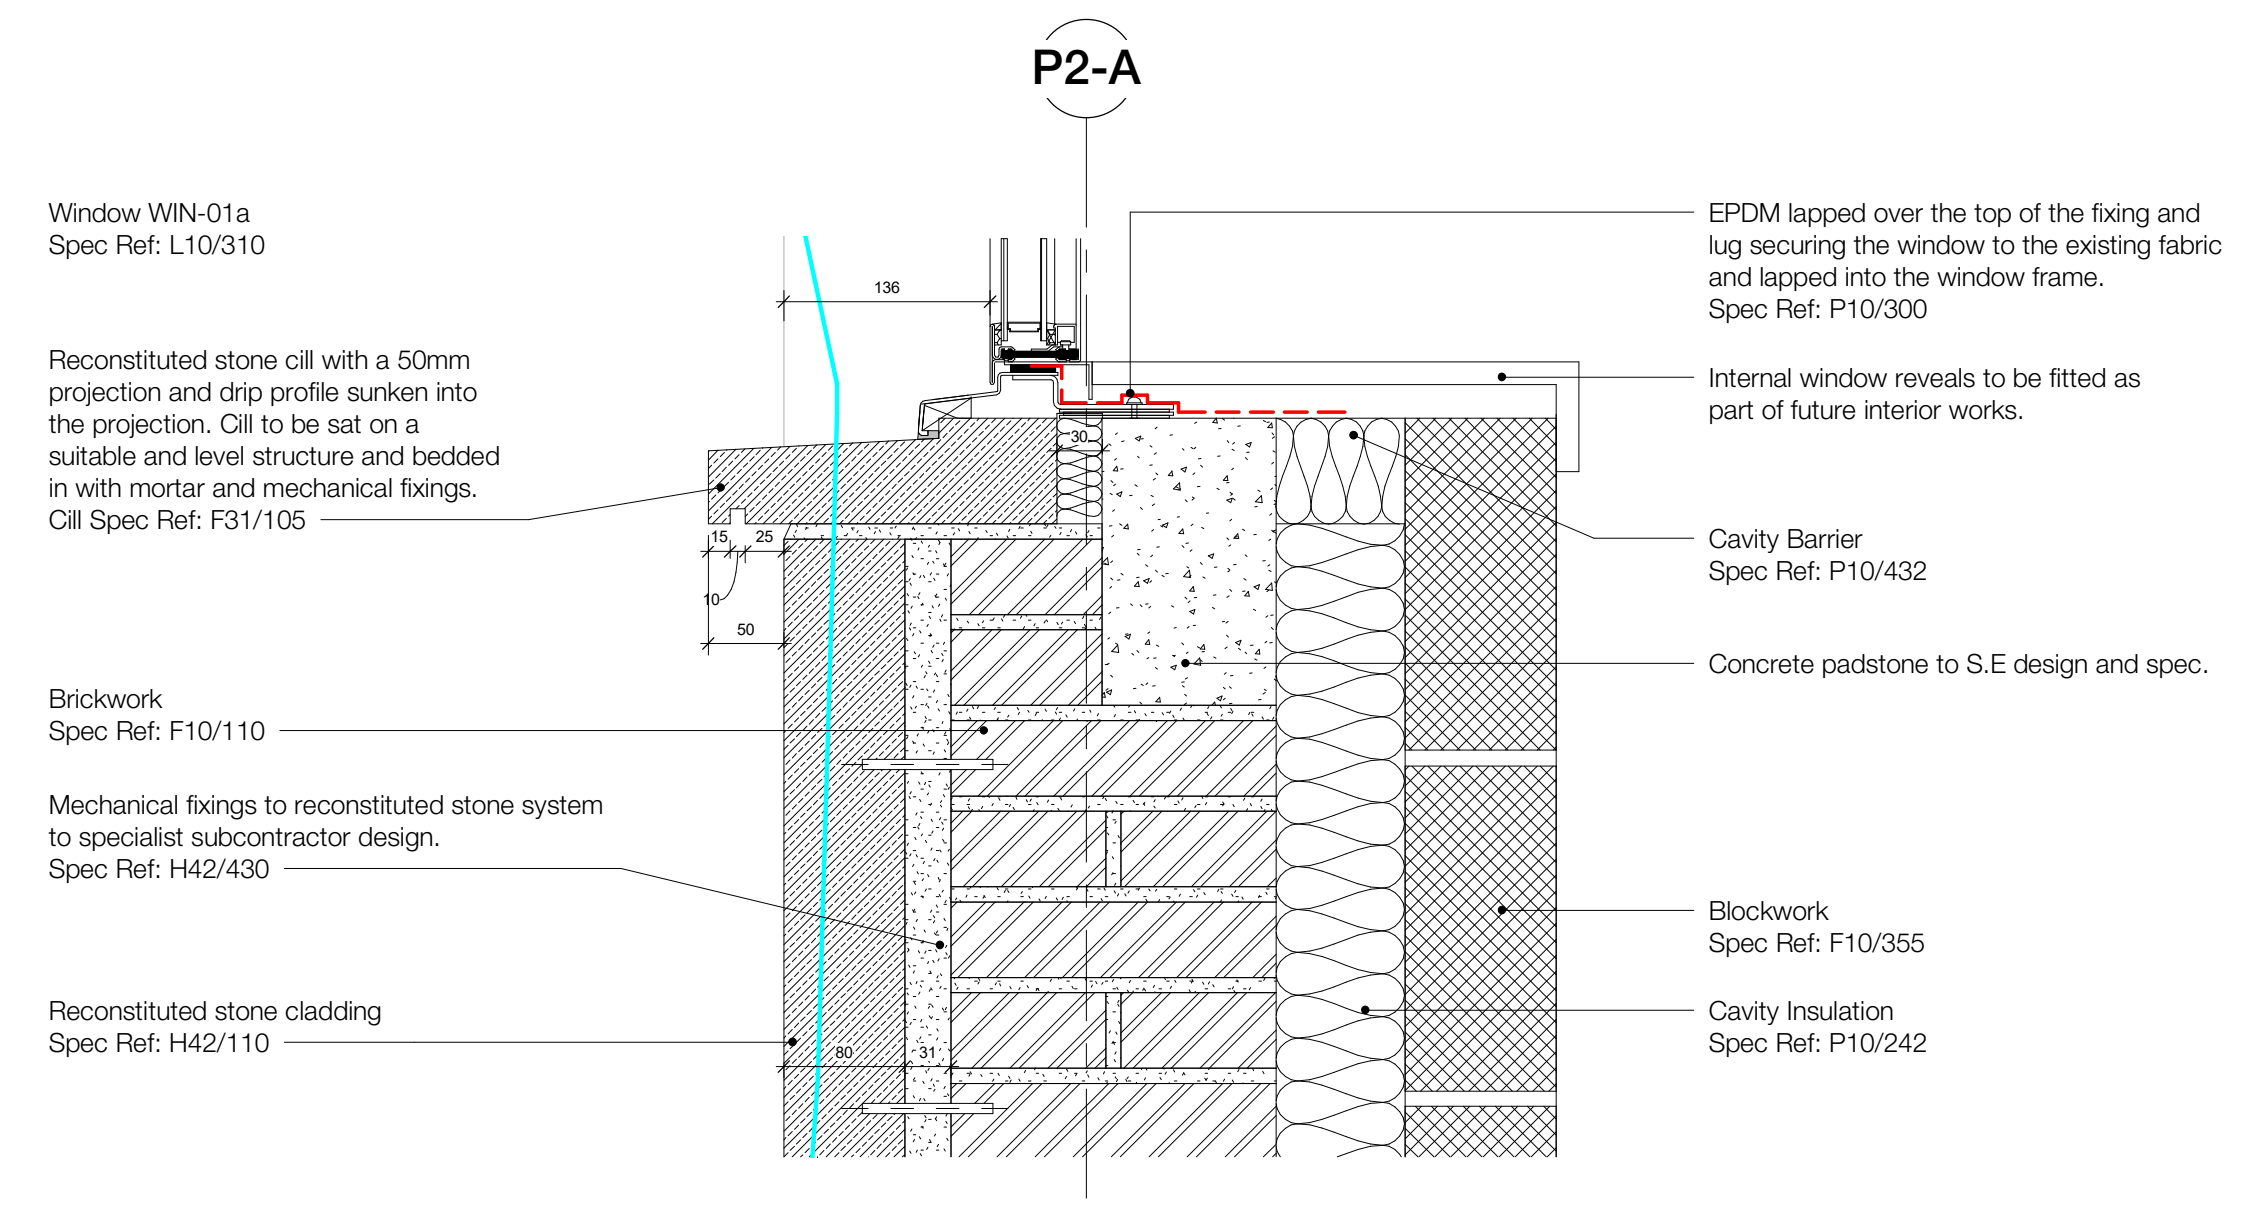
**2**  
1 : 5

**New Opening / Typical fixed window cill in stone overlaid**

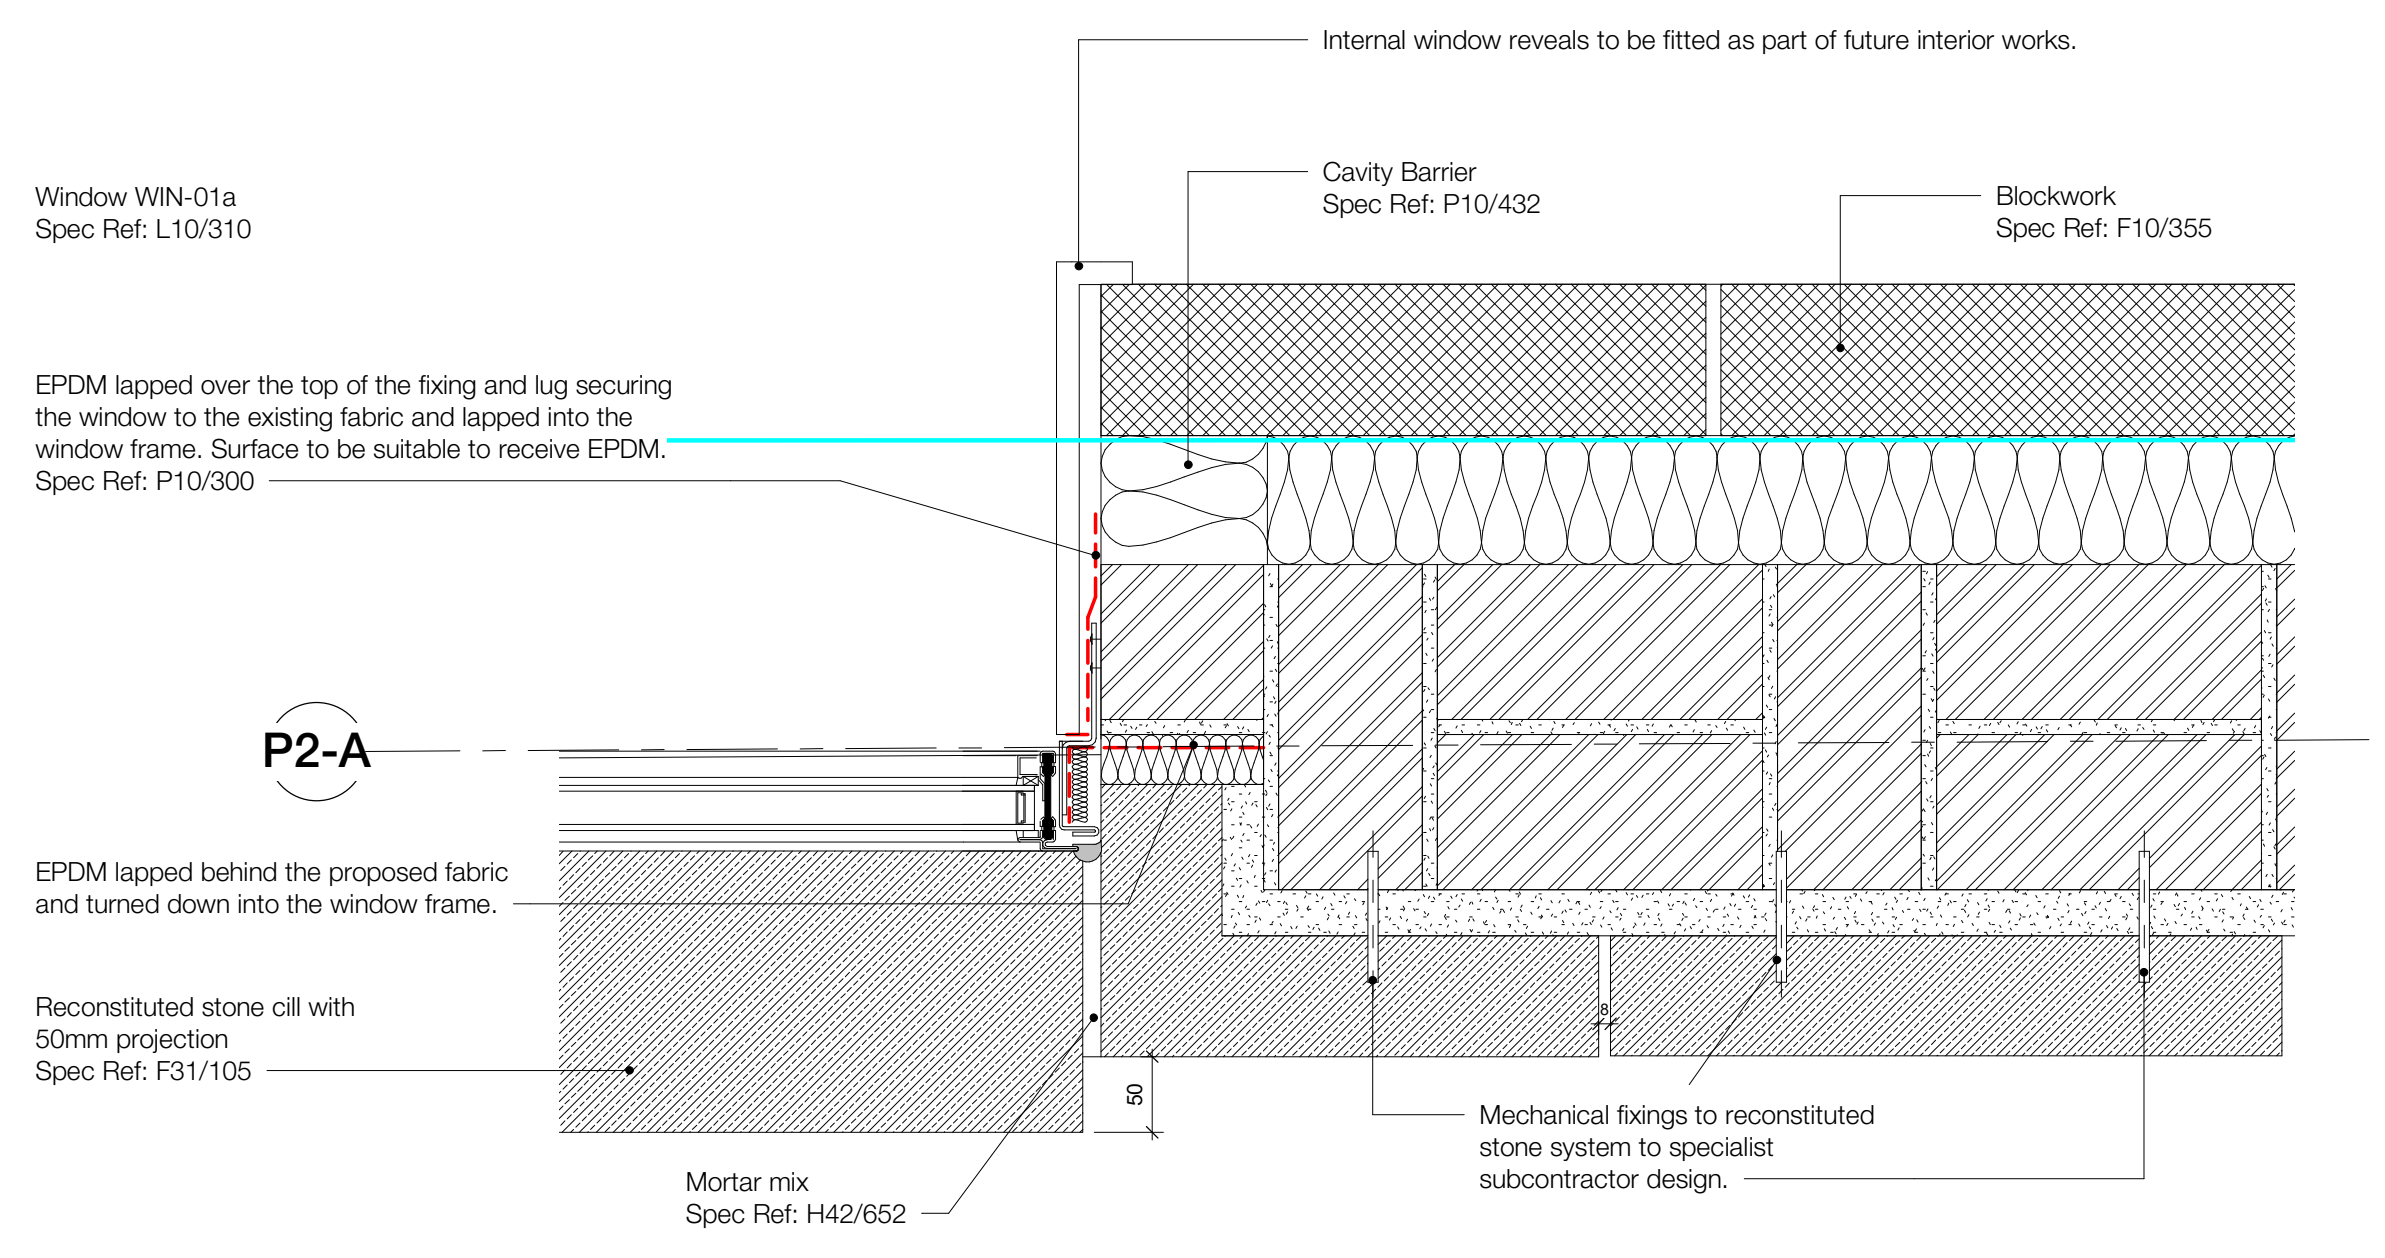
**3**  
1 : 5

**Plan - New Opening / Typical fixed window jamb in stone overlaid**
