Scale @ A1	Date	Job Number	Project
As indicated	10/07/24	17056A	IoN/DRI Redevelopment Project
Drawn By	Checked By	Status	256 Grays Inn Road, London, WC1X 8LD
MM	JP	S3	
Drawing No.	Rev	Purpose of Issue	Drawing
BEMP-HBA-P2-ZZ-DR-A-21-1412	P03	For Review & Comment	External Wall Detail (North Facade) Entrance sheet 3

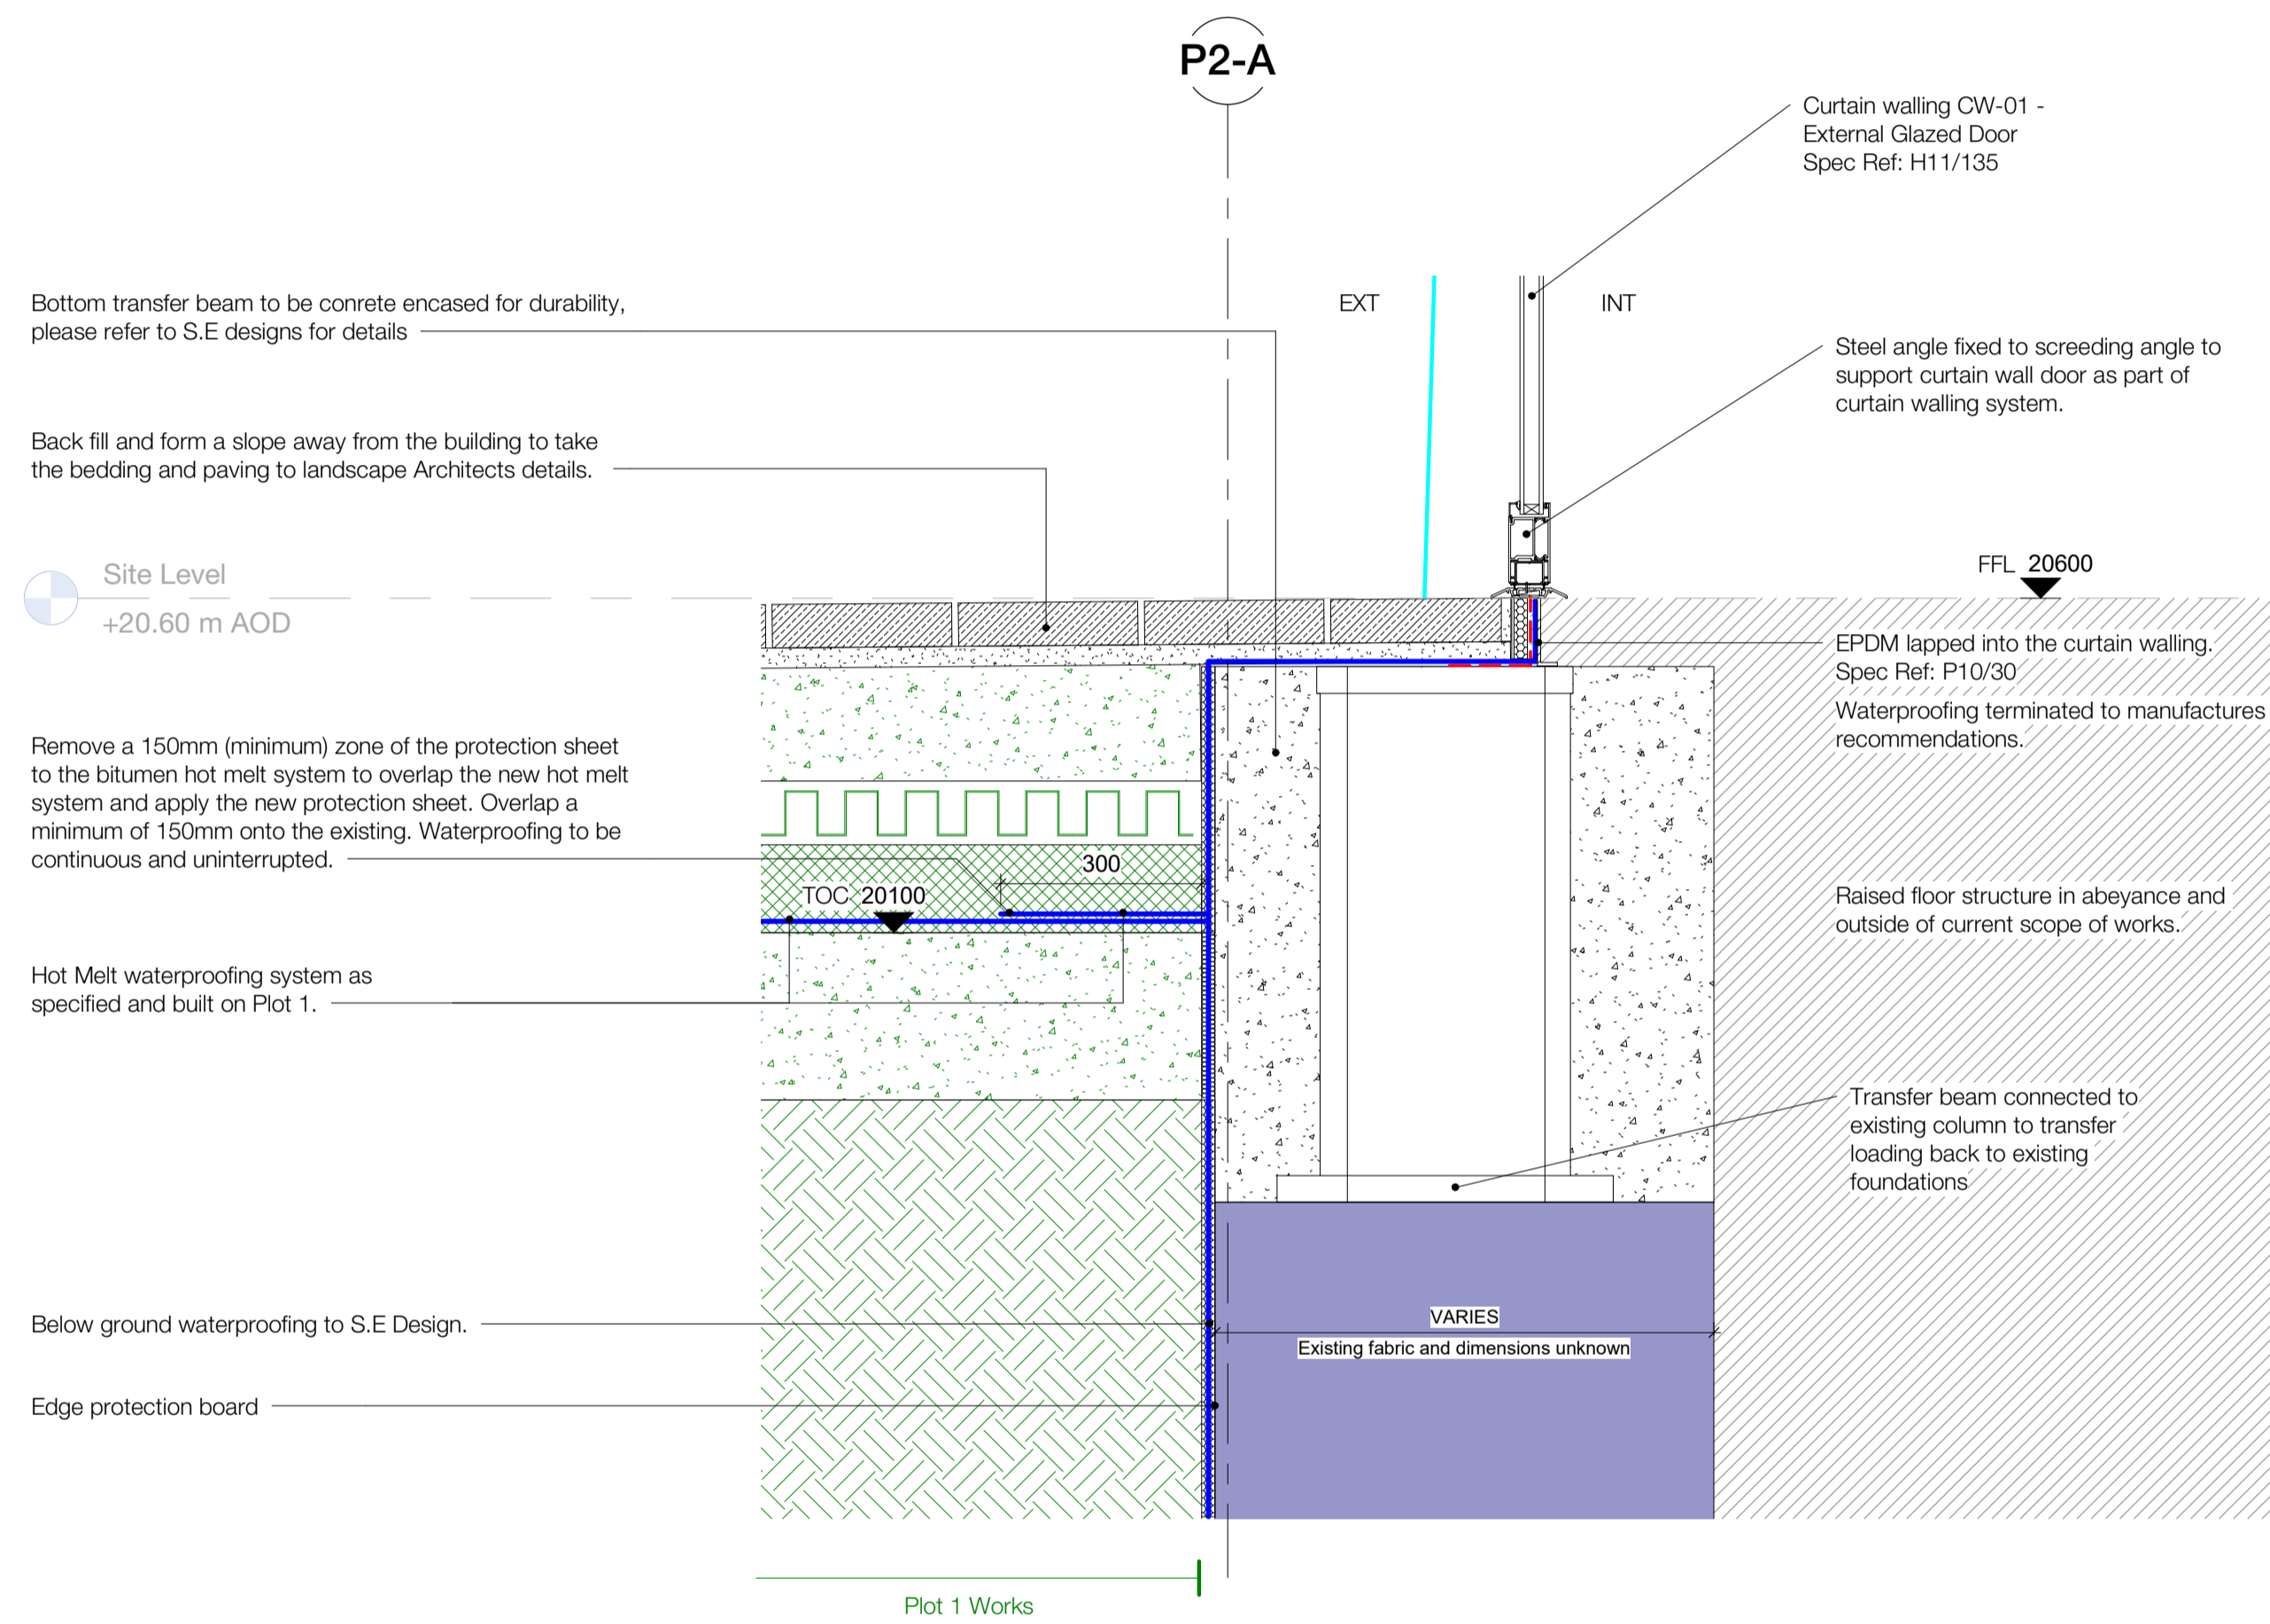
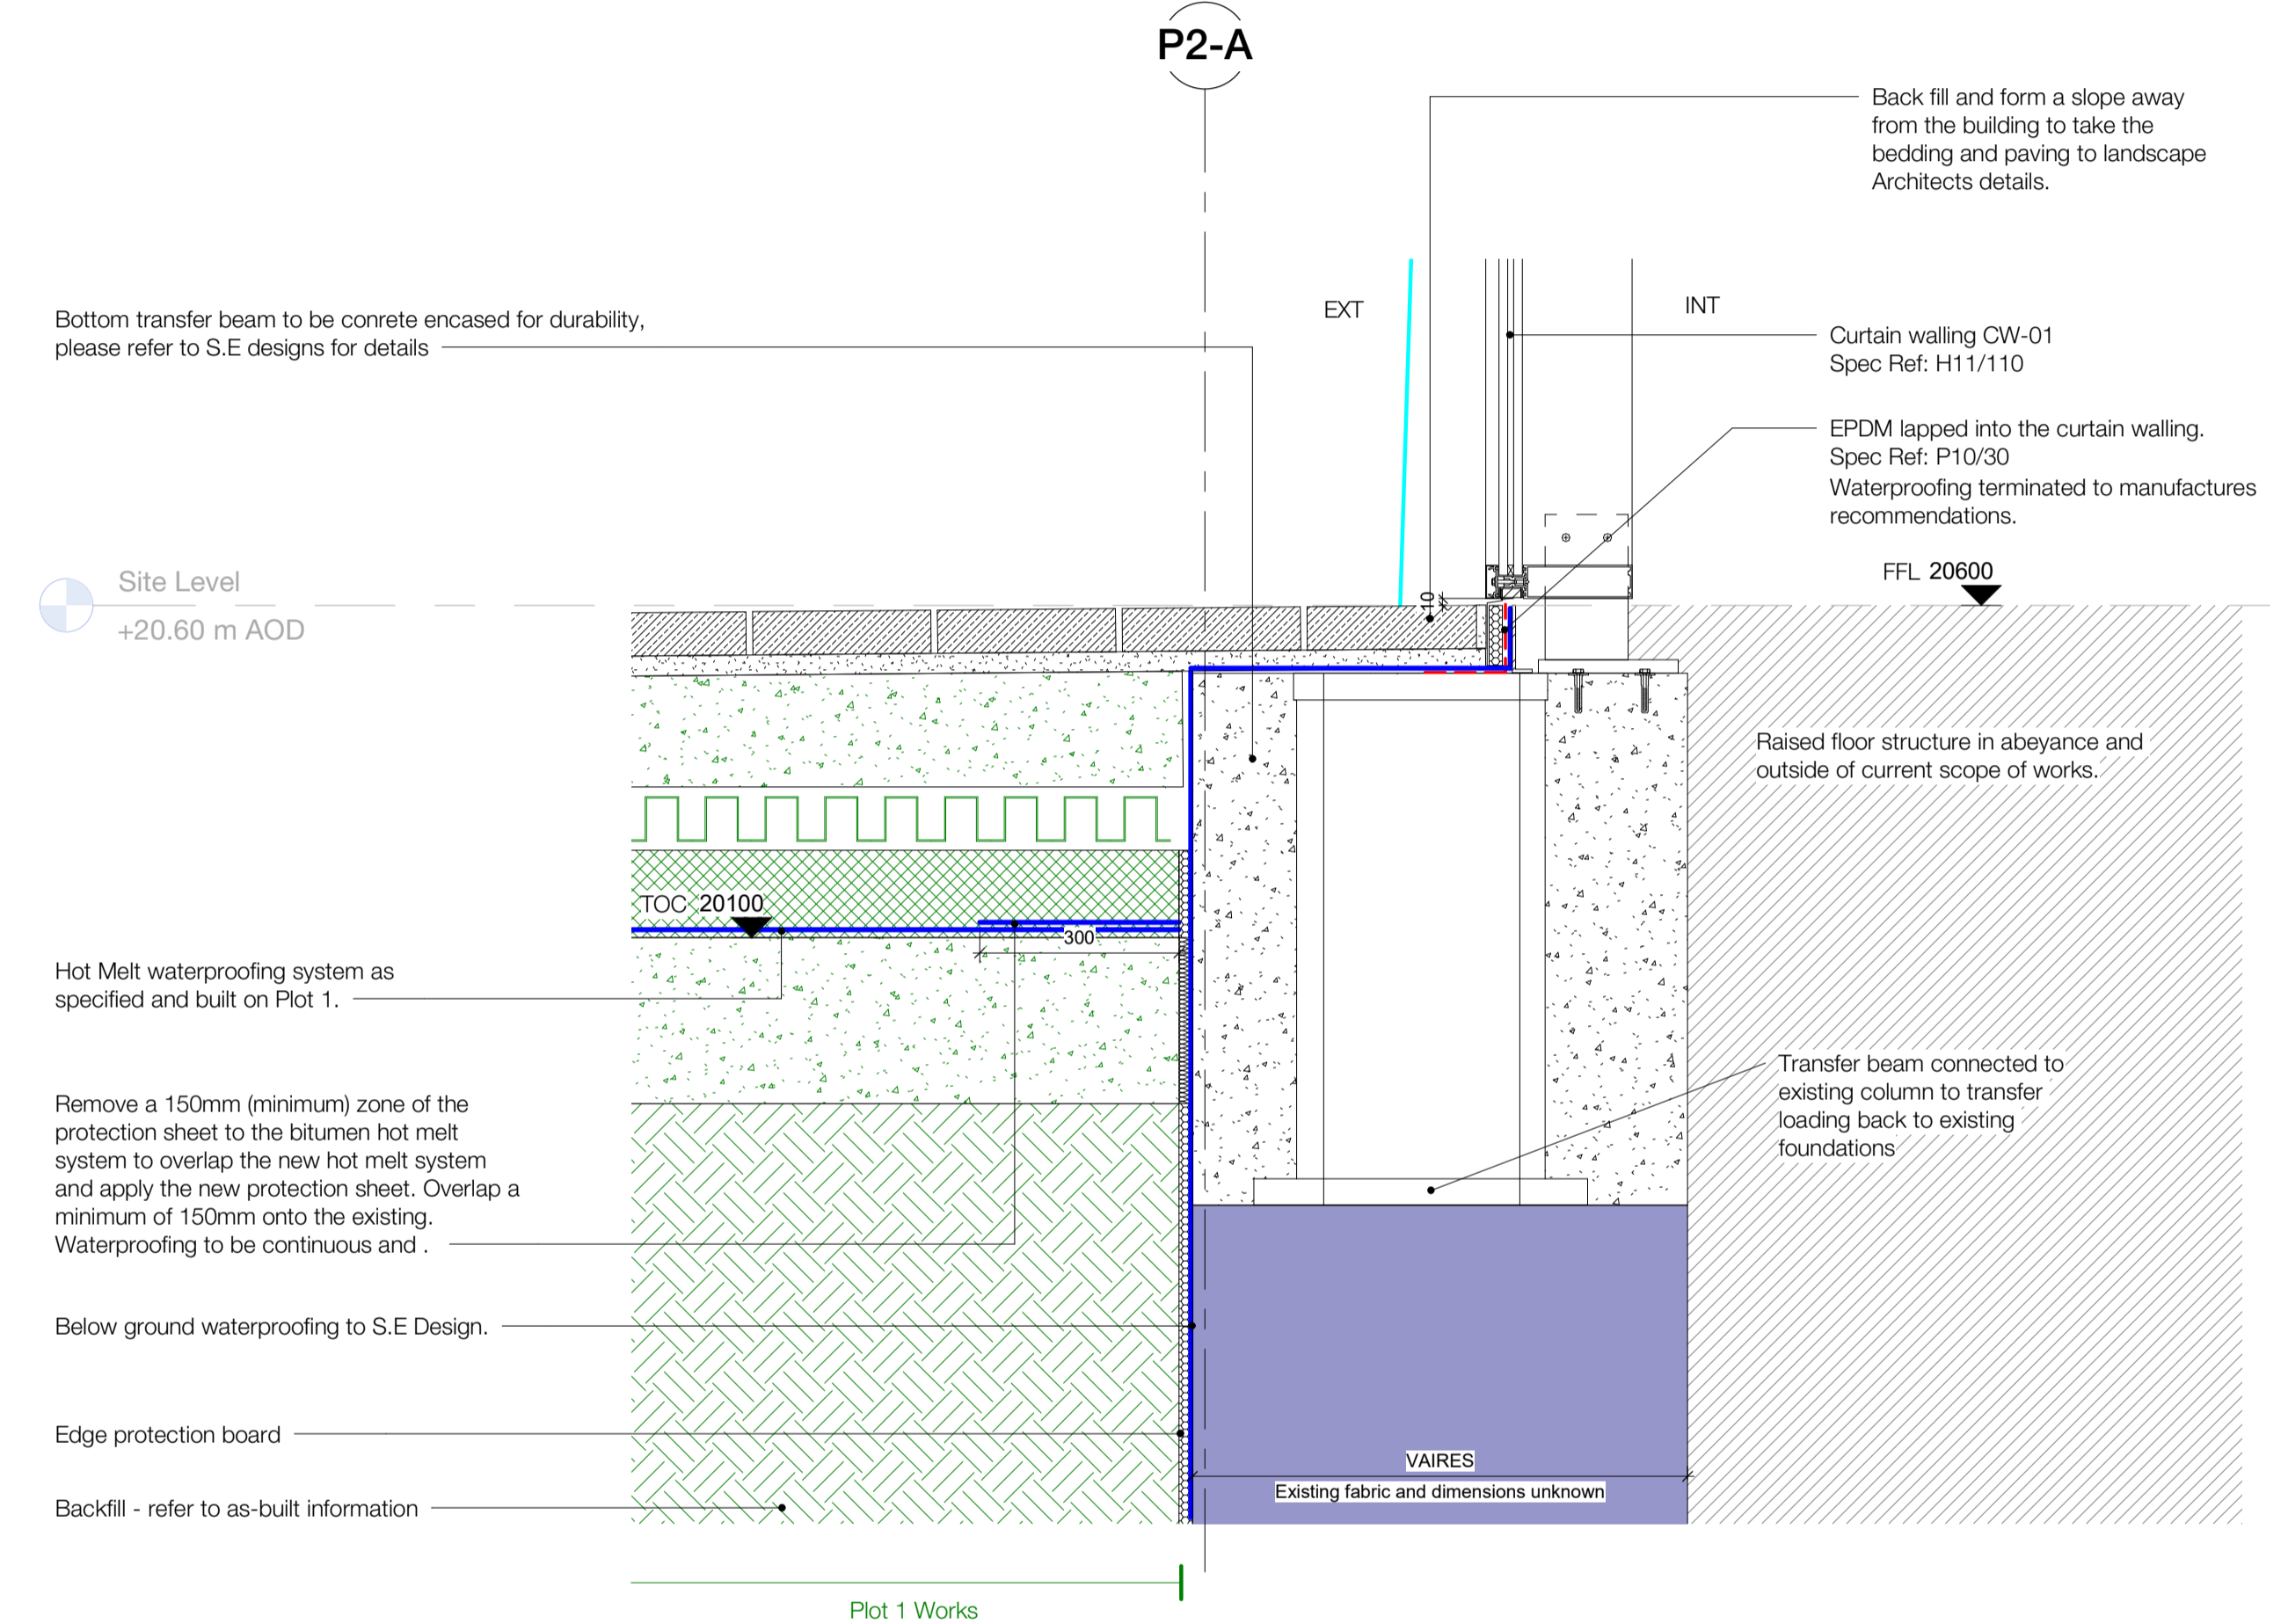
- Existing Fabric - Unknown dimensions and composition
- Plot 1 Works
- Proposed
- Approximate location of existing fabric based on SES point cloud survey. Exact location to be determined on site.
