After visiting n.8 Gloucester Gate, an impressive 6 storey residence designed by John Nash, dating 1832, we are happy to report the following. Behind the magnificent stucco fronted façade the interiors have been much altered from their original scheme, including 7 chimneypieces, 6 of which are later replacements, almost certainly having been installed in the 1980s during significance renovation and adaption. We will list methodically an outline of each chimneypiece in the interest of clarity. The fact that the chimneypieces are installed on raised hearths it's another clear sign that these are later additions, because they are laid on the existing floor while originally they would have been flush to the floor.

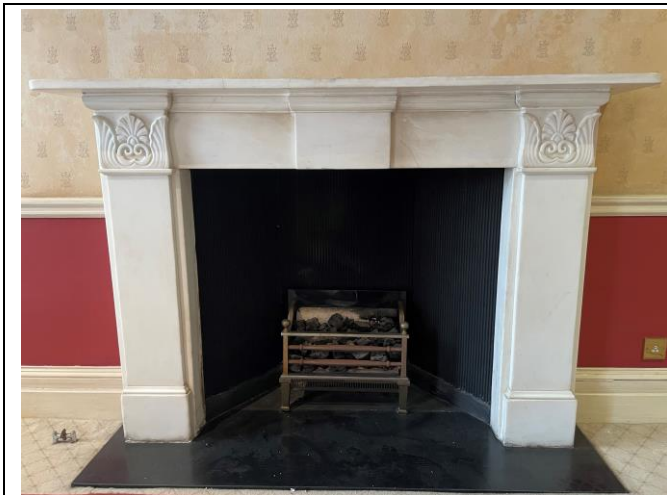
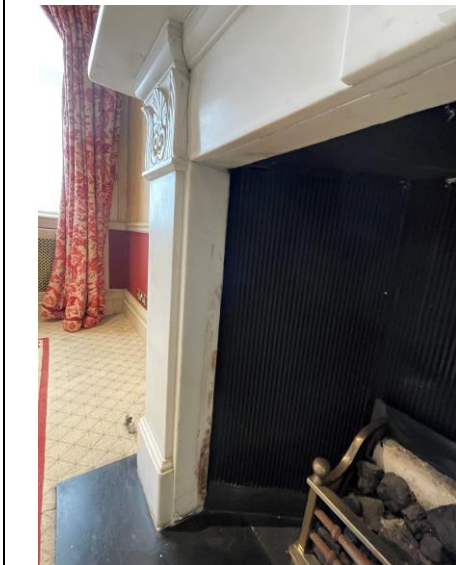
## 1. Dining Room

Recently installed on a raised hearth with new chamber lining, this chimneypiece, whilst attempting to create a sympathetic replacement, is pedestrian in design and lacks the architectural significance one would expect in a room of this calibre.

In terms of hierarchy this room would certainly have had a more important mantle, both sophisticated in execution and design.

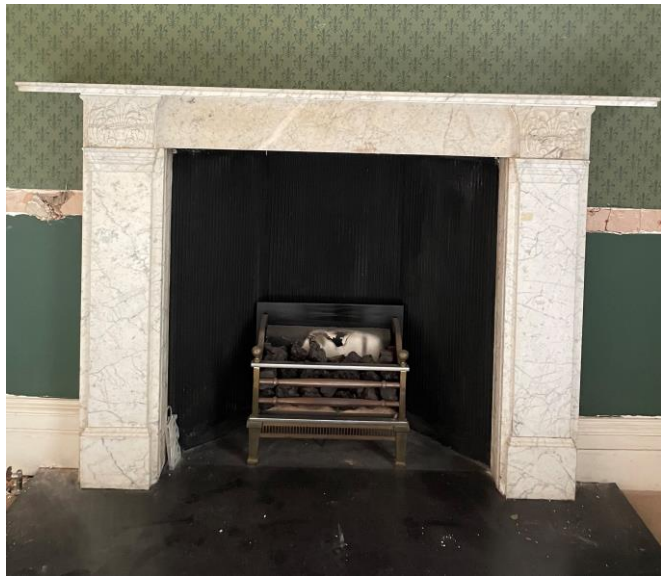
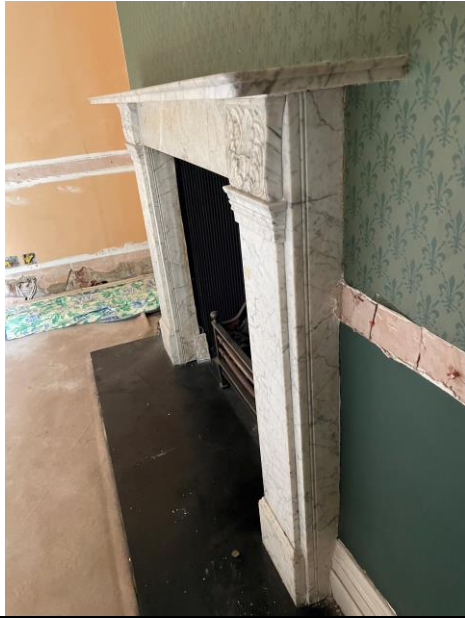
## 2. Bar

As per example 1, recently installed with raised hearth and sited on the entry level in a principle room, like its pier in the Dining Room it lacks architectural significance and design one would expect of a property of this calibre and historical importance.

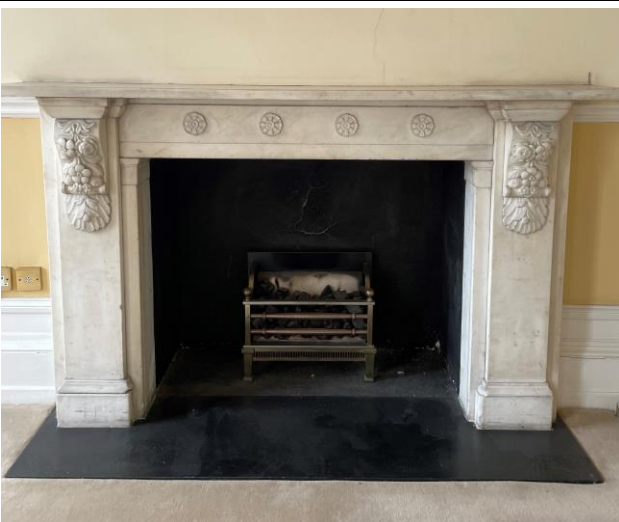
## 3. Reception

Arguably the two most important rooms in the house, the Reception and adjoining Family Room have a matching pair of later installed surrounds, mounted on raised hearths and fitted in the 1980s. These mantles are a later concoction using antique components, the shelves being later, the jambs from a poorly carved late 19<sup>th</sup> century surround blended with an earlier frieze of paterae in an attempt to make sympathetic with their surroundings. They are neither appropriate in quality of design nor manufacture for these two magnificent Drawing Rooms.

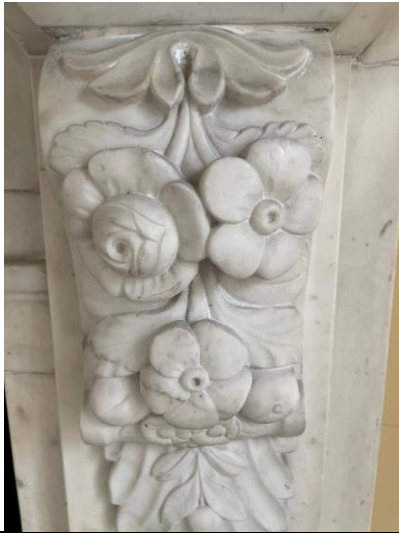
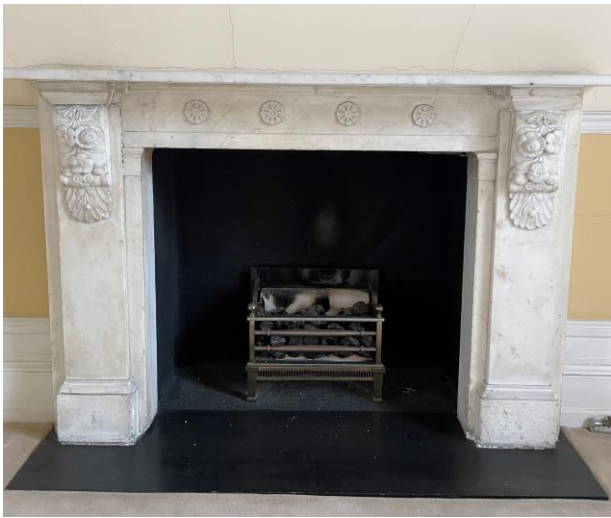
#### **4. Family Room**

As above.

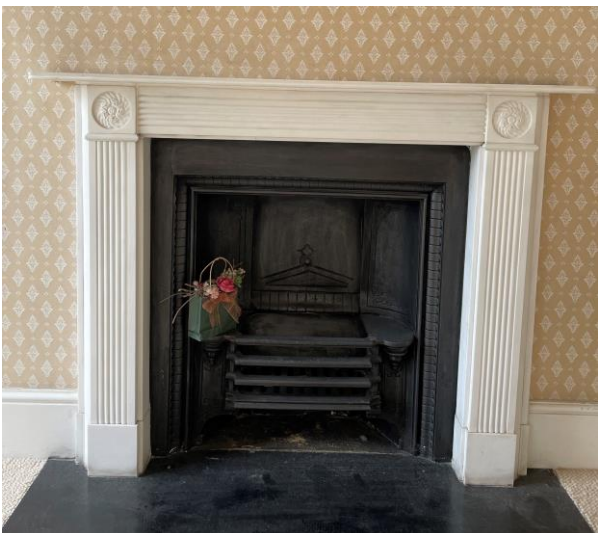
#### **5. Master Bedroom**

The Master Bedroom fireplace appears to be a 21<sup>st</sup> century reproduction. The appalling quality of the marble combined with very low quality of execution in carving make this chimneypiece totally inappropriate for this property.

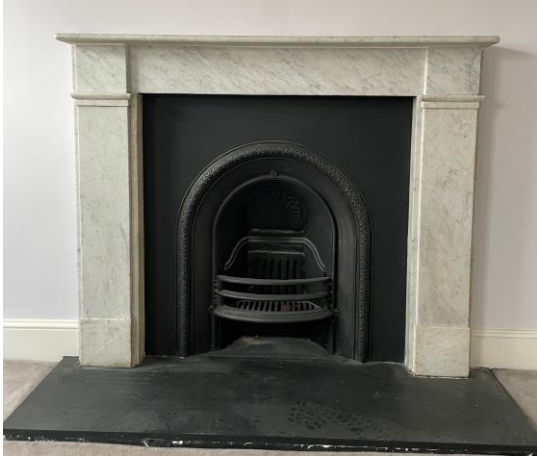
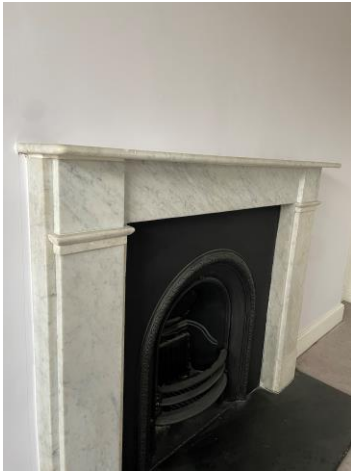
### **7. Bedroom 04**

Later installed on raised hearth, approximately 1980s, dating from the late 19<sup>th</sup> century this chimneypiece and grate are inappropriate for this magnificent building by John Nash.
