PROJECT	DESCRIPTION	DATE	SCALE AT A1	JOB NO
HOLBORN LINKS PROJECT 5 20-22 SP & 46-47 BS	46-47 BS DEMOLITION REAR ELEVATION	JULY '21	1:50	21.865
CLIENT	EDR	STATUS	PLANNING	DRAWING NO PL.1532
		DRAWN	CW	CHECKED
			RE	REV L2

With exception of works to parapet gulleys, tile replacement, and cast iron air bricks, all external works have already secured Full Planning & Listed Building Consent under application refs. 2023/0224/P and 2023/0882/L. They have been detailed on the plans for completeness.

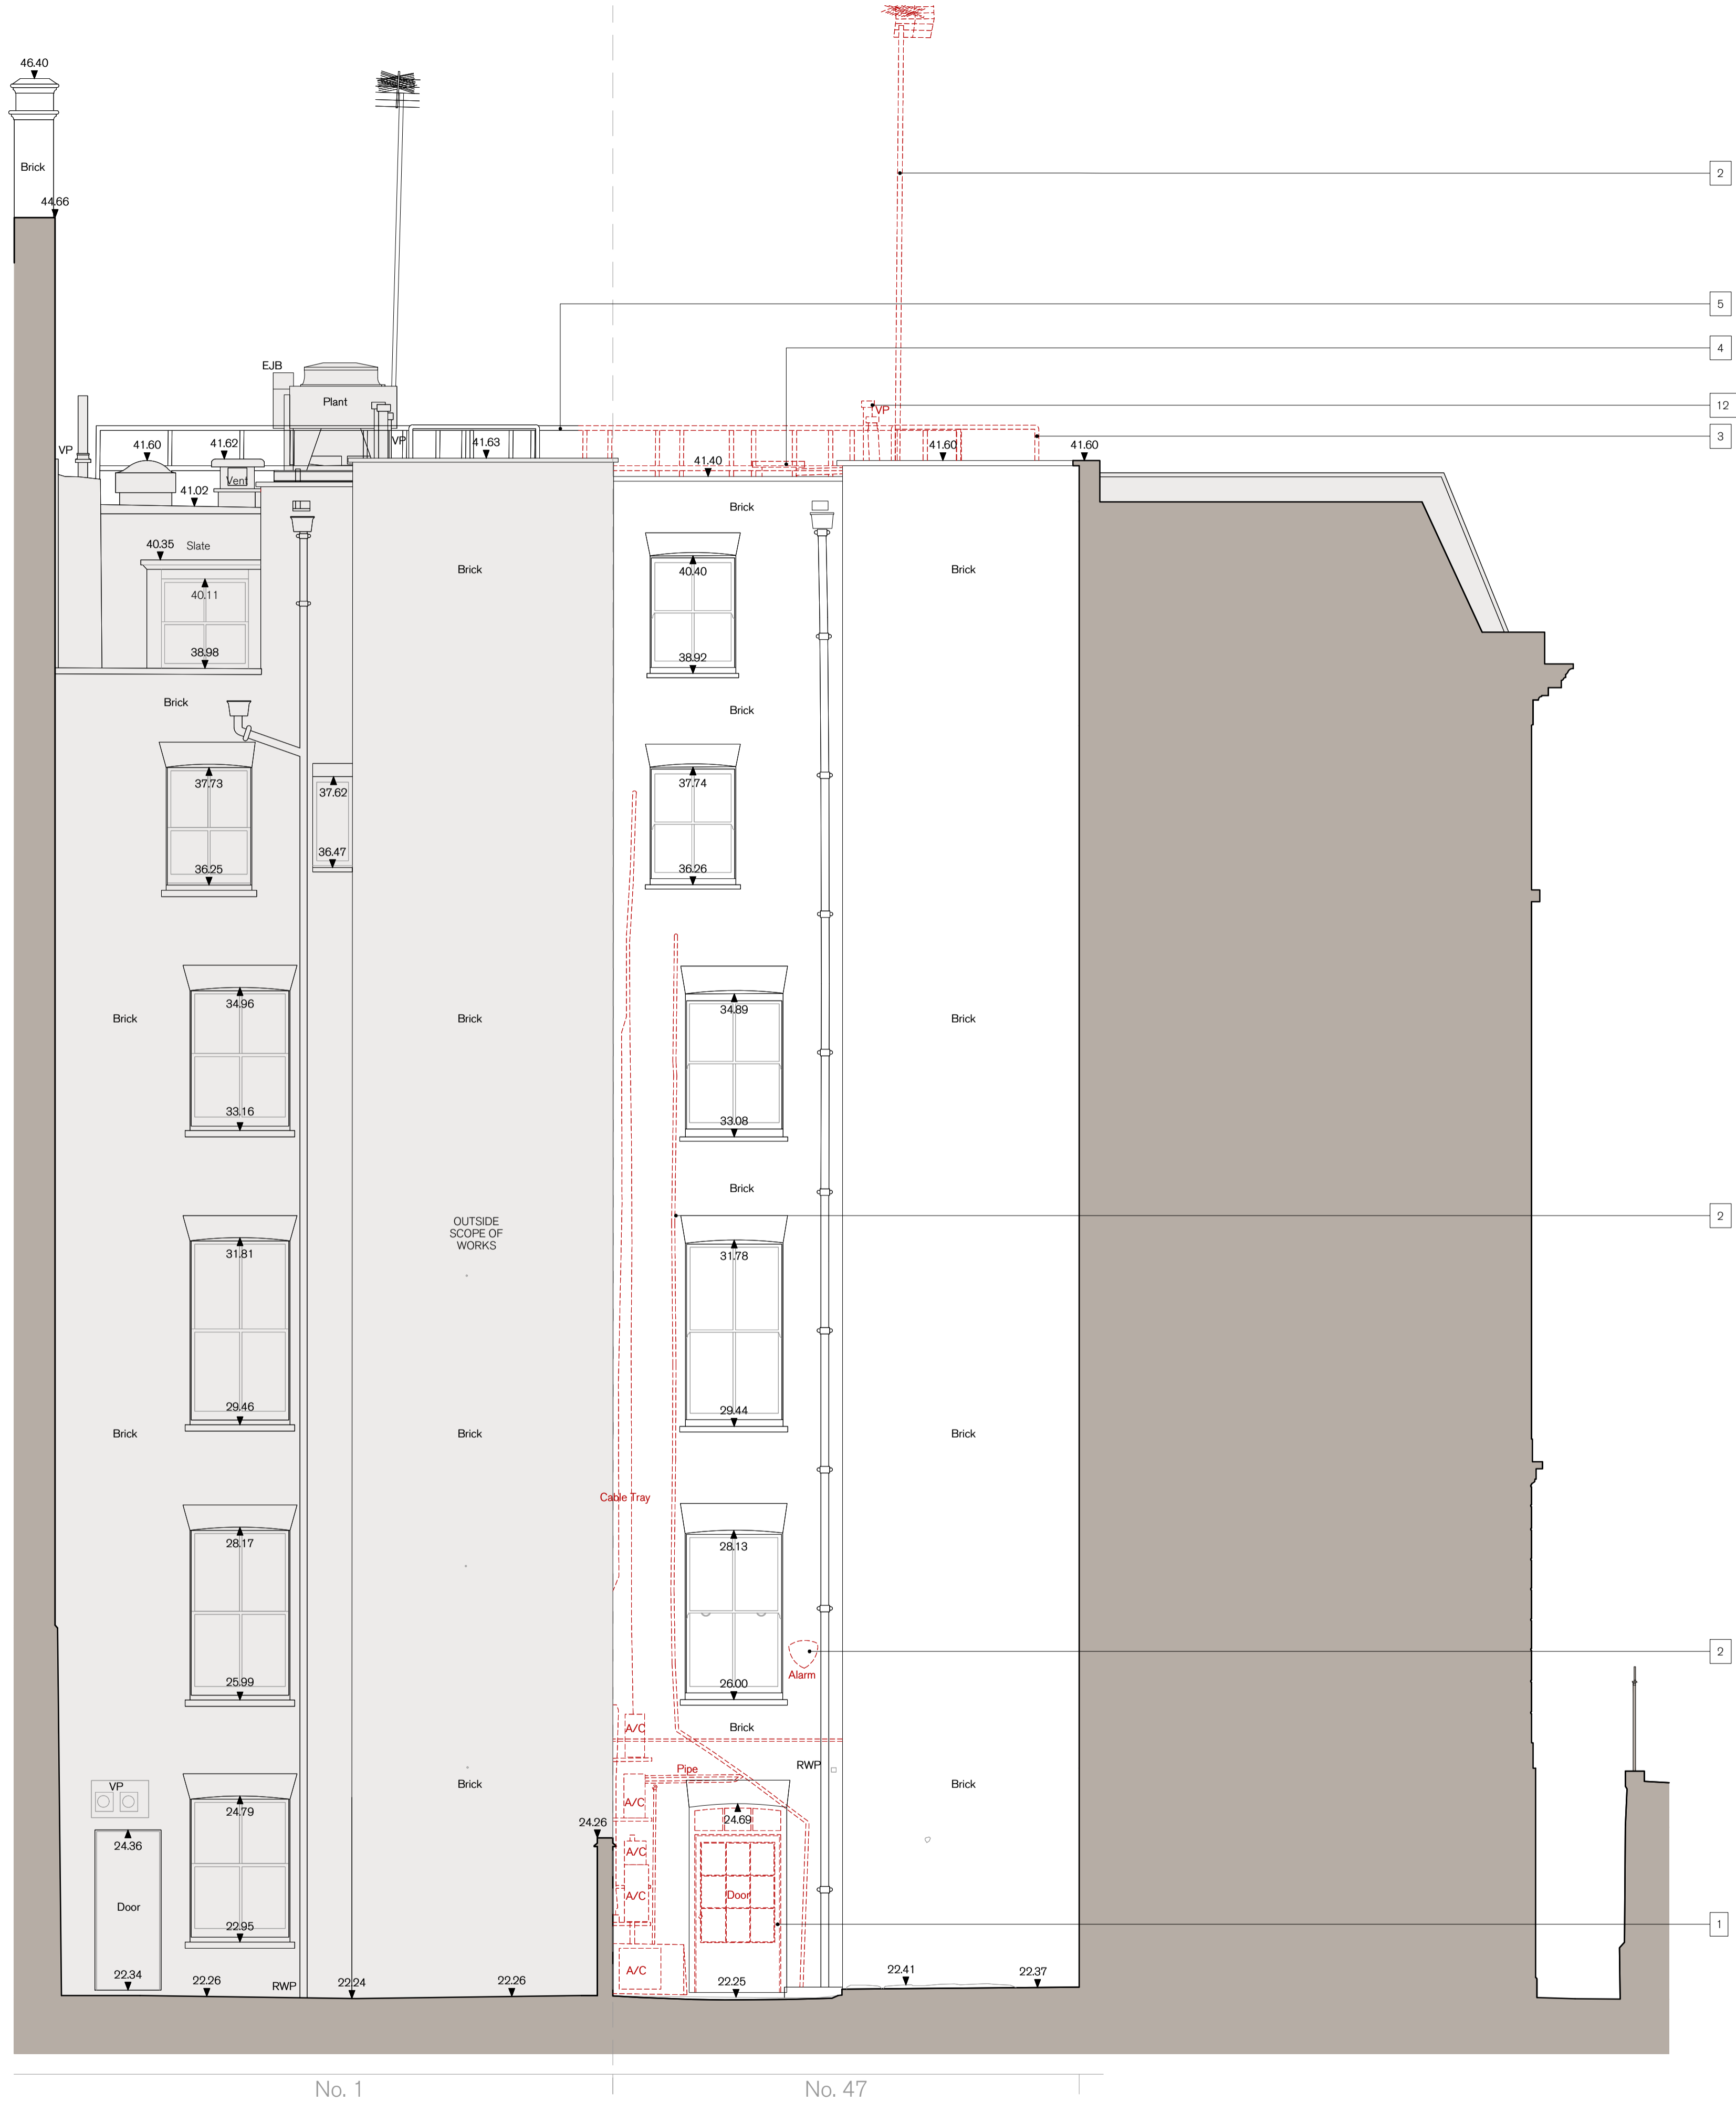
1. Existing window removed and sill below taken down to floor level to form new door. Abutments made good.
2. Existing externally fixed services carefully removed in line with MEP information. All redundant fixing locations made good and service penetrations infilled appropriately according to location and material.

3. Existing metal tube guarding and roof fixings / pedestals carefully removed and roof structure made good.
4. Existing sliding roof hatch carefully removed.

5. Guarding to be removed back to boundary for interface with new balustrade.
6. Existing redundant rooftop plant housings removed and roof made good.
7. Existing rooflights carefully removed.

8. Existing external doors and frames carefully removed and openings made good ready to receive new doors.
9. Existing window carefully removed and openings made good ready to receive new sash window.

10. Existing window removed and sill below taken down to floor level to form new door. Abutments made good. Existing security screens / bars carefully removed and old fixing points made good.

11. Existing metal balustrade removed and old fixing locations made good ready to receive new balustrade.
12. Existing redundant vents removed in accordance with MEP information. All redundant fixing locations made good and service penetrations infilled appropriately according to location and material.

13. Existing steel staircase carefully removed. Abutments made good.
