Project
2 - 9 CAMBRIDGE GATE
 London NW1 4JX

Drawing Title
FRONT ELEVATION - 9 & 8
 AS EXISTING

Drawing No
213

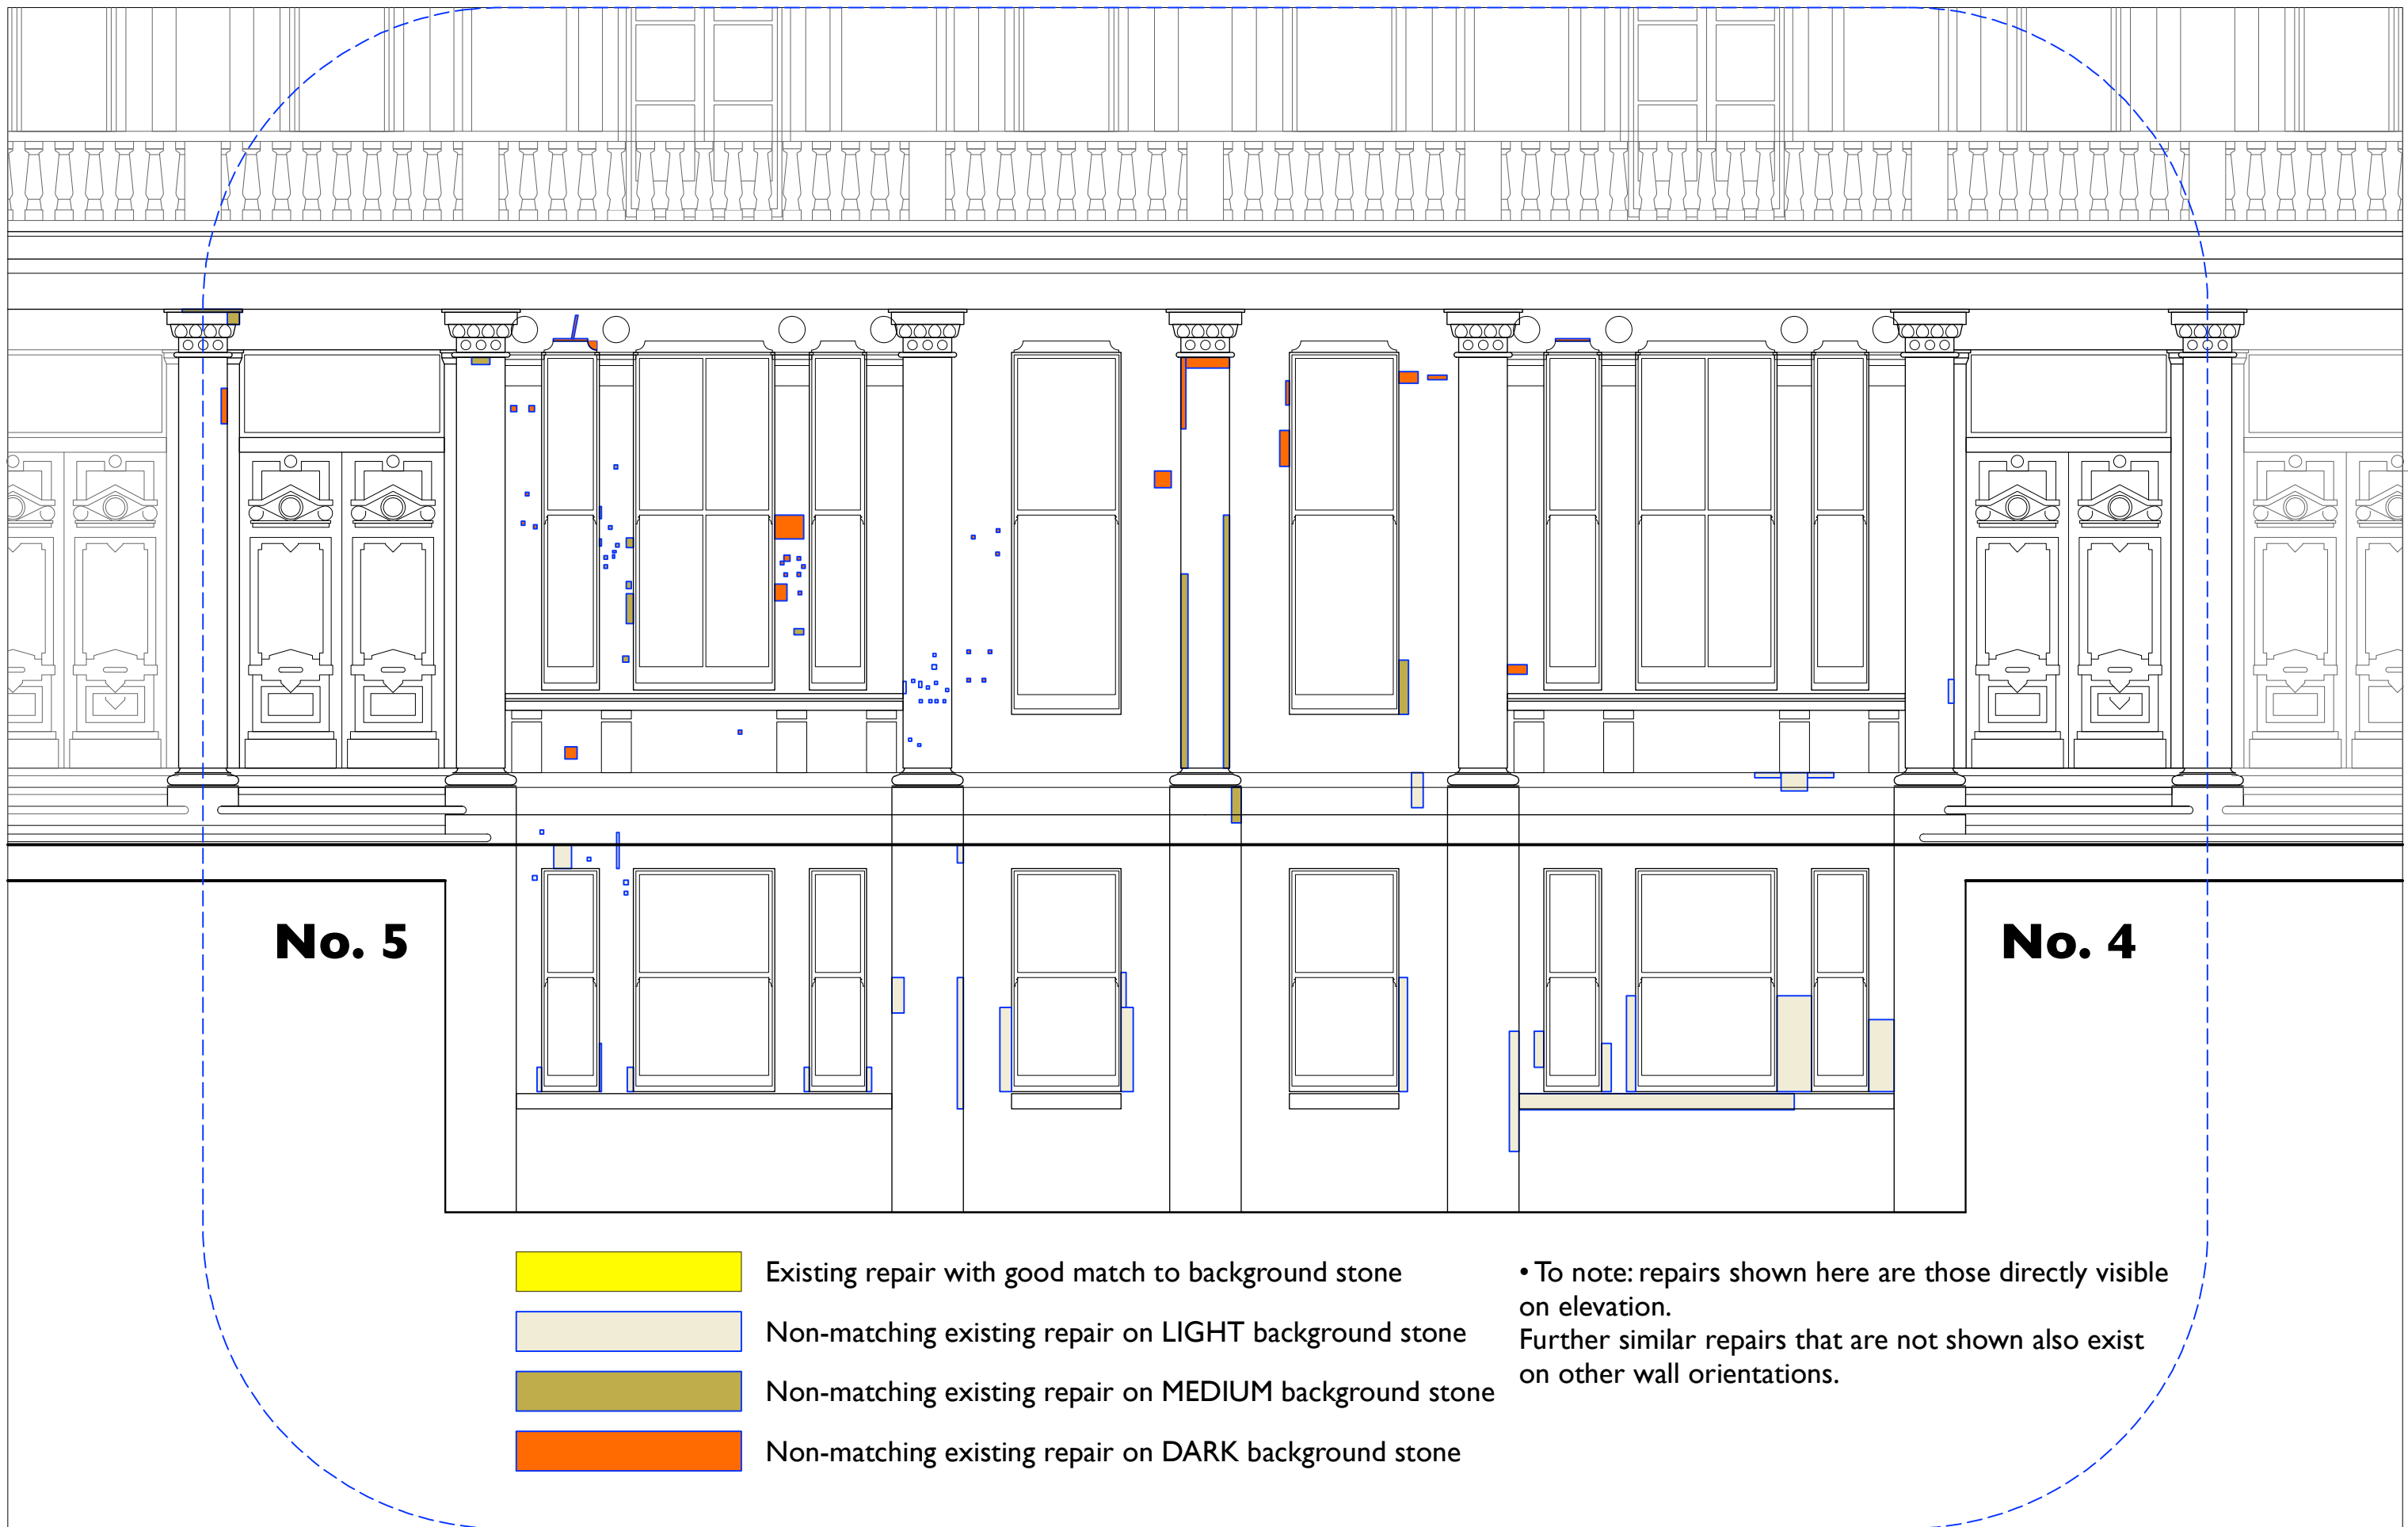
- Existing repair with good match to background stone
- Non-matching existing repair on LIGHT background stone
- Non-matching existing repair on MEDIUM background stone
- Non-matching existing repair on DARK background stone

• To note: repairs shown here are those directly visible on elevation.
Further similar repairs that are not shown also exist on other wall orientations.
