01.07.2024			1.0m			2.0m			3.0m			4.0m		
Rev	Date	Notes	Rev	Date	Notes	NOTES			Architect			Contact		
.	16.07.2024	Planning Issue.	.	.	.	1. Where applicable, this drawing is to be read in conjunction with specification. 2. Do not scale from this drawing. All dimensions to be checked on site prior to commencement of works. Contractor to report back any discrepancies with site dimensions.			ROBERT LOADER ARB RIBA CONSERVATION REGISTER 3 Newman House, Garden Row London SE1 6HE			t: 0794 880 1144 e: studio@robertloader.com		
									Project			Drawing Title		
									2 - 9 CAMBRIDGE GATE			FRONT ELEVATION - 9 & 8		
												AS EXISTING		
									Drawing Status			Job		
									PLANNING			CMBGT		
									Scale: 1:50 @ A3			Drawing No		
												214		
												Rev		
												.

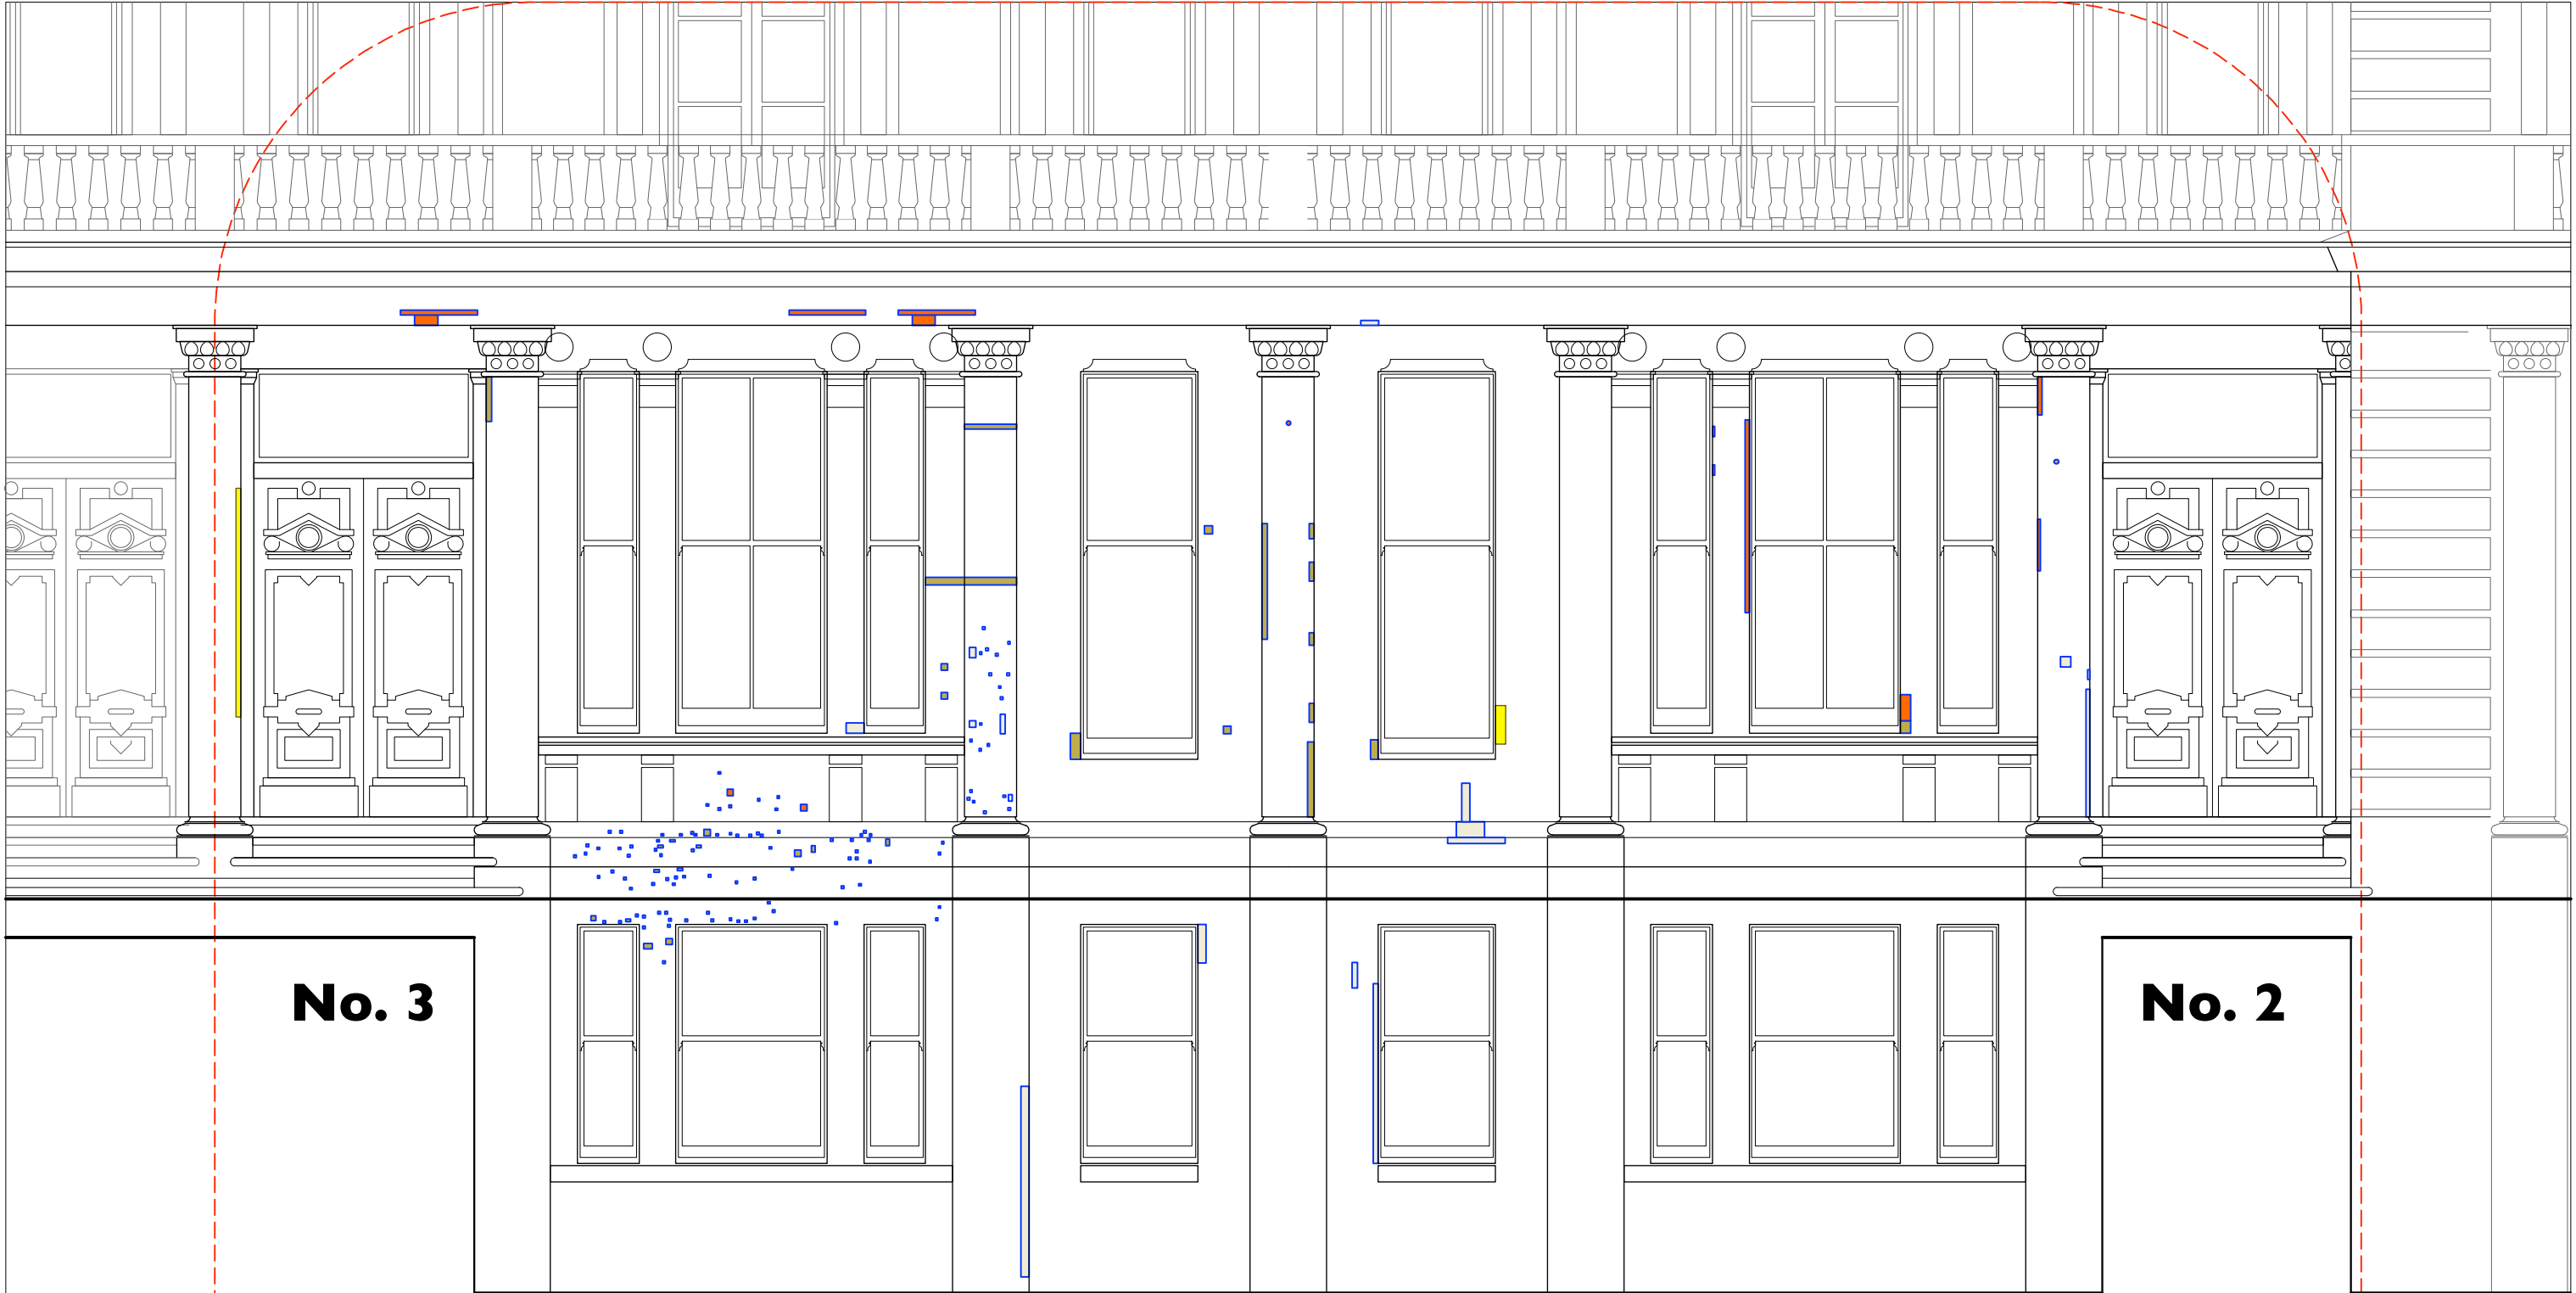
Existing repair with good match to background stone

Non-matching existing repair on LIGHT background stone

Non-matching existing repair on MEDIUM background stone

Non-matching existing repair on DARK background stone

• To note: repairs shown here are those directly visible on elevation. Further similar repairs that are not shown also exist on other wall orientations.
