### Appendix E – Front lightwells

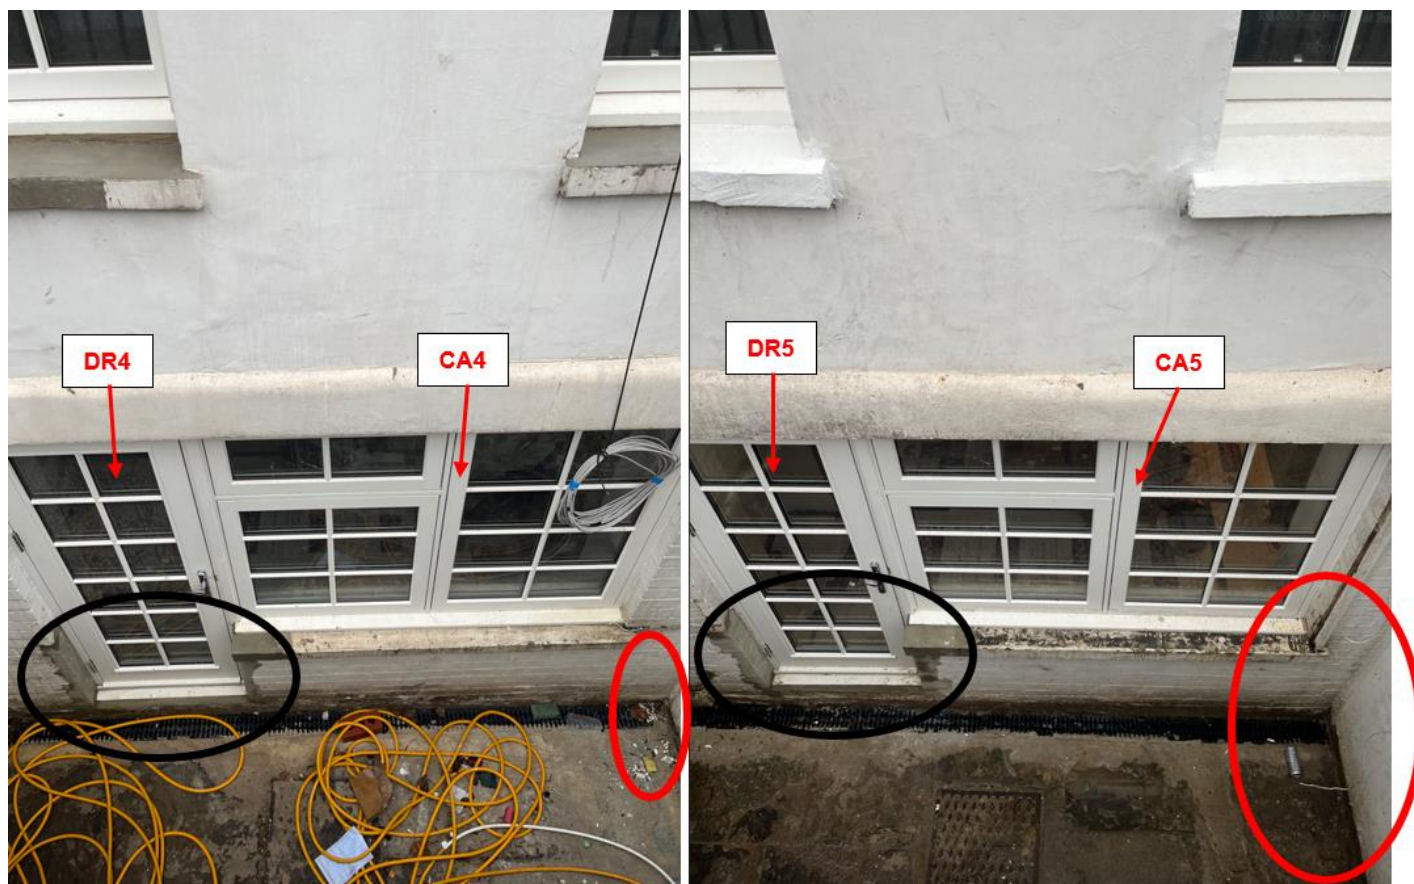
No.18 [left] & 20 [right]: TWO sections of masonry removed (circled in **black**), then installation of TWO unauthorised casement & doors (**DR4 & CA4**, and **DR5 & CA5**) – basement level. External access into the lightwell boarded up (circled in **red**).

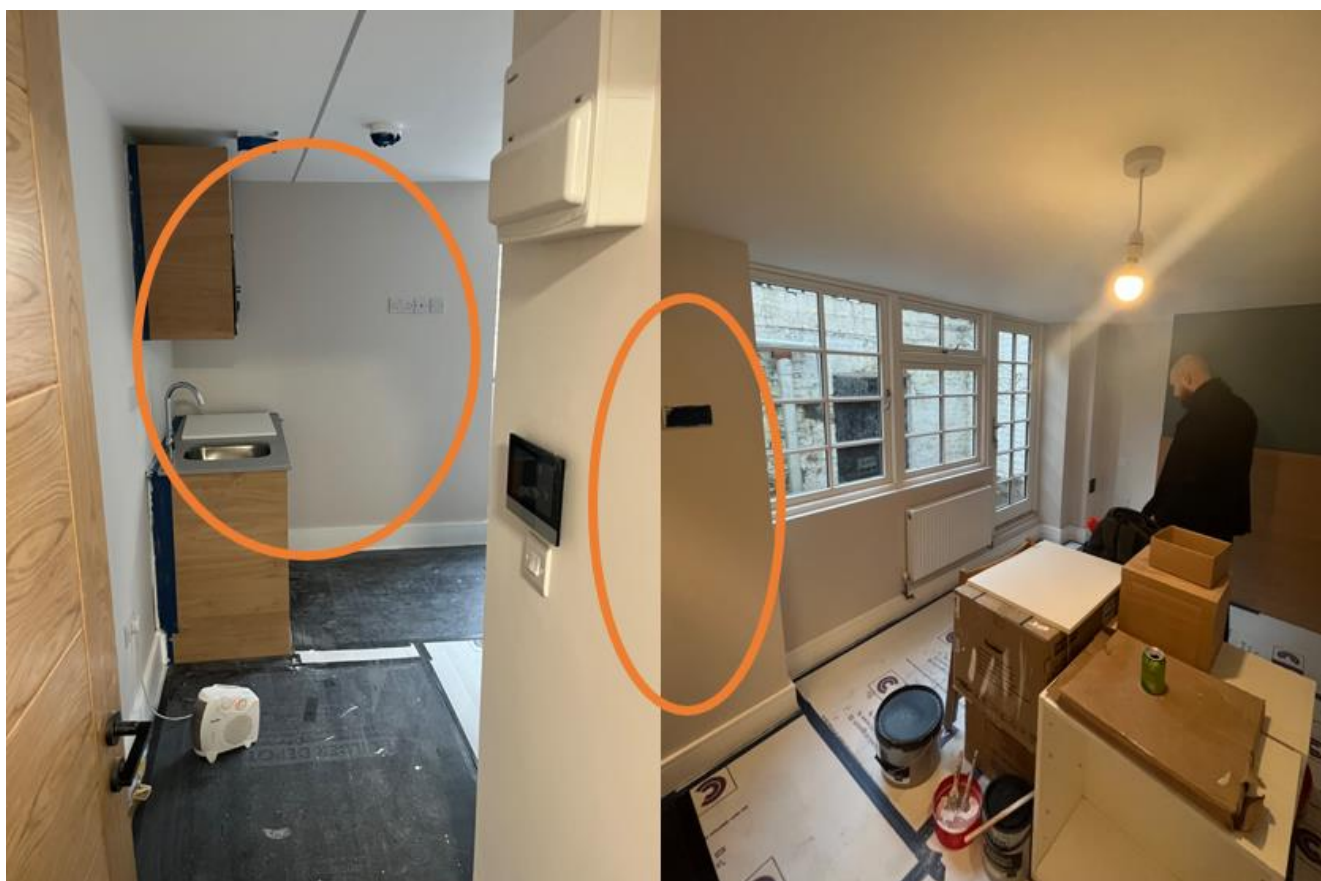
No.18 [left] & 20 [right]: Internal access into the lightwell also boarded up (circled in **orange**). See below labelled plan drawing with corresponding coloured circles.

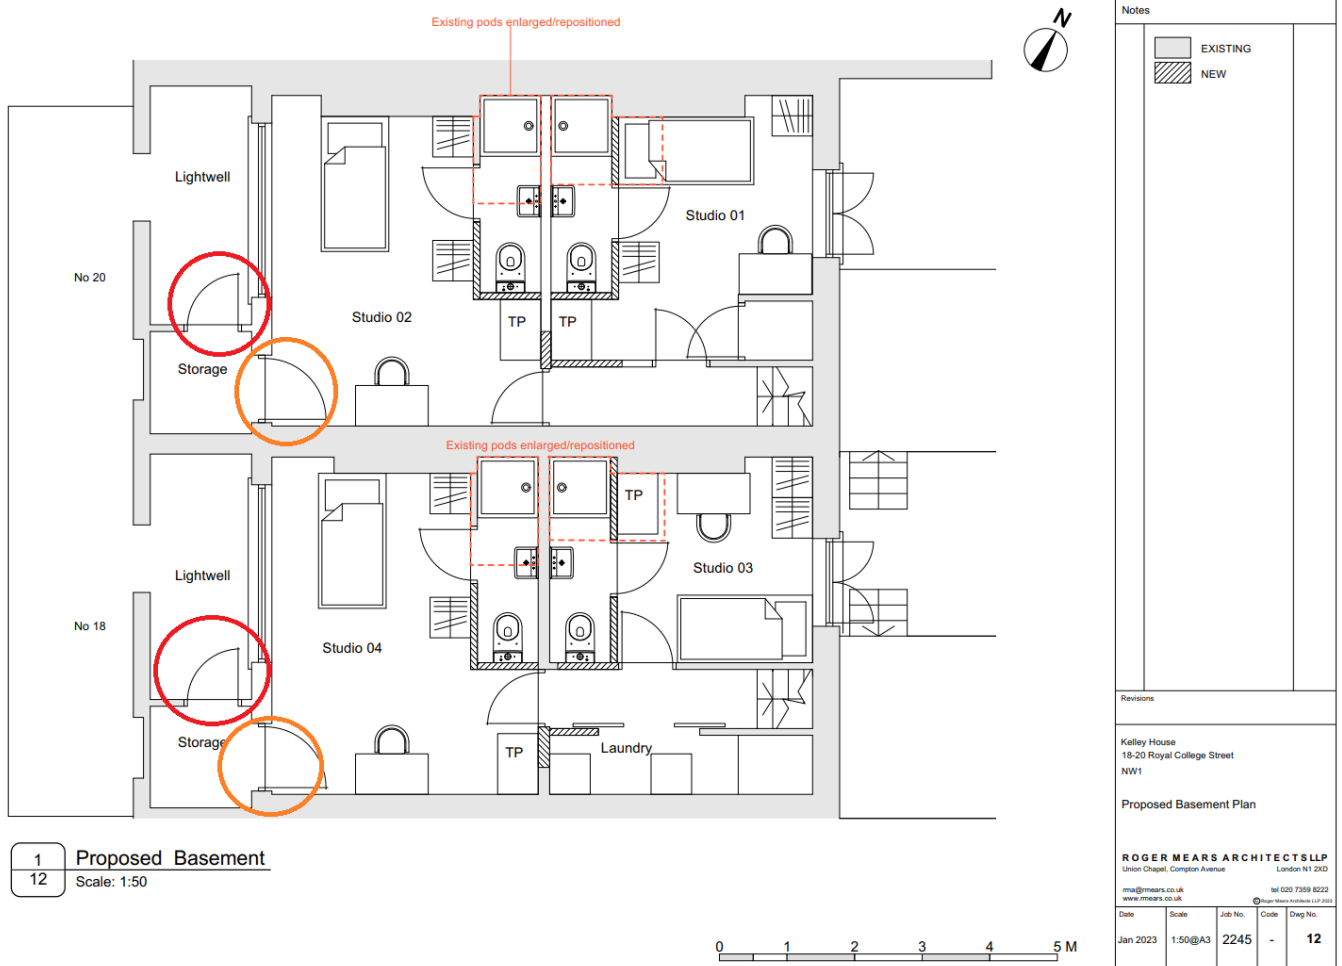
Annotated proposed basement plan drawing from the 2023/0285/L consent - **Red** circles are where external access has been boarded up, and **orange** circles where the internal access has been boarded up.

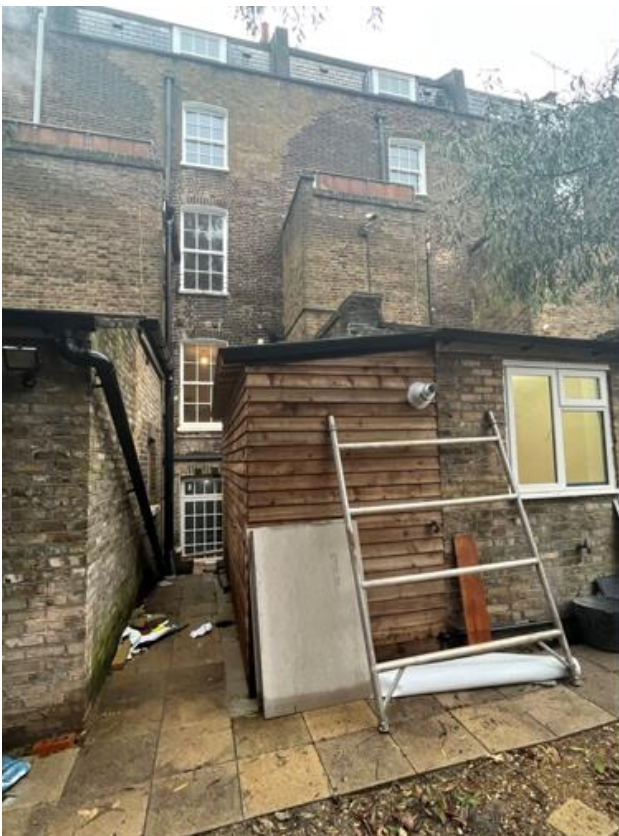
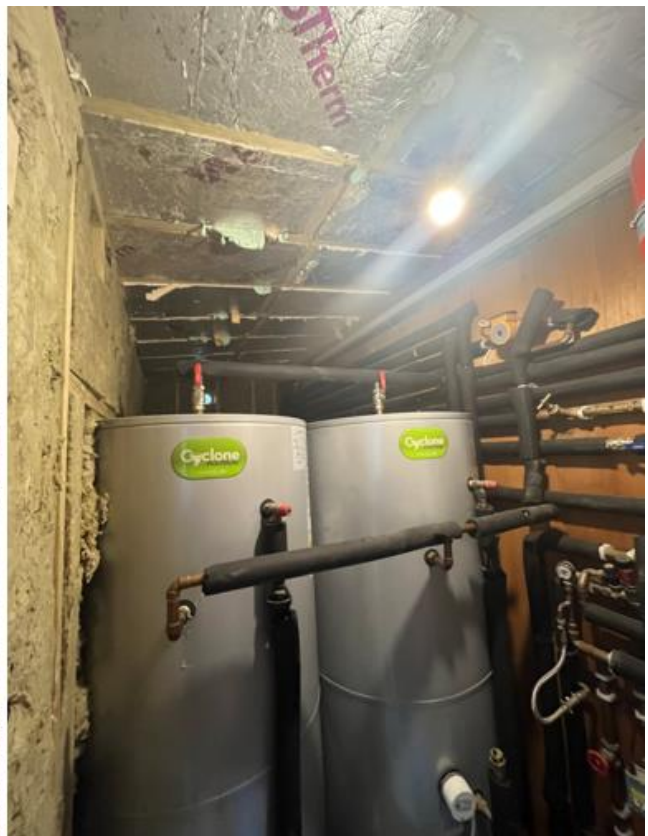
### Appendix F – Boiler outbuilding

ONE unauthorised boiler outbuilding and ancillary plant equipment installed – ground floor level.
