**7 THE GROVE,  
LONDON N6 6JU**

**FRONT GARDEN  
FRONT BOUNDARY  
GATES & RAILINGS  
GRO7 / COP / 916**  
1:10 @ A1  
DO NOT SCALE FROM THIS DRAWING  
REFER ALL DISCREPANCIES TO ARCHITECT

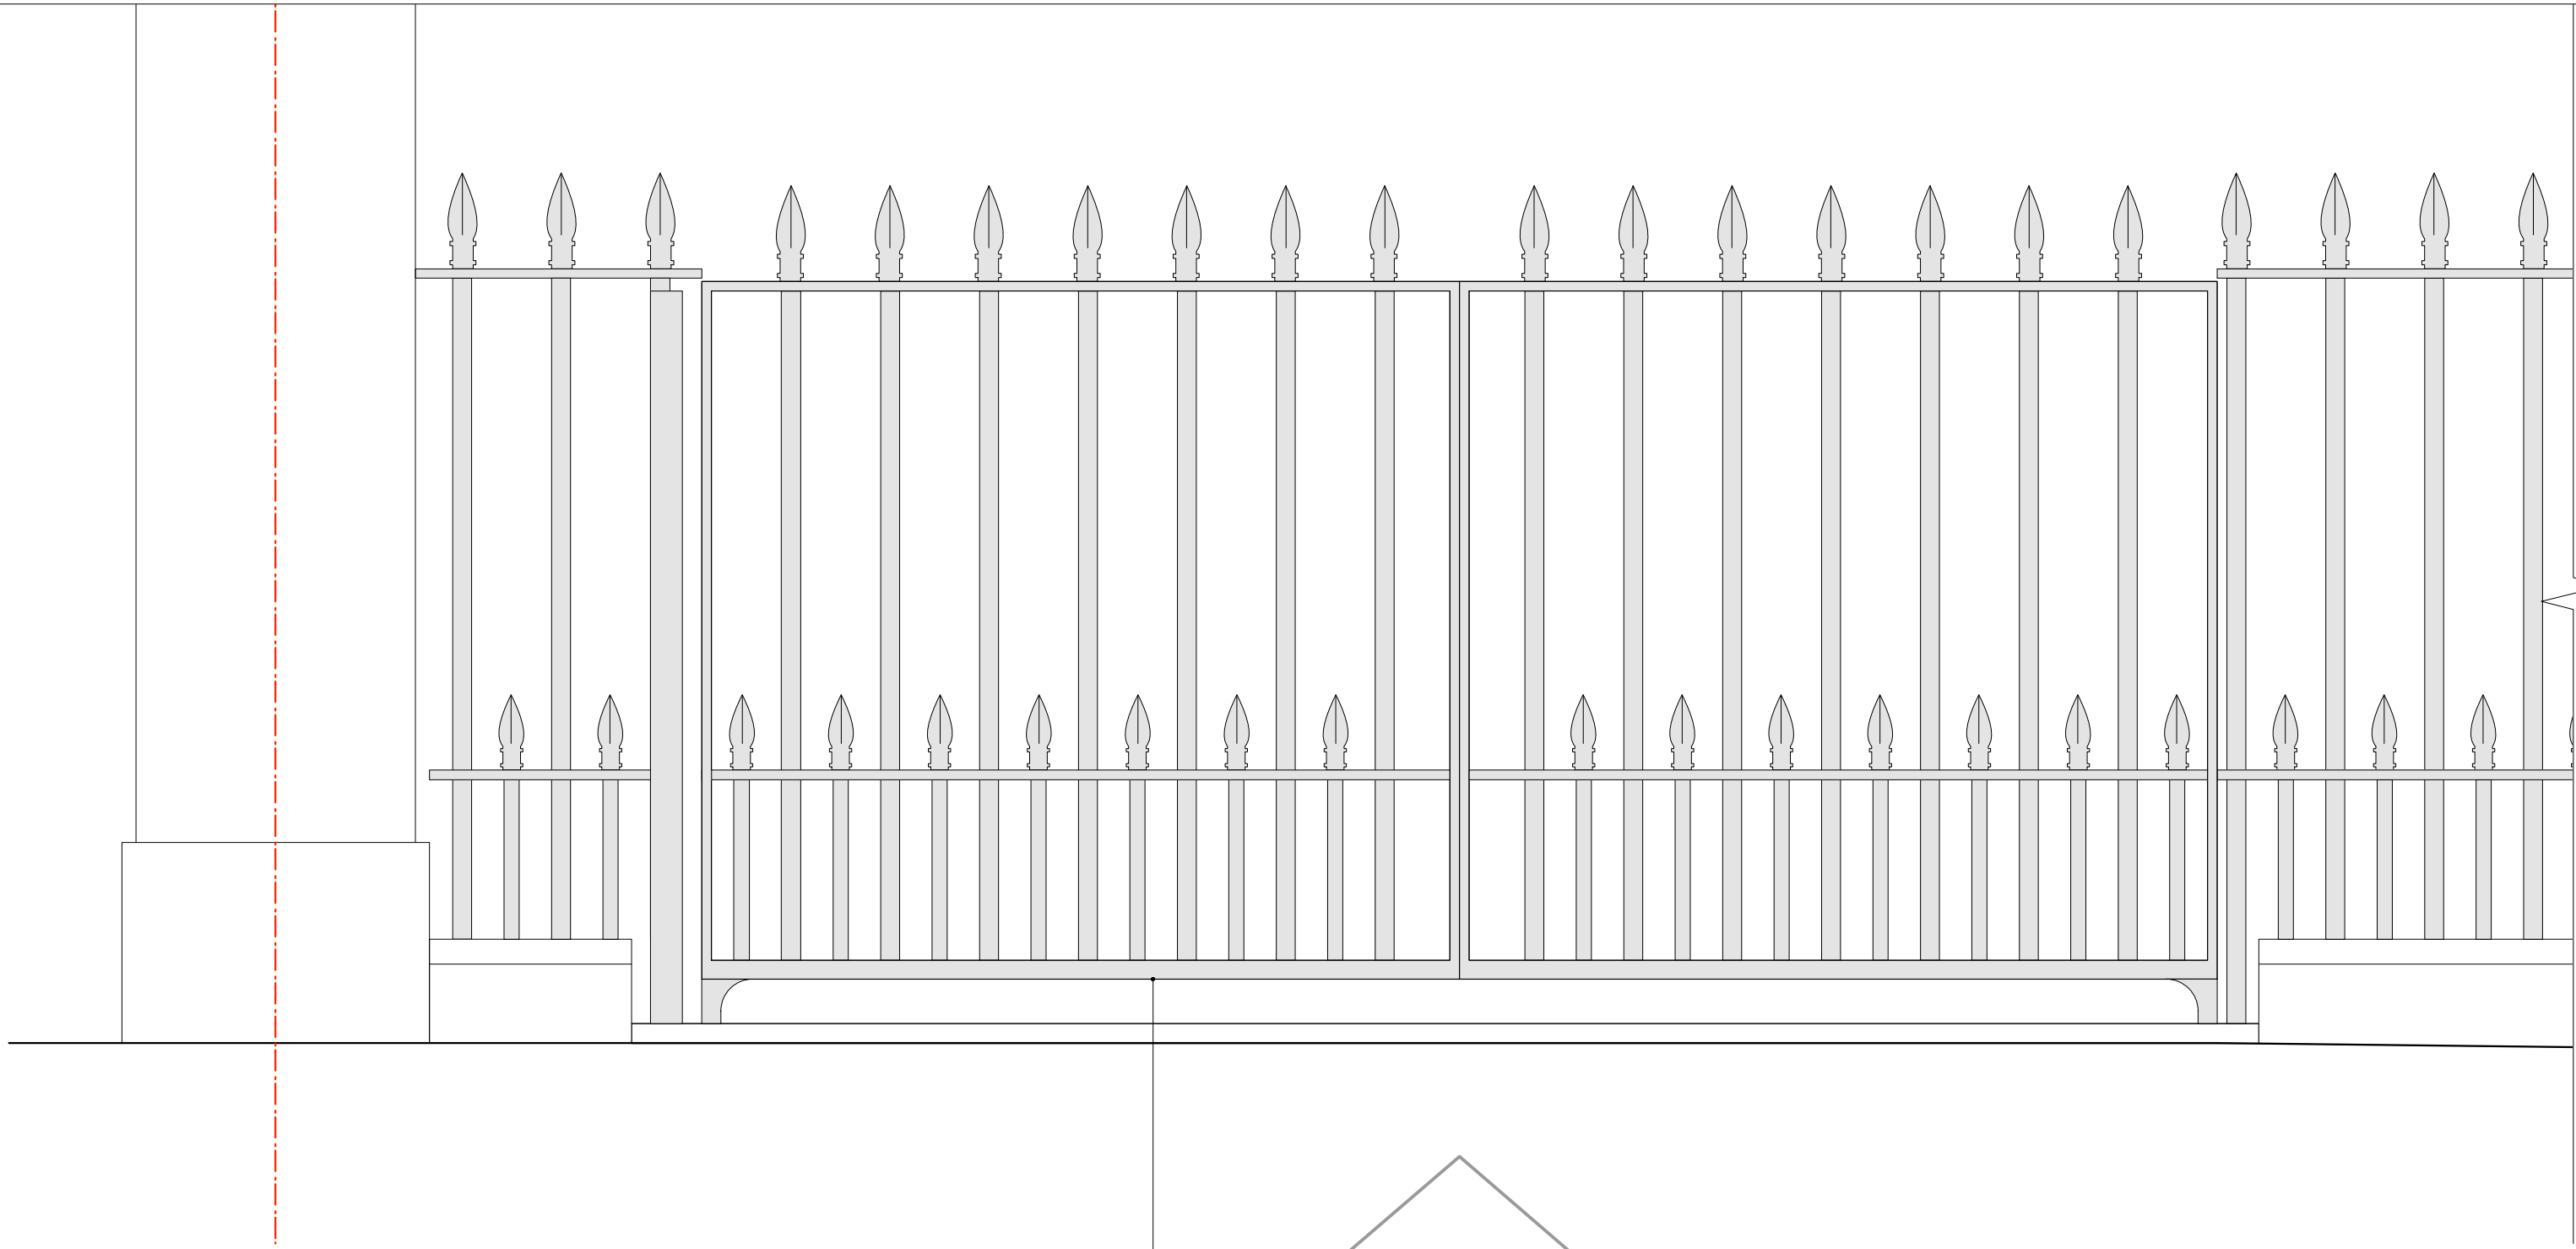
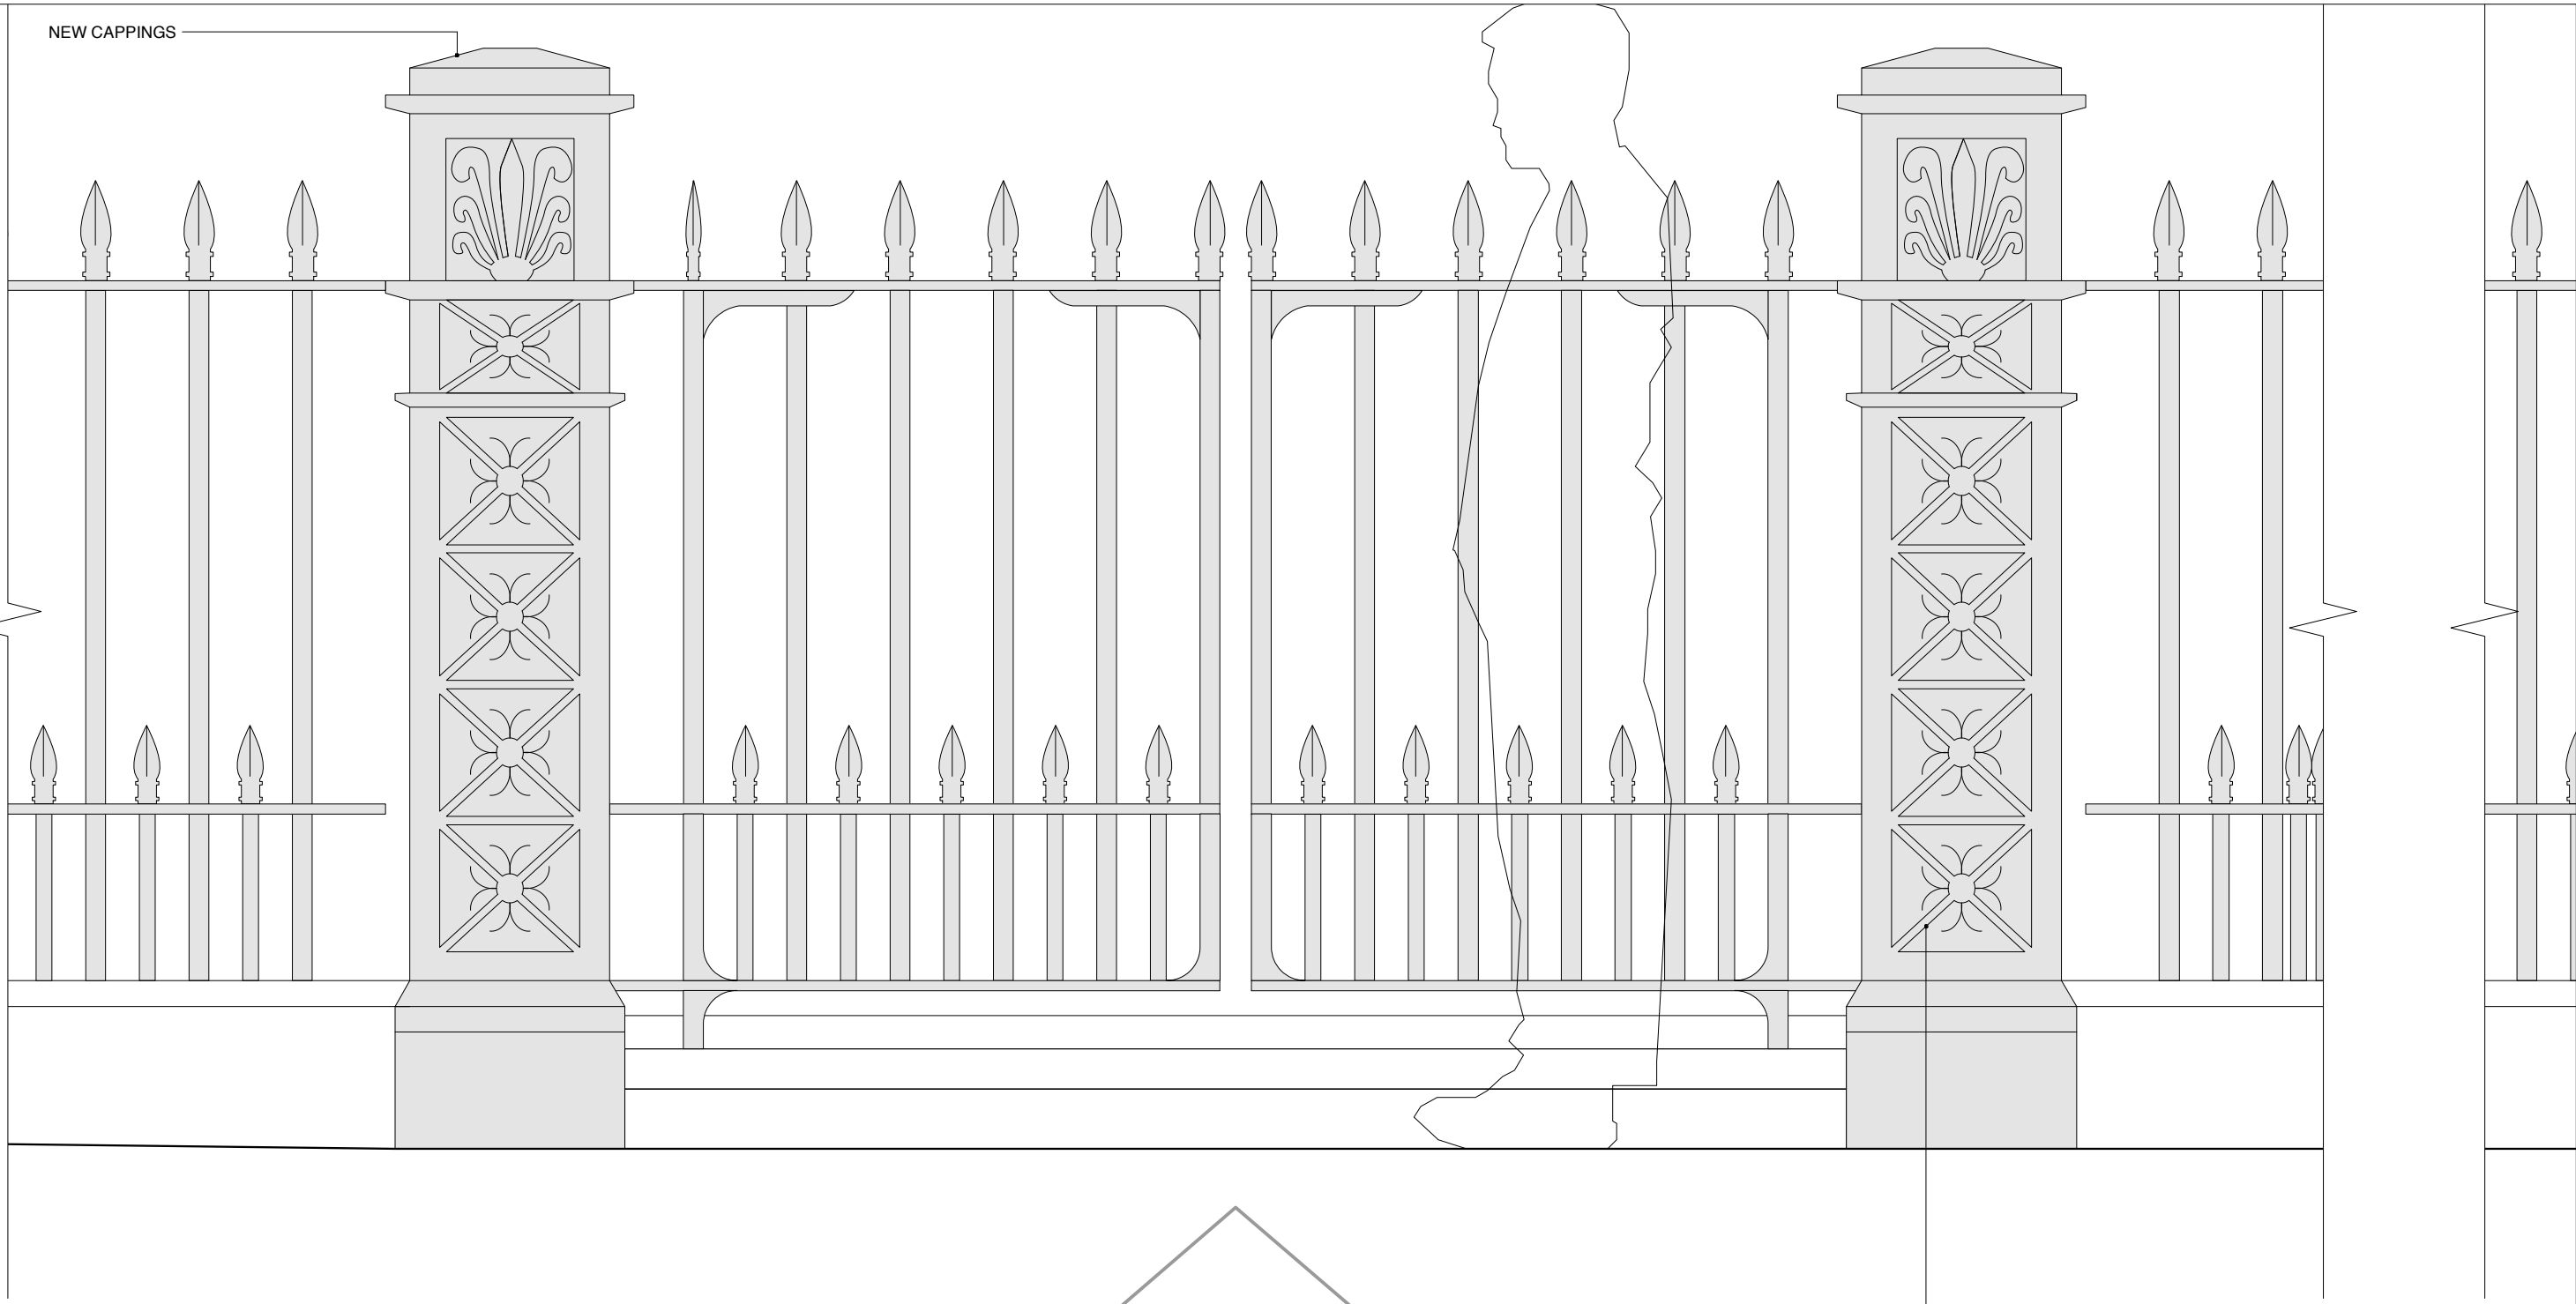
ELEVATION

ACCESS TO NO. 7 THE GROVE  
REPLACE DAMAGED GATE POST TO MATCH EXISTING, WITH NEW CAPPING

**SPECIFICATION**  
RETAIN, REPAIR AND REFURBISH EXISTING RAILINGS AND GATES  
NEW 'CAPPING' DETAIL TO NO. 7 GATE POSTS, TO MATCH NO. 8  
STRIP BACK, PAINT FINISH

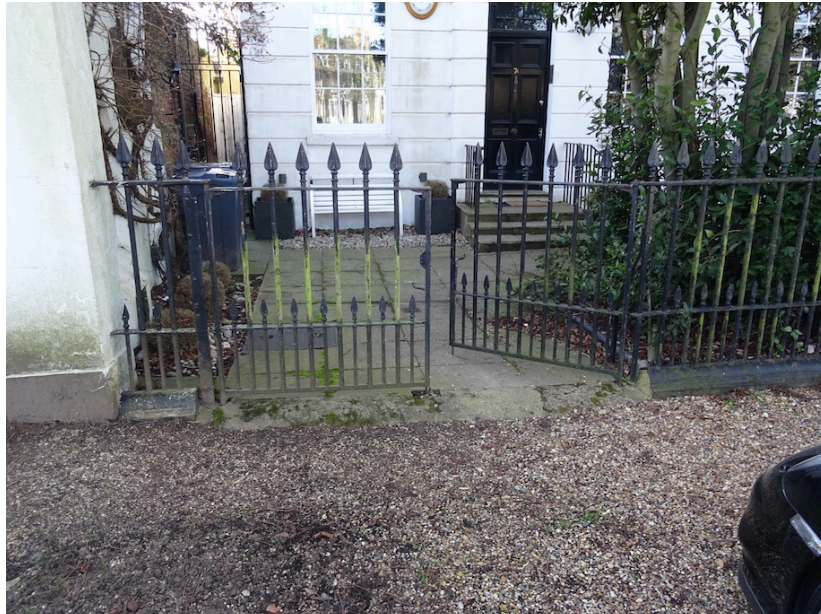
EXISTING NO. 7A FRONT  
BOUNDARY GATE

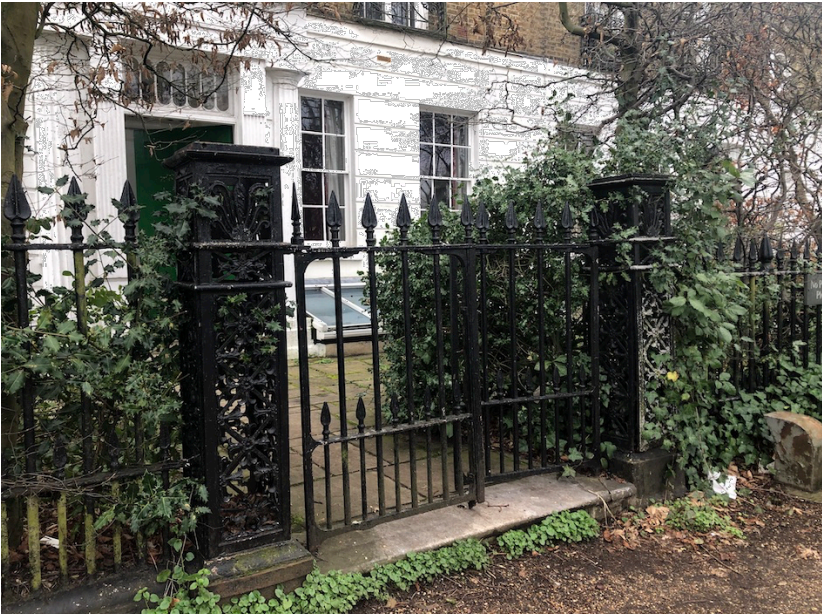
EXISTING NO. 7 FRONT  
BOUNDARY GATE

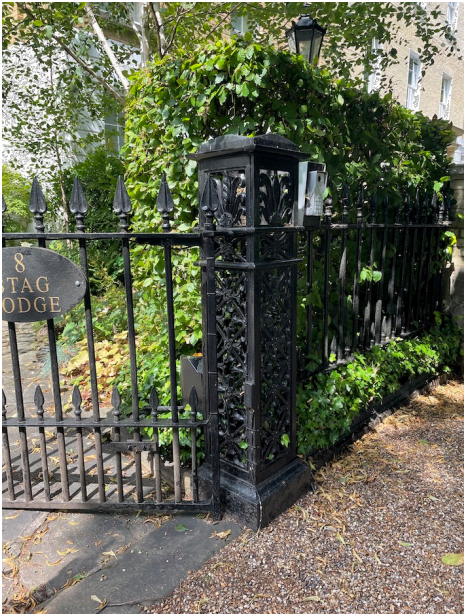
NO. 8 FRONT BOUNDARY  
GATE POST PRECEDENT
