Caroline Merrell	and Simon E	veritt	
Flat 1, 36 Platts	Lane, Londor	ı, NW3 7	NT
Block Plan			
C32926A	22/09/24	REV O	
	1:500@A4

Caroline Merr	ell and Simon E	veritt	
Flat 1, 36 Pla	tts Lane, Londo	n, NW3 7	NT
Existing Floor	Plan, Elevation	s & Roof	Plan
C32926C	DRAWING DATE 22/09/24	REV 0	
	1:100@A4

Flat 1, 36 Platts Lane, London, NW3 7NT			
, ,			
, ,			
DANGES NAME			
RAWING NAME			
Proposed Floor Plan, Elevations & Roof Plan			
RAWING NUMBER DRAWING DATE REV			
C32926D 22/09/24 0			
SCALE			
1:100@A4

Flat 1, 36 Platts Lane, London, NW3 7NT  PRAVING NAME Green Roof Details  C32926E  22/09/24  SCALE	NAME	Caroline Merrell	and Simon E	veritt	
Green Roof Details  C32926E  SSCALE  GRAWING DATE  C22/09/24  SSCALE	ADDRES		Lane, Londor	n, NW3 7	NT
C32926E 22/09/24 0	DRAWII		ails		
SCALE	DRAWII			nev O	
1:20@A4			1:20@A4

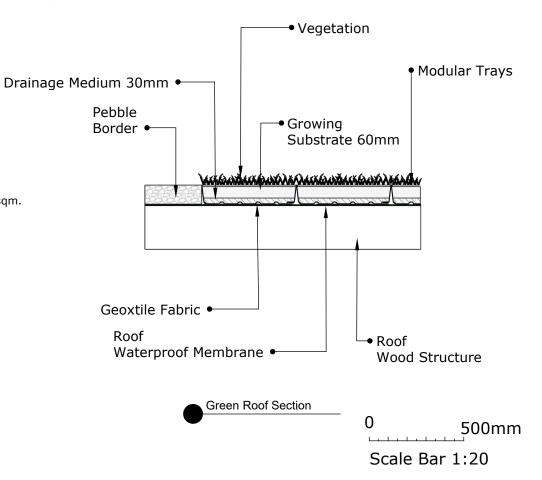
## Sedum species:

Sedum album 'f.murale', Sedum lydium, Sedum acre, Sedum sexangulare, Sedum hispanicum var. minus, Sedum spurium 'Fuldaglut', Sedum floriferum, Sedum kamtschaticum, Sedum hybridum 'Immergrunchen', Sedum reflexum (S.rupestre).

## **Maintenance requirements:**

It is recommended that the following maintenance tasks are carried out twice a year:

- 1. Remove any unwanted weeds from the modules.
- 2. Remove leaf litter or litter that may have blown onto the roof.
- 3. Check that outlets are not obstructed and water is able to flow freely away from the roof.
- 4. Feed your roof with a low nitrogen slow release fertiliser applied at approximately 25g per sqm.

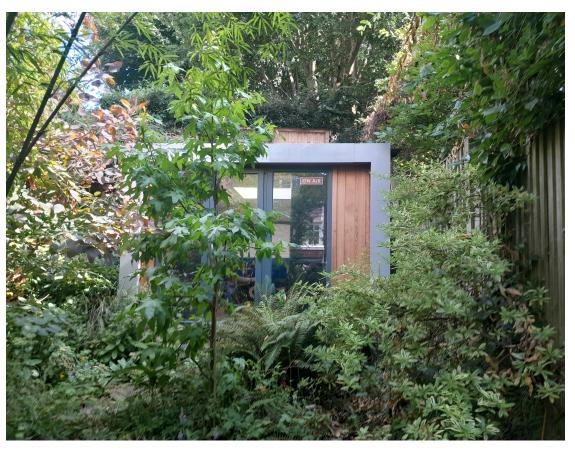
Existing Garden Room

Viewed from the lower rear patio at position V1 as shown
