ADDRESS			Flat A, 26 Belsize Park Gardens, NW3 4LH		
DRAWING NAME			Block Plan		
DRAWING NUMBER		DRAWING DATE	REV		
C32948A		21/10/24	0		
SCALE			1:500@A4

ADDRESS		
Flat A, 26 Belsize Park Gardens, NW3 4LH		
DRAWING NAME		
Green Roof Details		
DRAWING NUMBER	DRAWING DATE	REV
C32948D	21/10/24	0
SCALE		
1:20@A4

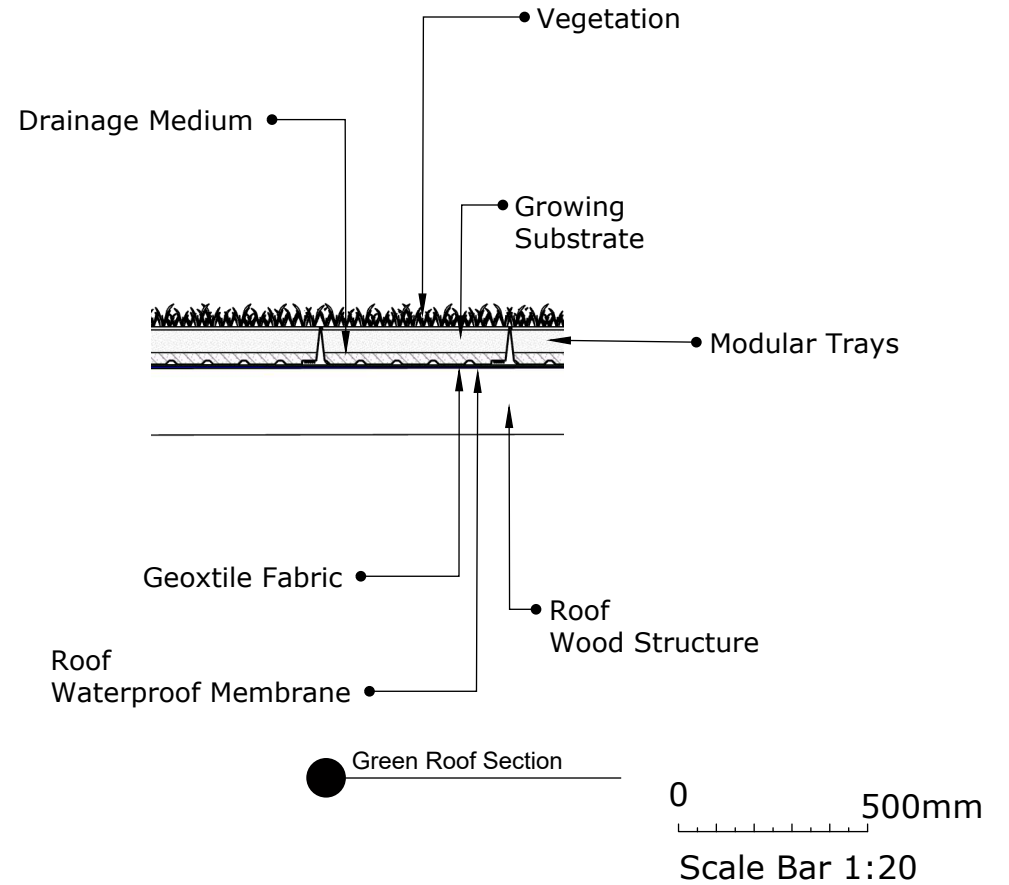
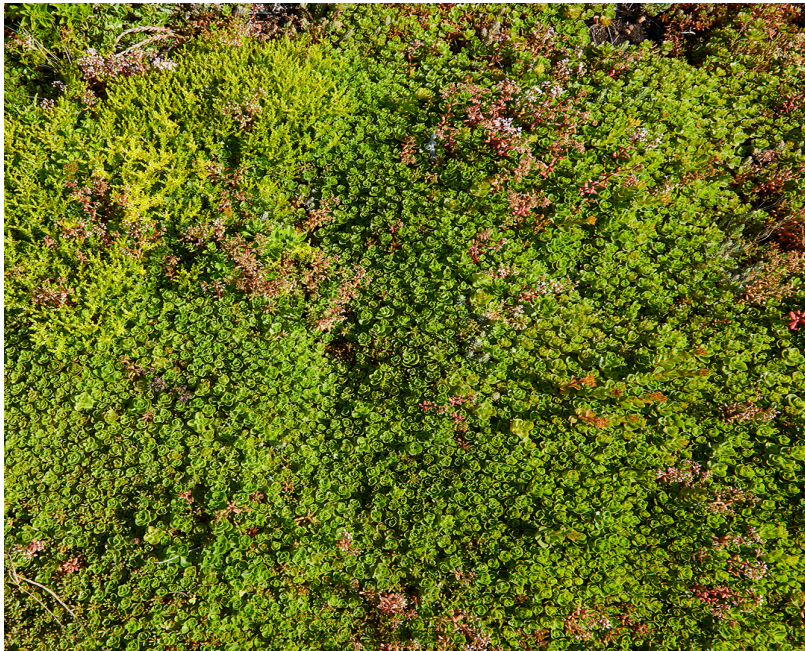
Sedum species:

Sedum album 'f.murale', Sedum lydium, Sedum acre, Sedum sexangulare, Sedum hispanicum var. minus, Sedum spurium 'Fuldaglut', Sedum floriferum, Sedum kamtschaticum, Sedum hybridum 'Immergrunchen', Sedum reflexum (S.rupestre).

Maintenance requirements:

It is recommended that the following maintenance tasks are carried out twice a year:

1. Remove any unwanted weeds from the modules.
2. Remove leaf litter or litter that may have blown onto the roof.
3. Check that outlets are not obstructed and water is able to flow freely away from the roof.
4. Feed your roof with a low nitrogen slow release fertiliser applied at approximately 25g per sqm.
