Proposed Service Route Through Glazed Bricks - Location within Basement B1

Proposed Service Route Through Glazed Bricks - Existing Photographs

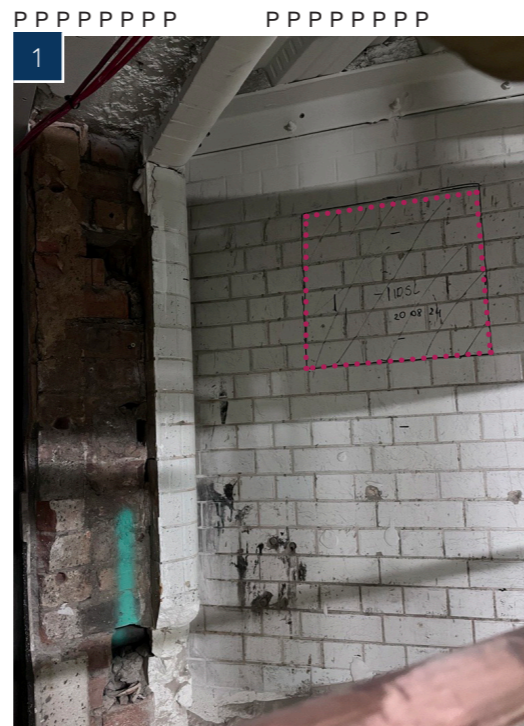
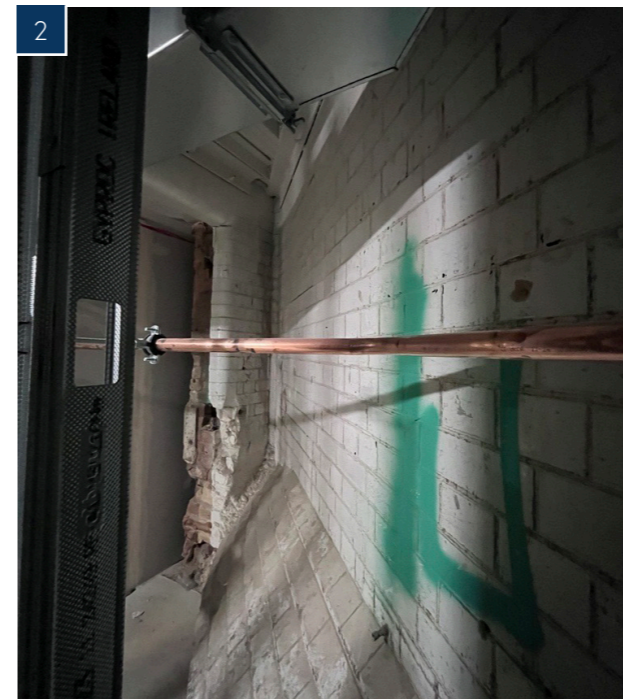
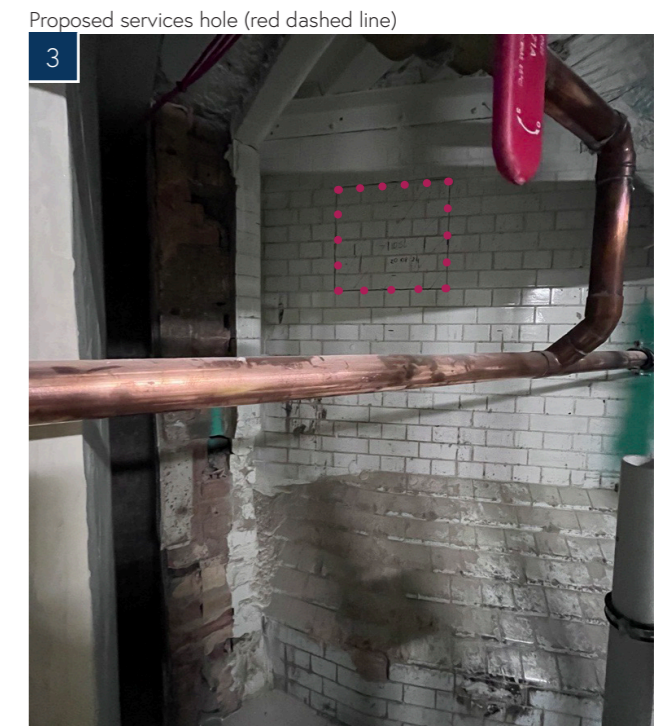
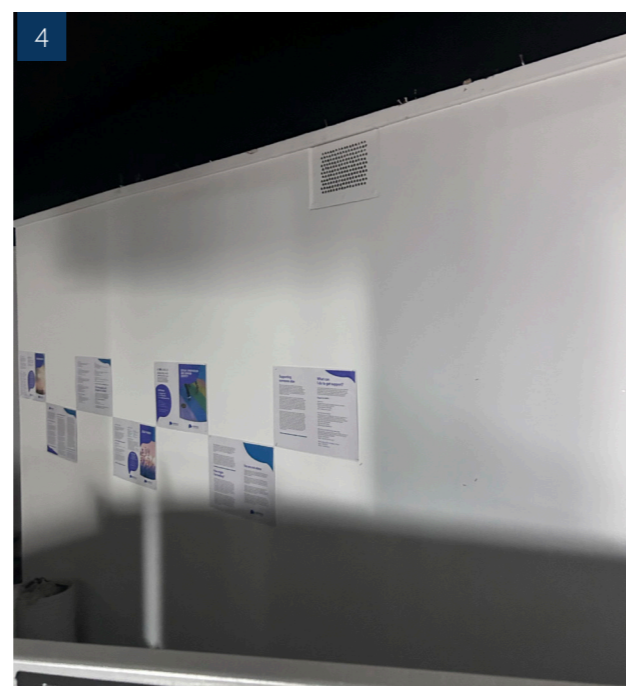
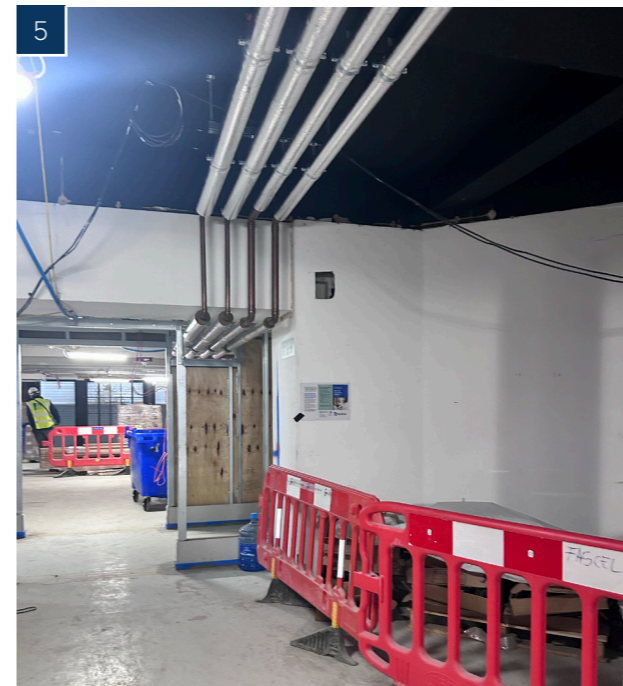
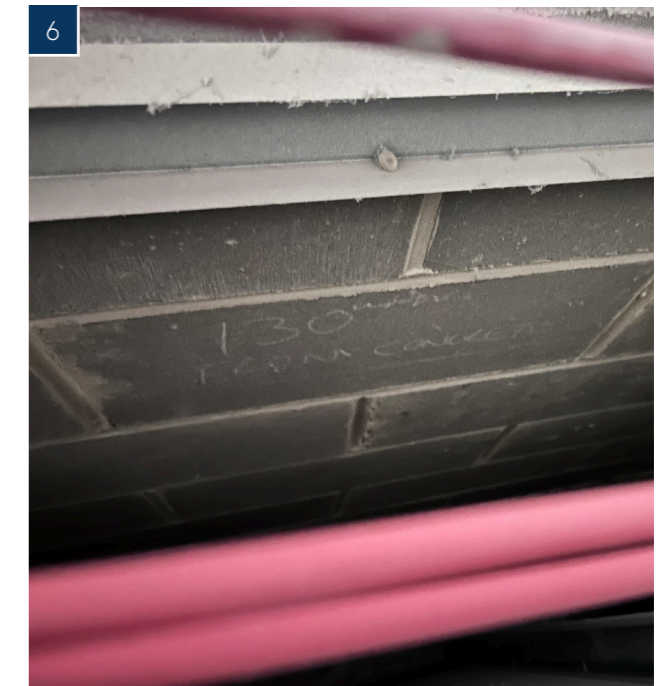
1. Glazed Brick Wall - proposed services route through
2. Glazed Brick Wall
3. Glazed Brick Wall - proposed services route through
4. 'Internal' Wall face - plasterboard
5. Contemporary plasterboard wall (not original materials)
6. Contemporary block wall (not original materials)
