**PROJECT**  
 The Hoo  
 17 Lyndhurst Gardens,  
 Hampstead

**DRAWING**  
 Stone, Brick and Roof Repairs  
 South and East Elevations

JOB No	DRAWING No	REVISION
19-013	3011	F
STATUS	PLANNING

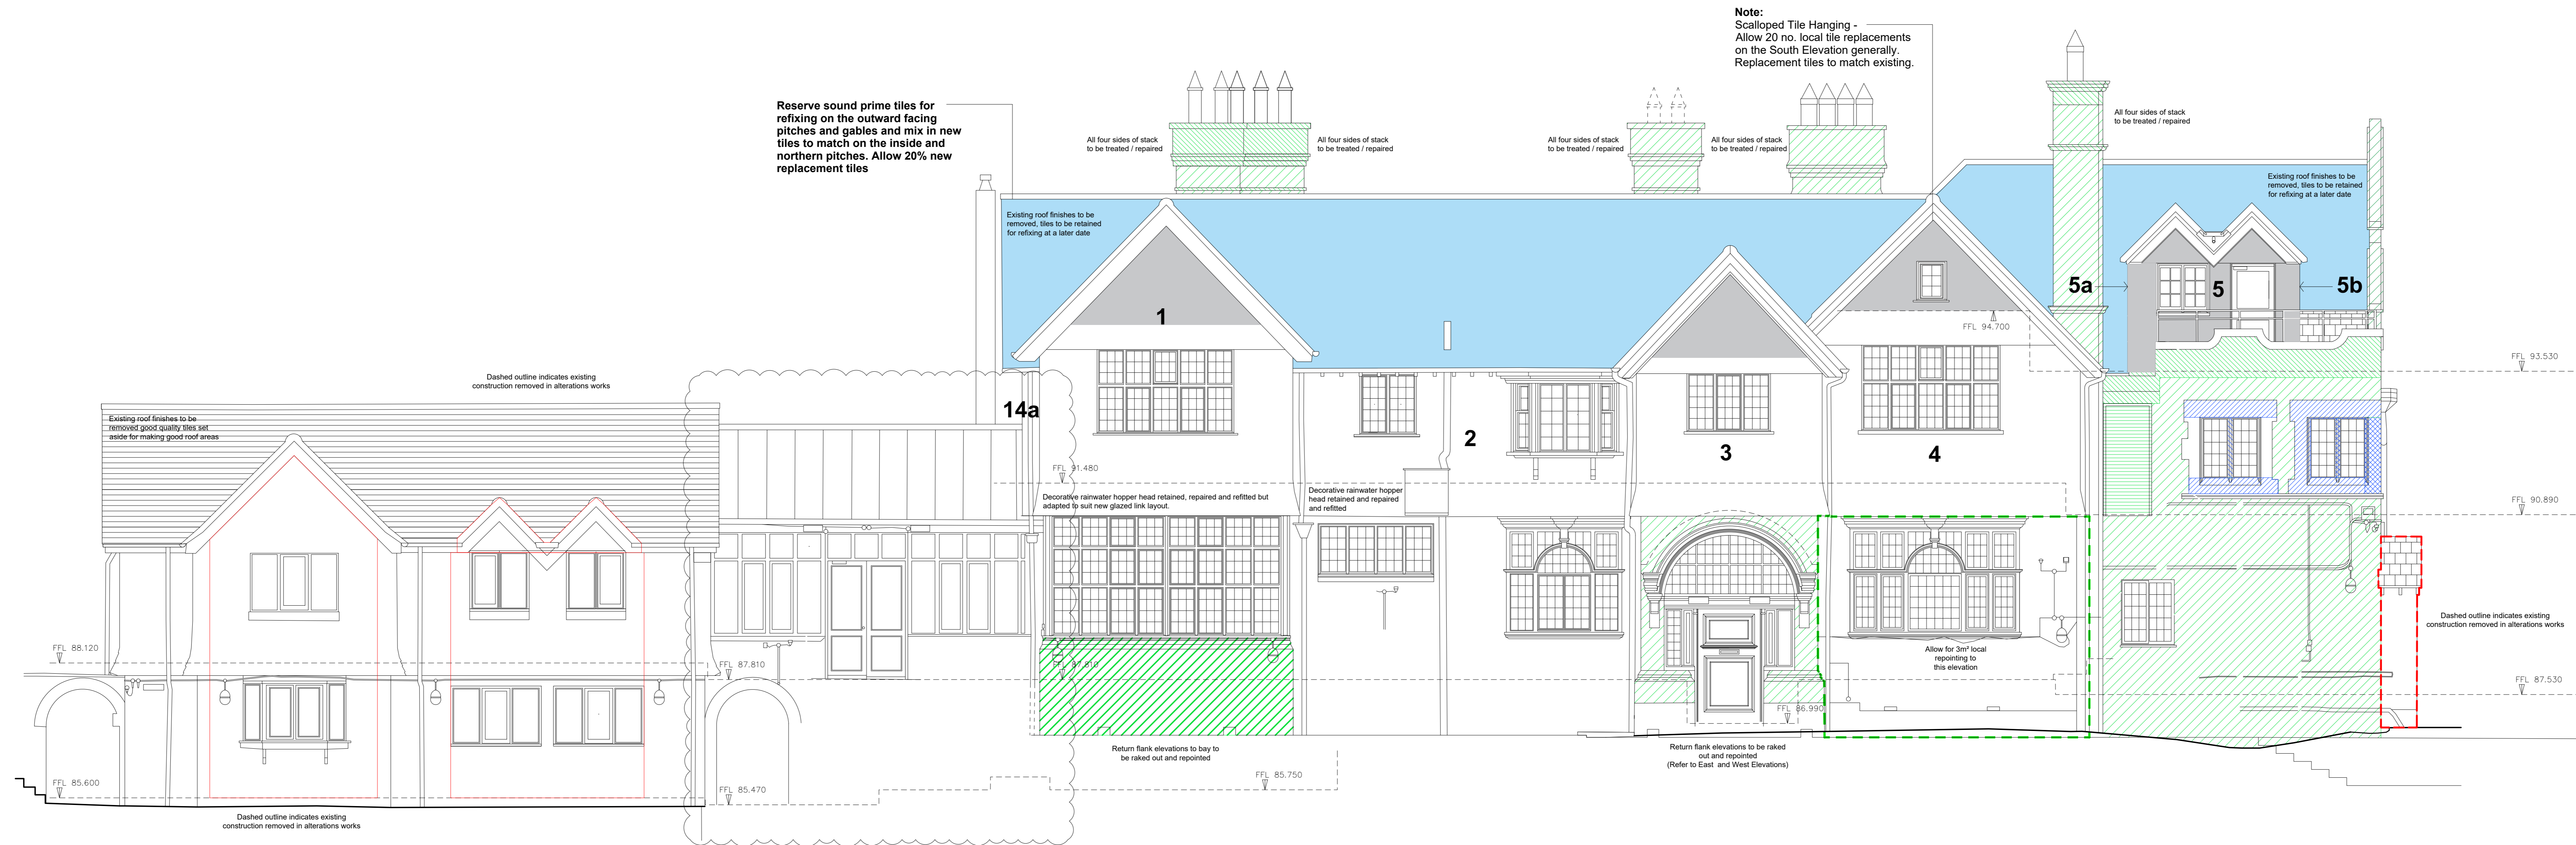
South Elevation - Main House and Lodge Stone and Brick Repairs

- Masonry Repairs Key**
- Brickwork**
    - Rake out and repoint with lime mortar
    - Cut out individually badly weathered or damaged bricks. Replace locally with new bricks to match existing - allow 30% of area shown

- New brickwork to match existing
    - New window / door openings
  - Stonework**
    - Indent to approximately 120mm or to depth of window rebate detail

- Indent / replace face of mullion if practicable, back to plane of window frame
    - Support lintels and replace mullion entirely
    - Cut out and replace head or sill entirely

- Render**
    - Hack off existing render and re-render
  - Roofing**
    - Existing roof tiles to be carefully removed and stored on site for re-fixing

- Vertical tiling**
    - Vertical tile hanging areas to be carefully removed, noting plain and club tile lines, tiles to be stored on site for re-fixing at a later date and to be re-instated to the original pattern as high, new tiles to be allowed for 20% of area to be tiled.
