Section A-A East - The Annexe, Main House and Lodge Stone and Brick Repairs

Section B-B West - Main House and Lodge Stone and Brick Repairs

PROJECT
 The Hoo
 17 Lyndhurst Gardens,
 Hampstead

DRAWING
 Stone, Brick and Roof Repairs
 Sections AA and BB

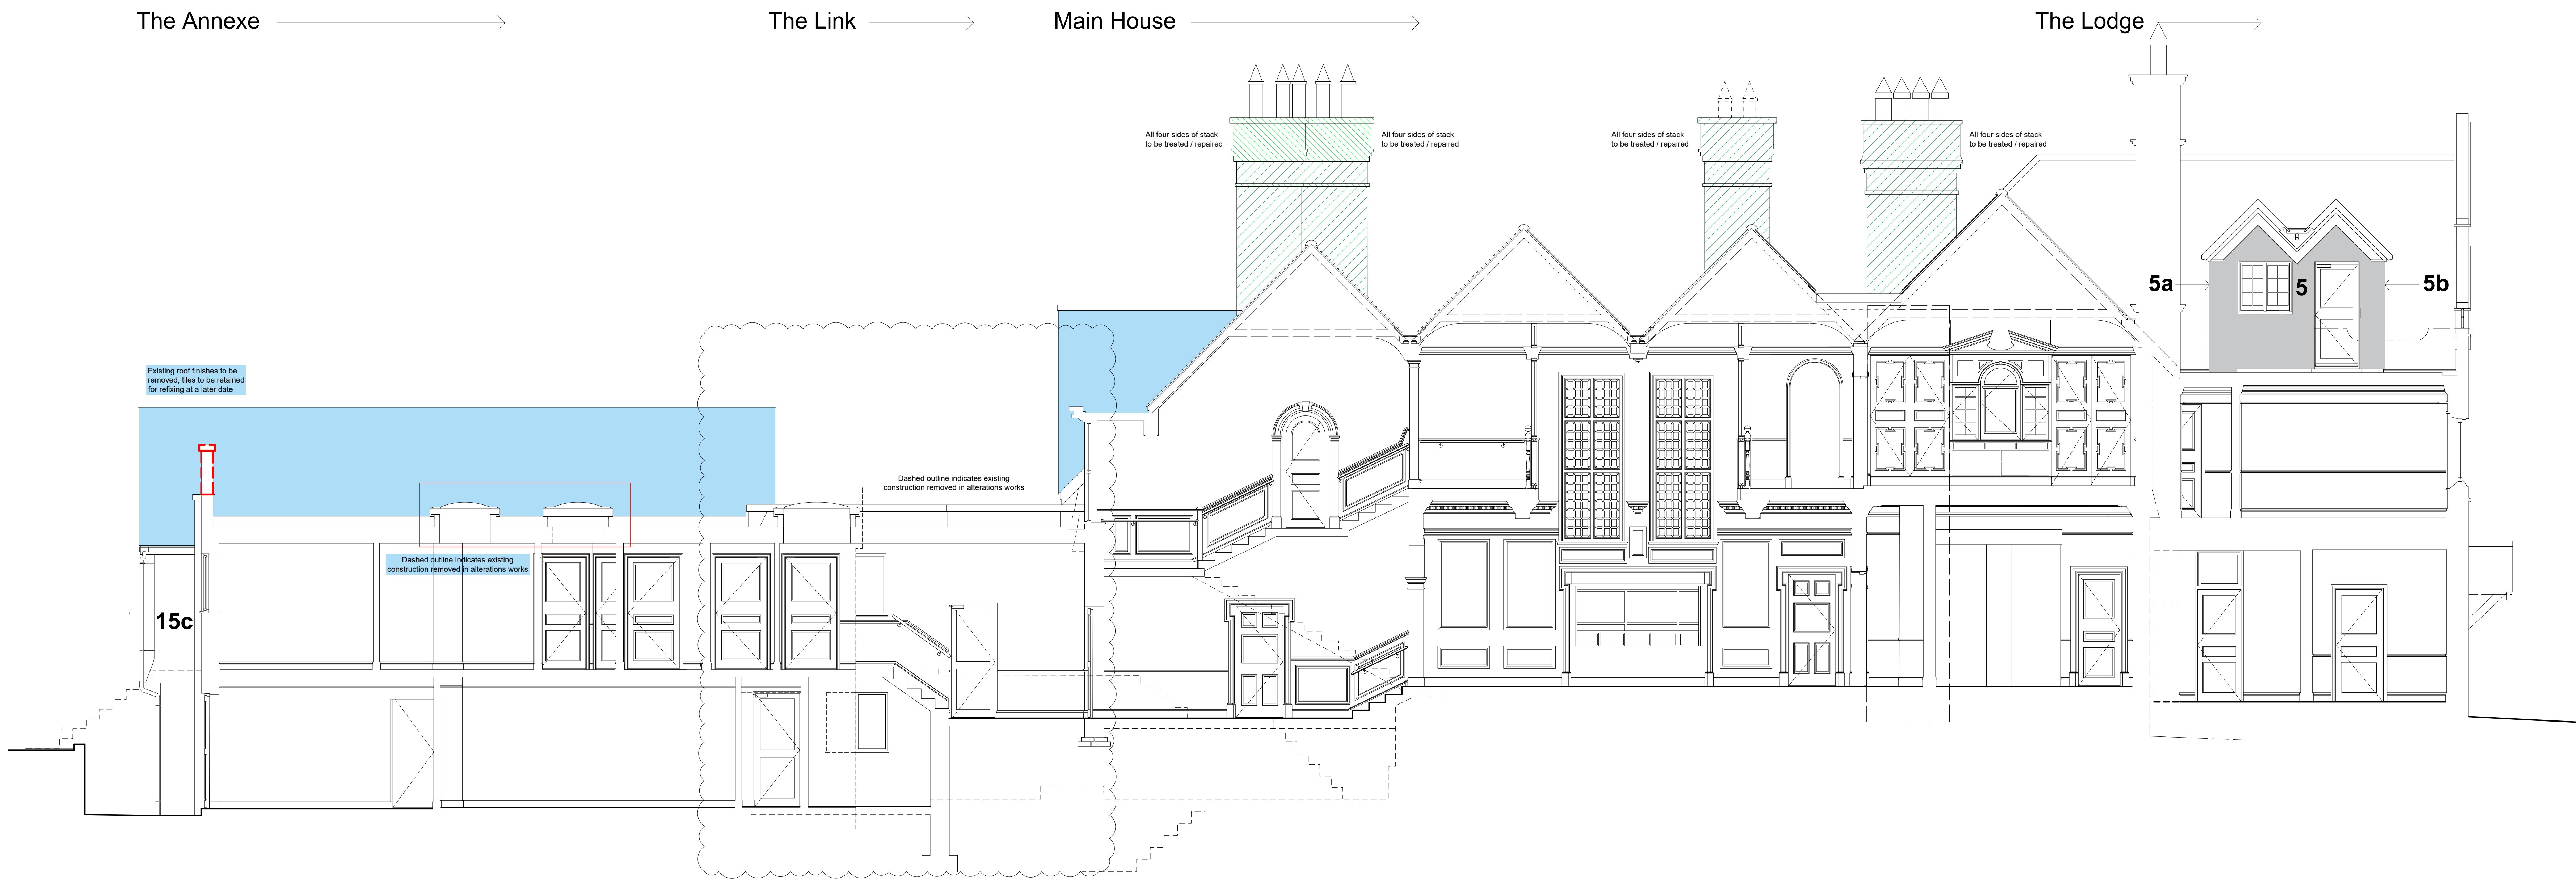
Rake out and repoint with lime mortar
-

Cut out individually badly weathered or damaged bricks. Replace locally with new bricks to match existing - allow 30% of area shown

New brickwork to match existing
-

Indent to approximately 120mm or to depth of window rebate detail

Indent / replace face of mullion if practicable, back to plane of window frame
-

Support lintels and replace mullion entirely
-

Cut out and replace head or sill entirely

Hack off existing render and re-render
- Roofing**
-

Existing roof tiles to be carefully removed and stored on site for re-filing
- Vertical tiling**

Vertical tile hanging areas to be carefully removed, noting plain and club tile rows, tiles to be stored on site for re-filing at a later date and to be re-instated to the original pattern design, new tiles to be allowed for 20% per area to be re-filed.
