LEVEL MONITORING - RELATIVE SURVEY READINGS

Provider Details			Client Details		Risk Address	Risk Address			
Name: MHN Ltd			Insurance Co.: Alianz		Occupier:	180 Camden Road Ltd			
name.	WITH LLC		Client Name:	Crawford & Co	Address:	180 Camden Road			
			Contact:	A Wyse	Address:	London			
Date of Issue:		4/3/22	Email:		Town:				
			Client Ref:	SU1904991	County:				
Monitoring Details			Address:	Cartwright House	Post Code:	NW1 9HG			
Instruction Date:		5/5/20	Address:	Tottle Road	Tel Home:				
First Reading Date:		02/06/2020	Town:	Riverside Business Park	Tel Work:				
Maximum No Visits:		4	County:	Nottingham	Mobile:				
Anticipated Expiry Date:		Feb 2022	Post Code:	NG2 1RT	Other:				
Monitoring Int:		2 Monthly	Other Email:		Other:

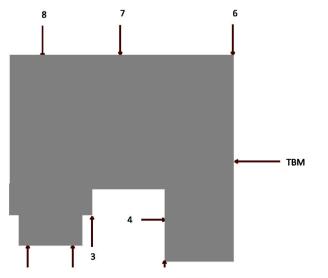
- No new concerns raised at time of visit.
- It was not possible to install all stations within a common brickcourse. Therefore initial readings cannot be interpretted as Distortion Data.
- Rear readings have been made relative to a point on the RHS of the property. Both have an assumed value of 10.0000m. If this is not appropriate, please advise if a deep datum is required?
