This drawing represents a record of our site investigations carried out in June and November 2024. It shows the as-seen structural layouts and provides commentary of condition of remaining historic and adequacy of recently installed elements.

9 The Mount

Layout and condition of structure as seen in November 2024:
2nd Floor Plan

Drawing No. 24-034/14

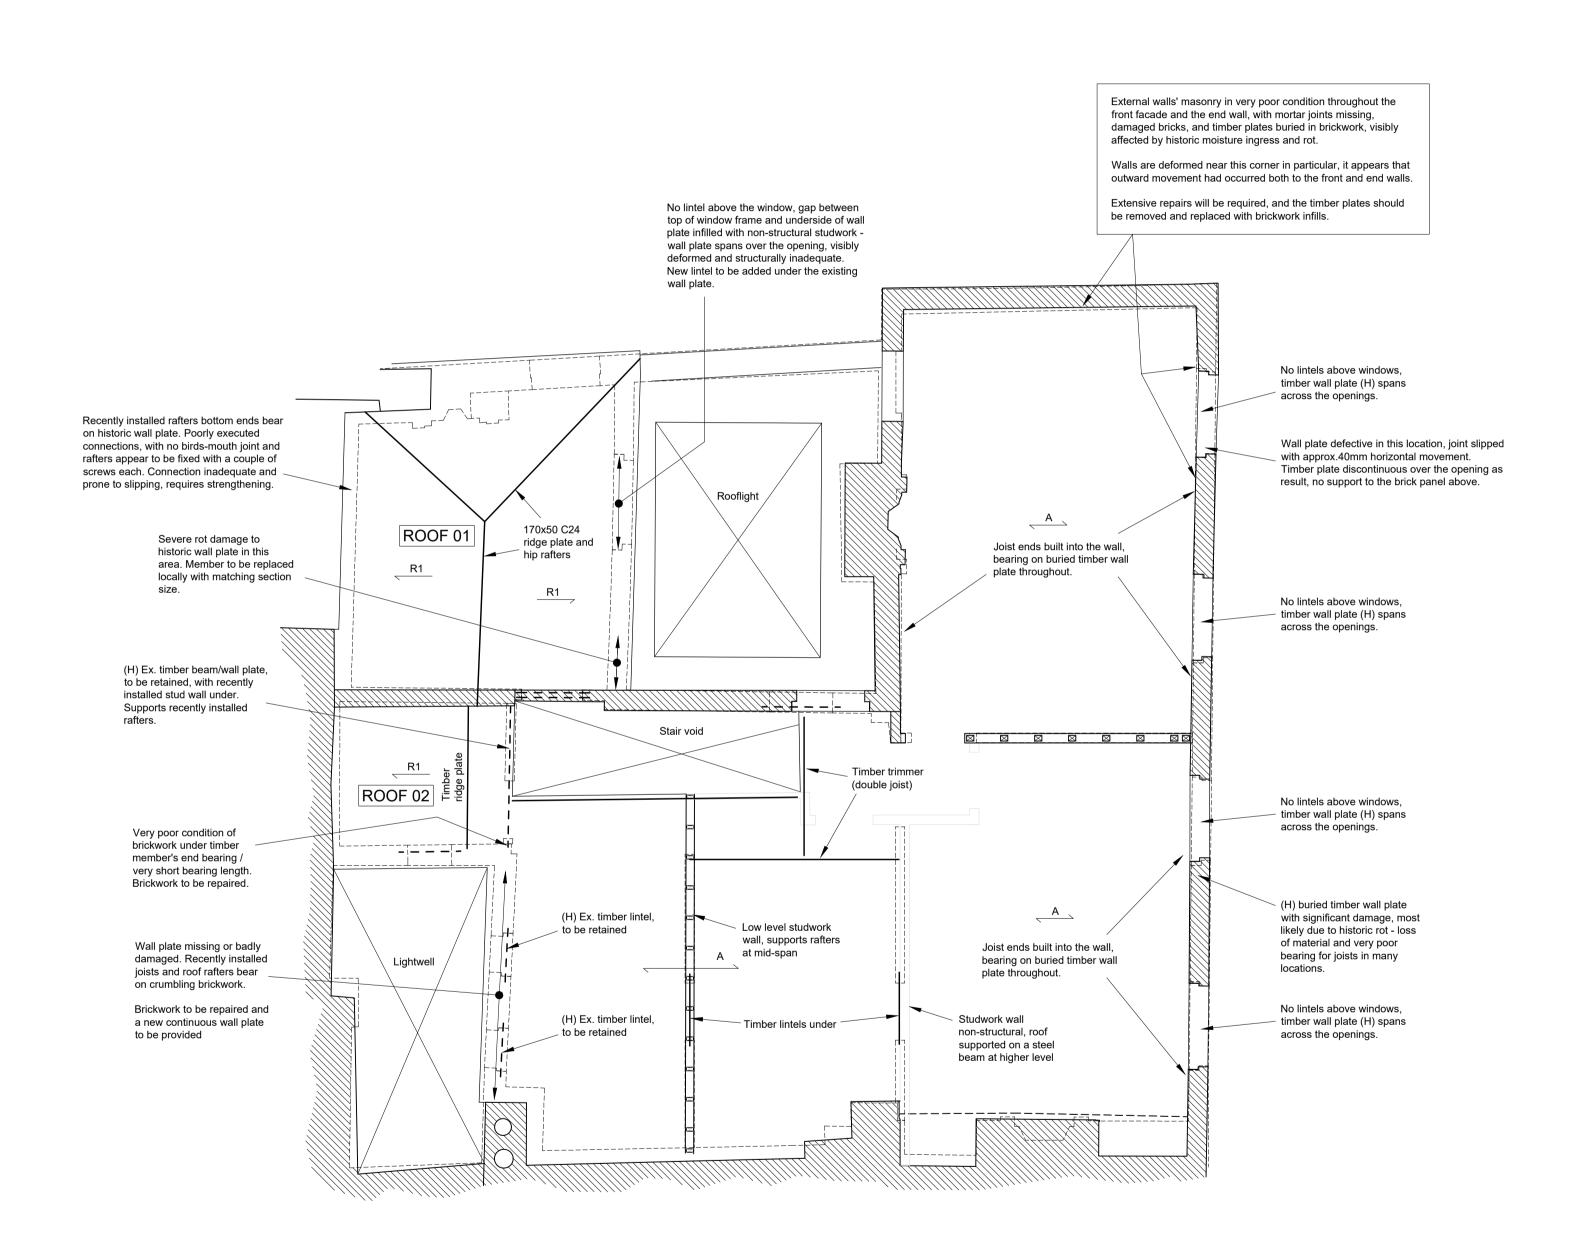
2nd Floor Plan

(H) 150x50 joists at 400mm c/c - relatively modern. Joists inadequate for the proposed roof terrace loads, to be removed.
