This drawing represents a record of our site investigations carried out in June and November 2024. It shows the as-seen structural layouts and provides commentary of condition of remaining historic and adequacy of recently installed elements.

Layout and condition of structure as seen in November 2024:
1st Floor Plan

Drawing No. 24-034/13

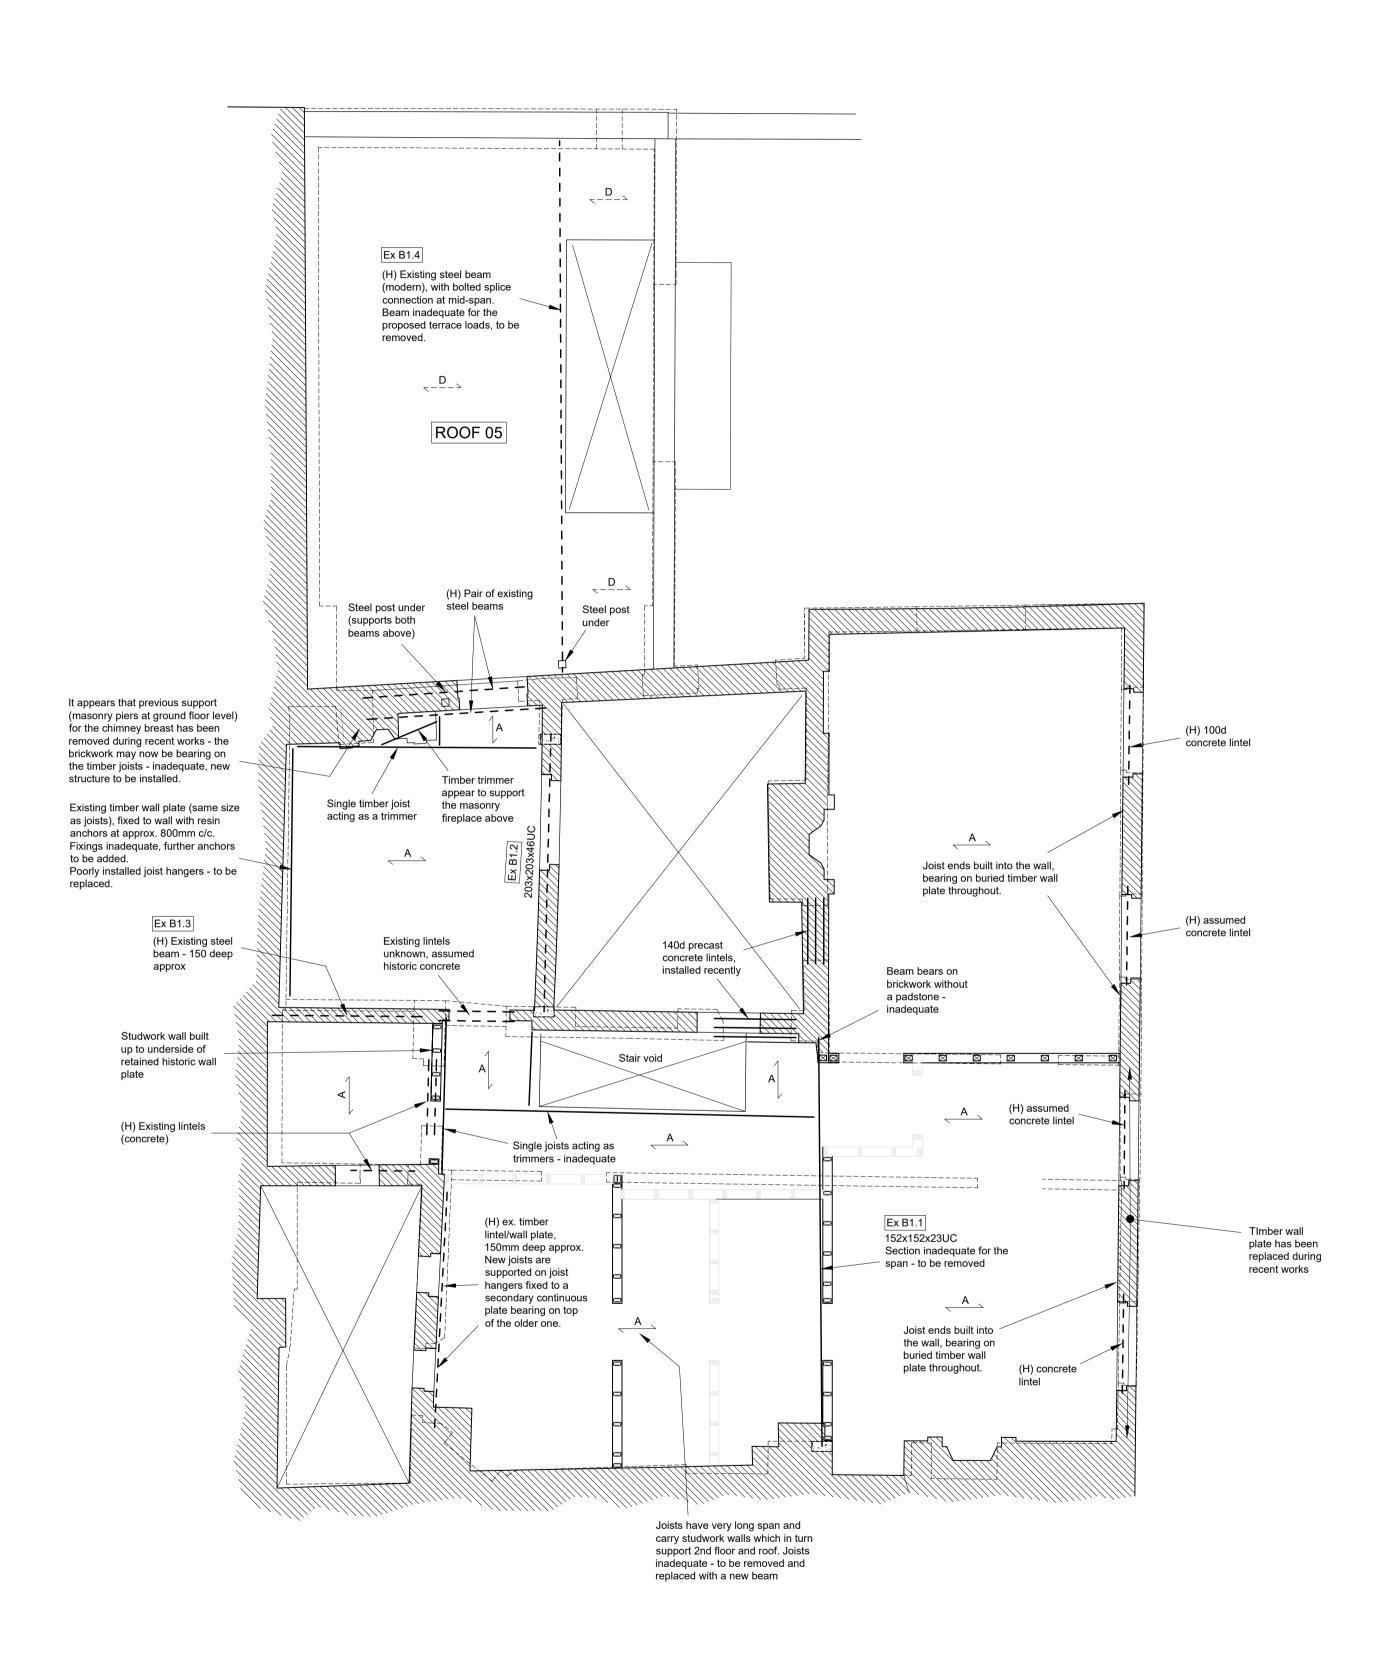
1st Floor Plan

(H) 150x50 joists at 400mm c/c - relatively modern. Joists inadequate for the proposed roof terrace loads, to be removed.

Recently installed load-bearing timber studwork wall, comprising 95x70 C24 studs at 450mm c/c approx

Recently installed load-bearing timber studwork wall, comprising 42x95 C24 studs at 400mm c/c approx

Refer to drawings series 20 for the proposed structural interventions.
