Project		
Alterations to listed building		
Client		
Mr Godwin & Mr Dickinson		
Site Address		
4a King Edward Mansions, London		
Approved	Date	Scales
Prelim	Jul 24	1:50
Drawing No.	JJ24-004a	
		Sheet
		004 Rev H

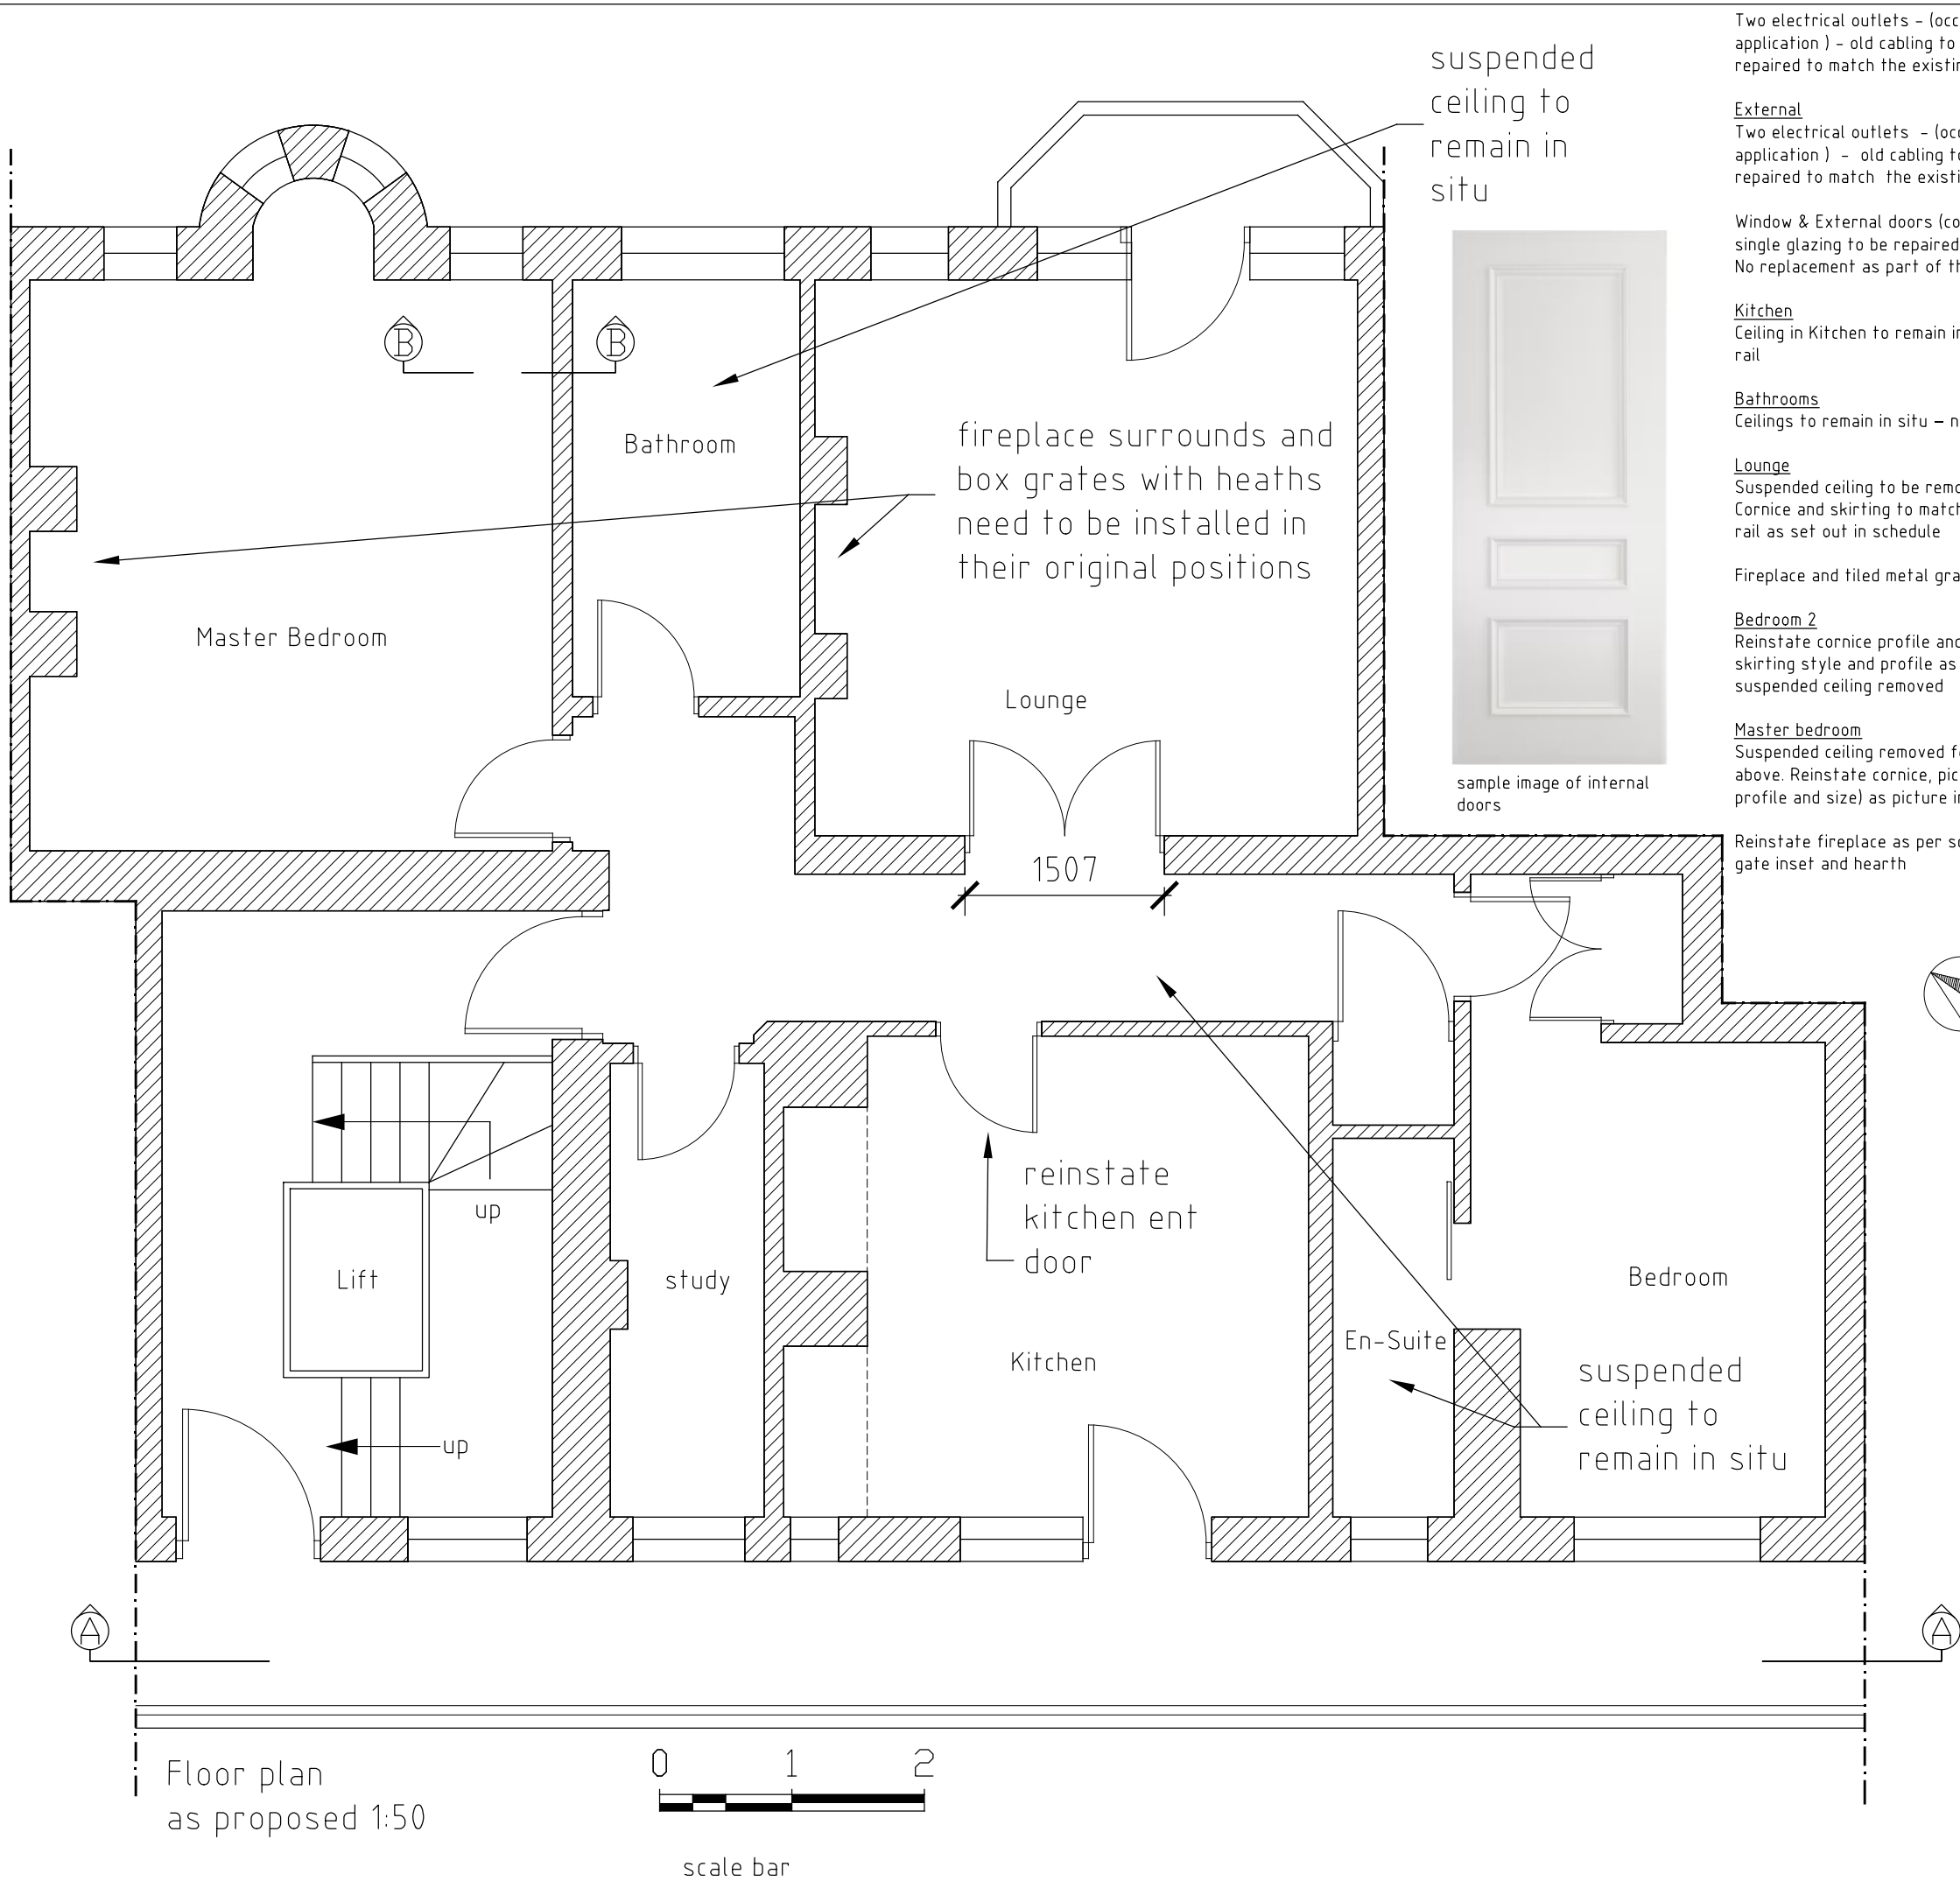
Two electrical outlets - (occurred pre-ownership of the application) - old cabling to be removed and brick work repaired to match the existing immediate elevation

External
Two electrical outlets - (occurred pre-ownership of the application) - old cabling to be removed and brick work repaired to match the existing immediate elevation

Window & External doors (courtyard only) - timber and single glazing to be repaired where possible (like for like). No replacement as part of this consent.

Kitchen
Ceiling in Kitchen to remain in situ - no cornice - no picture rail

Bathrooms
Ceilings to remain in situ - no cornice

Lounge
Suspended ceiling to be removed.
Cornice and skirting to match picture in schedule - picture rail as set out in schedule

Bedroom 2
Reinstate cornice profile and size as below. Reinstate skirting style and profile as schedule -no picture rail-suspended ceiling removed

Master bedroom
Suspended ceiling removed following water leak from flat above. Reinstate cornice, picture rail and skirting (style, profile and size) as picture in schedule

Reinstate fireplace as per schedule with tiled and metal gate inset and hearth

Study
Remove suspended ceiling. Plaster cornice to match existing profile and style as below. Skirting to be 30mm (timber)

Hallway
Ceiling to remain in place - Plaster cornice to match existing profile and style. Skirting to be 30mm (timber)
Moulded rail as per schedule to be introduced to match profile and scale as per schedule

Floors
Throughout (other than bathrooms) -
Aged oak in a plain running board

Bathrooms
Main bathroom & ensuite: tiling to be limited to the floor and wet areas (shower area and behind sink extending to height of shower area.

Ceiling rose - Victorian ceiling rose in lounge and both bedrooms. Pendant style as previous.

All internal walls as set out in the submitted plans to be reinstated with a lime plaster.

Cornice
Lounge & Bedroom 1 -Dentil cornice matching (scaled) existing profile as identified in Lounge picture in schedule. Speak to the other flats and match measurements if required.

Secondary cornice to match existing. The surviving portion in the study is to be measured repaired and retained. All to match in Bedroom 2 and Hallway.

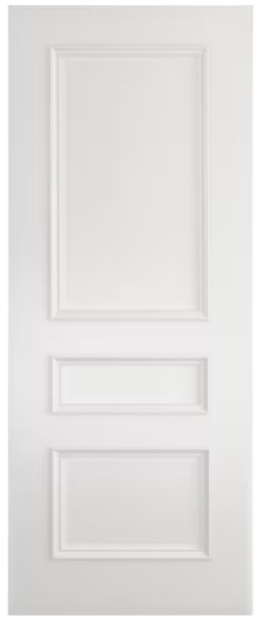
All internal Doors
<https://www.expressdoorsdirect.co.uk>
windsor primed white door - as image

sample image of internal doors
