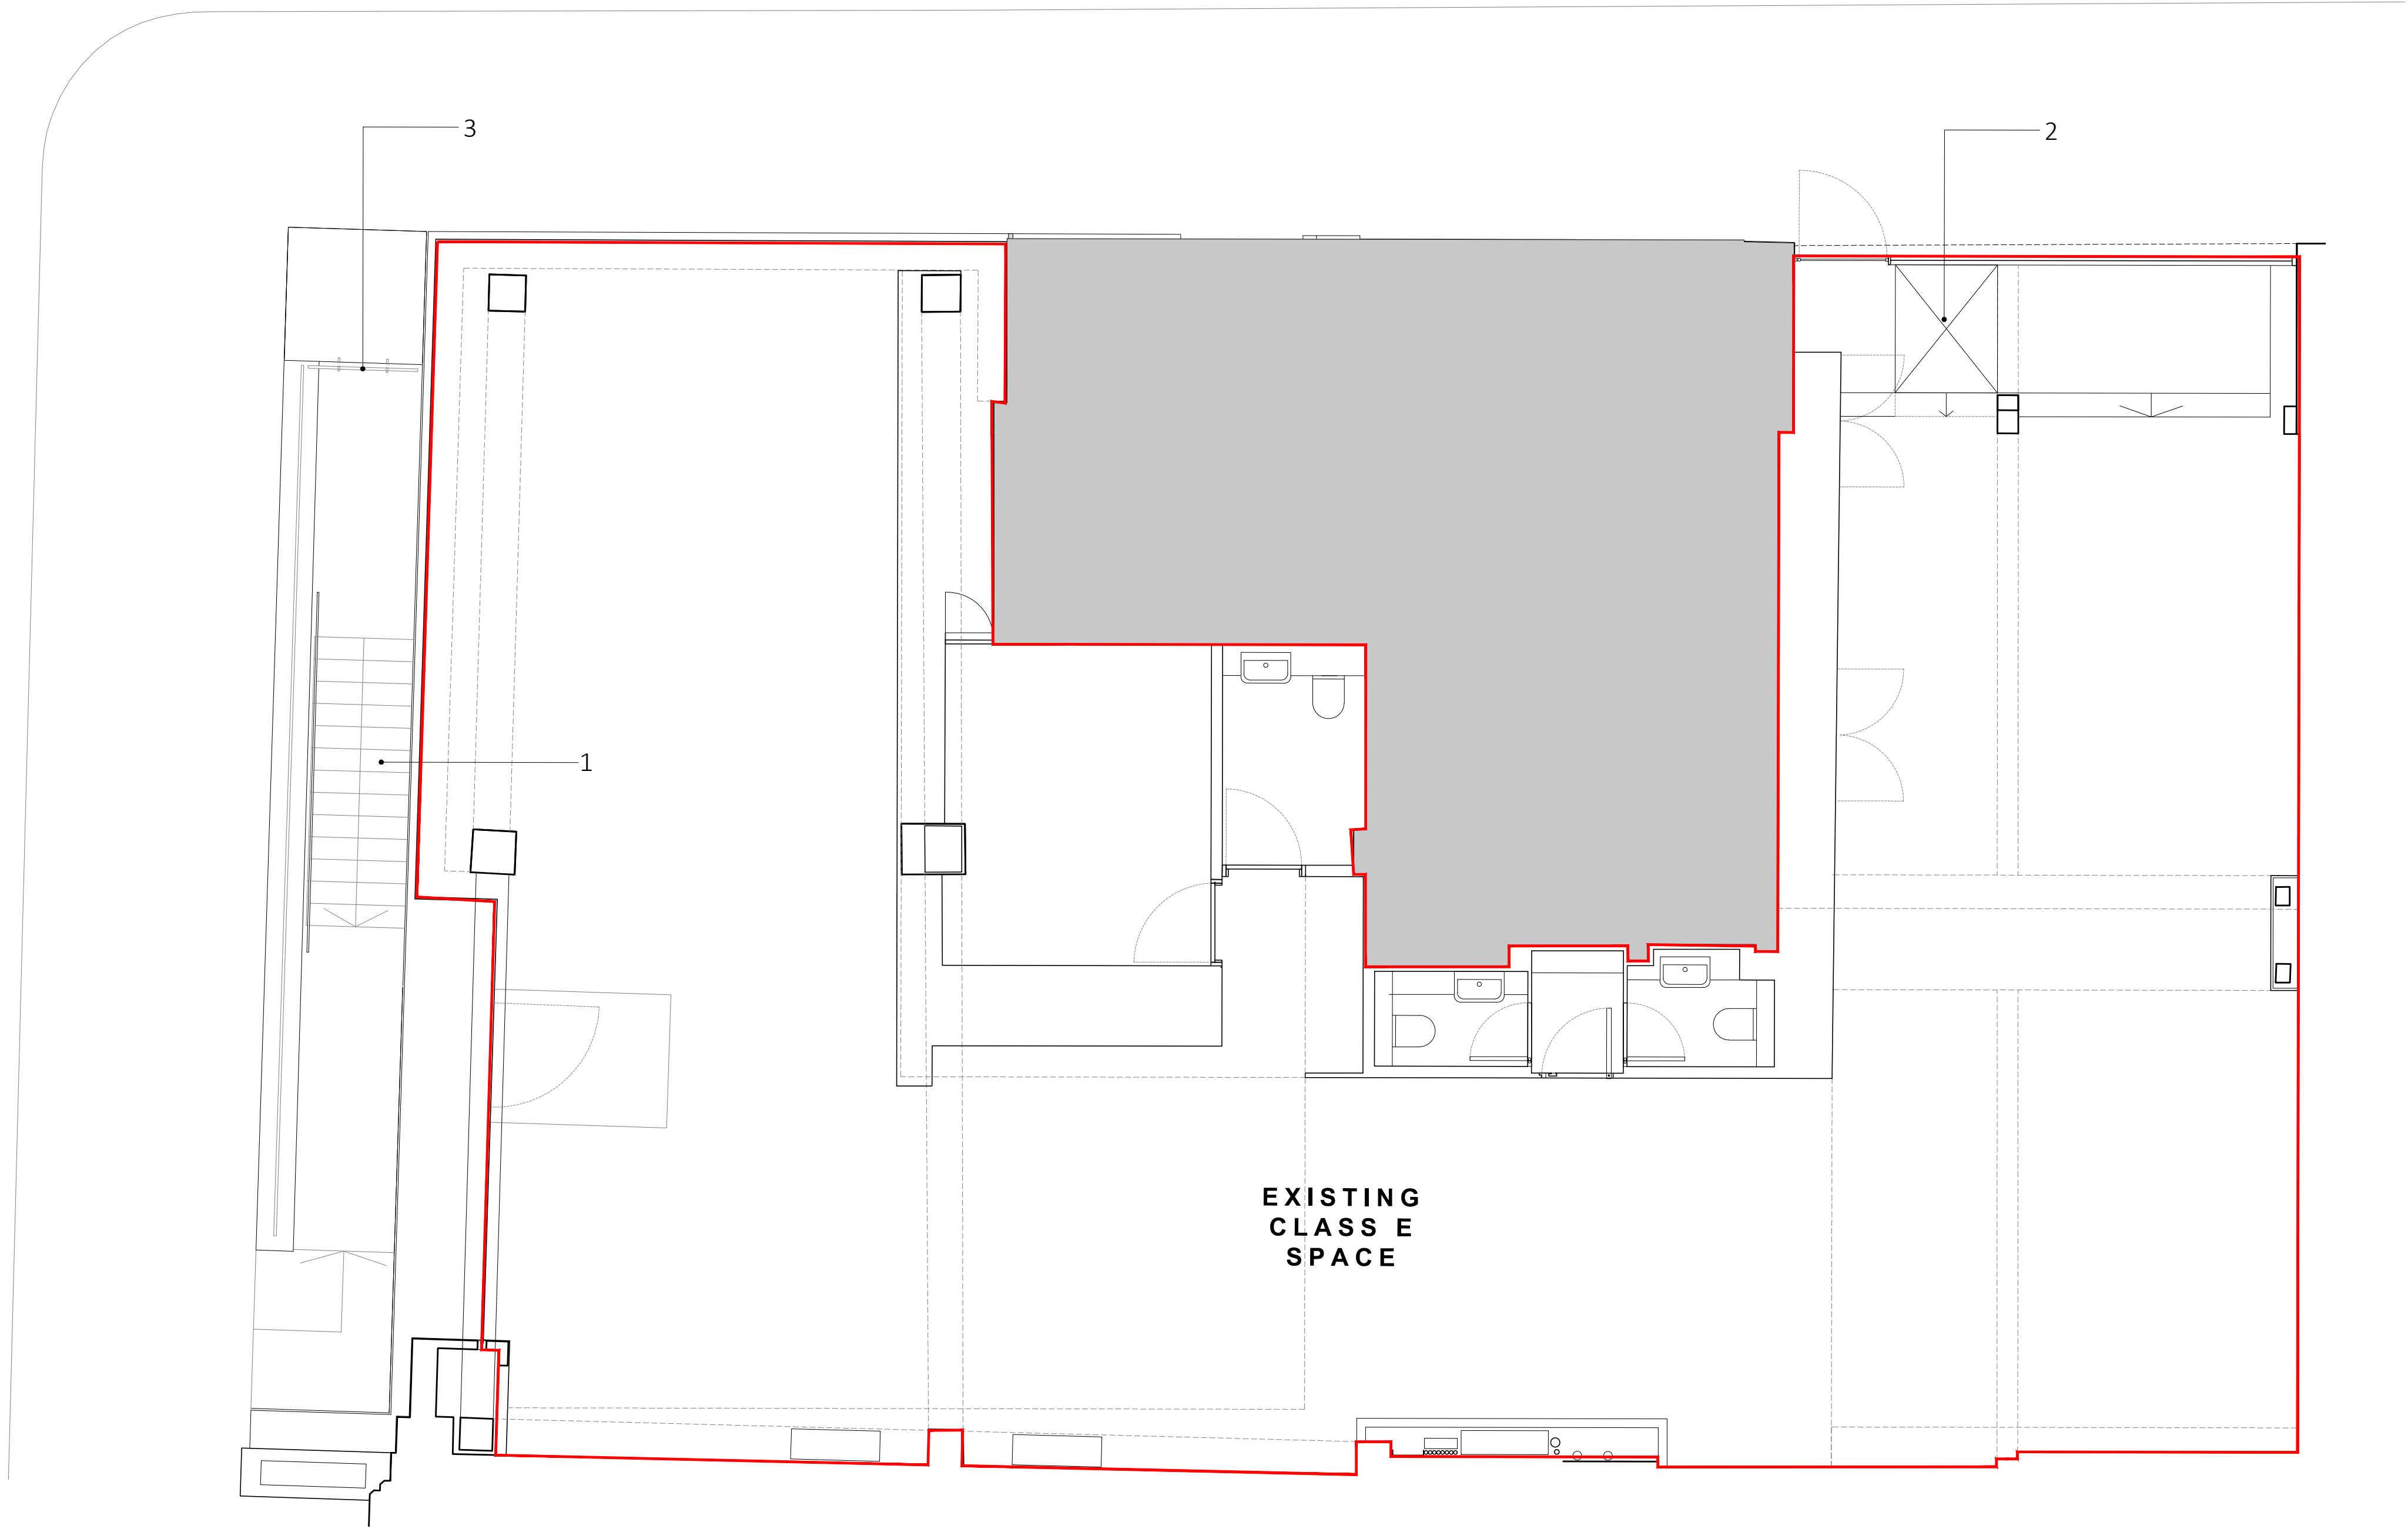
New metal stair with bike channel to match existing finishes
2.

Existing entrance with new platform lift for wheelchair access
3.

New glass balustrade to match existing
