Scale @ A1	Date	Job Number
As indicated	10/07/24	17056A
Drawn By	Checked By	Status
MM	JP	S3
Drawing No.	Rev	Purpose of Issue
BEMP-HBA-P2-ZZ-DR-A-21-1401	P04	Issued for Review and Comment

Project  
**IoN/DRI Redevelopment Project**  
256 Grays Inn Road, London, WC1X 8LD

Drawing  
External Wall Detail - Stone Plinth / Landscape / Basement Wall

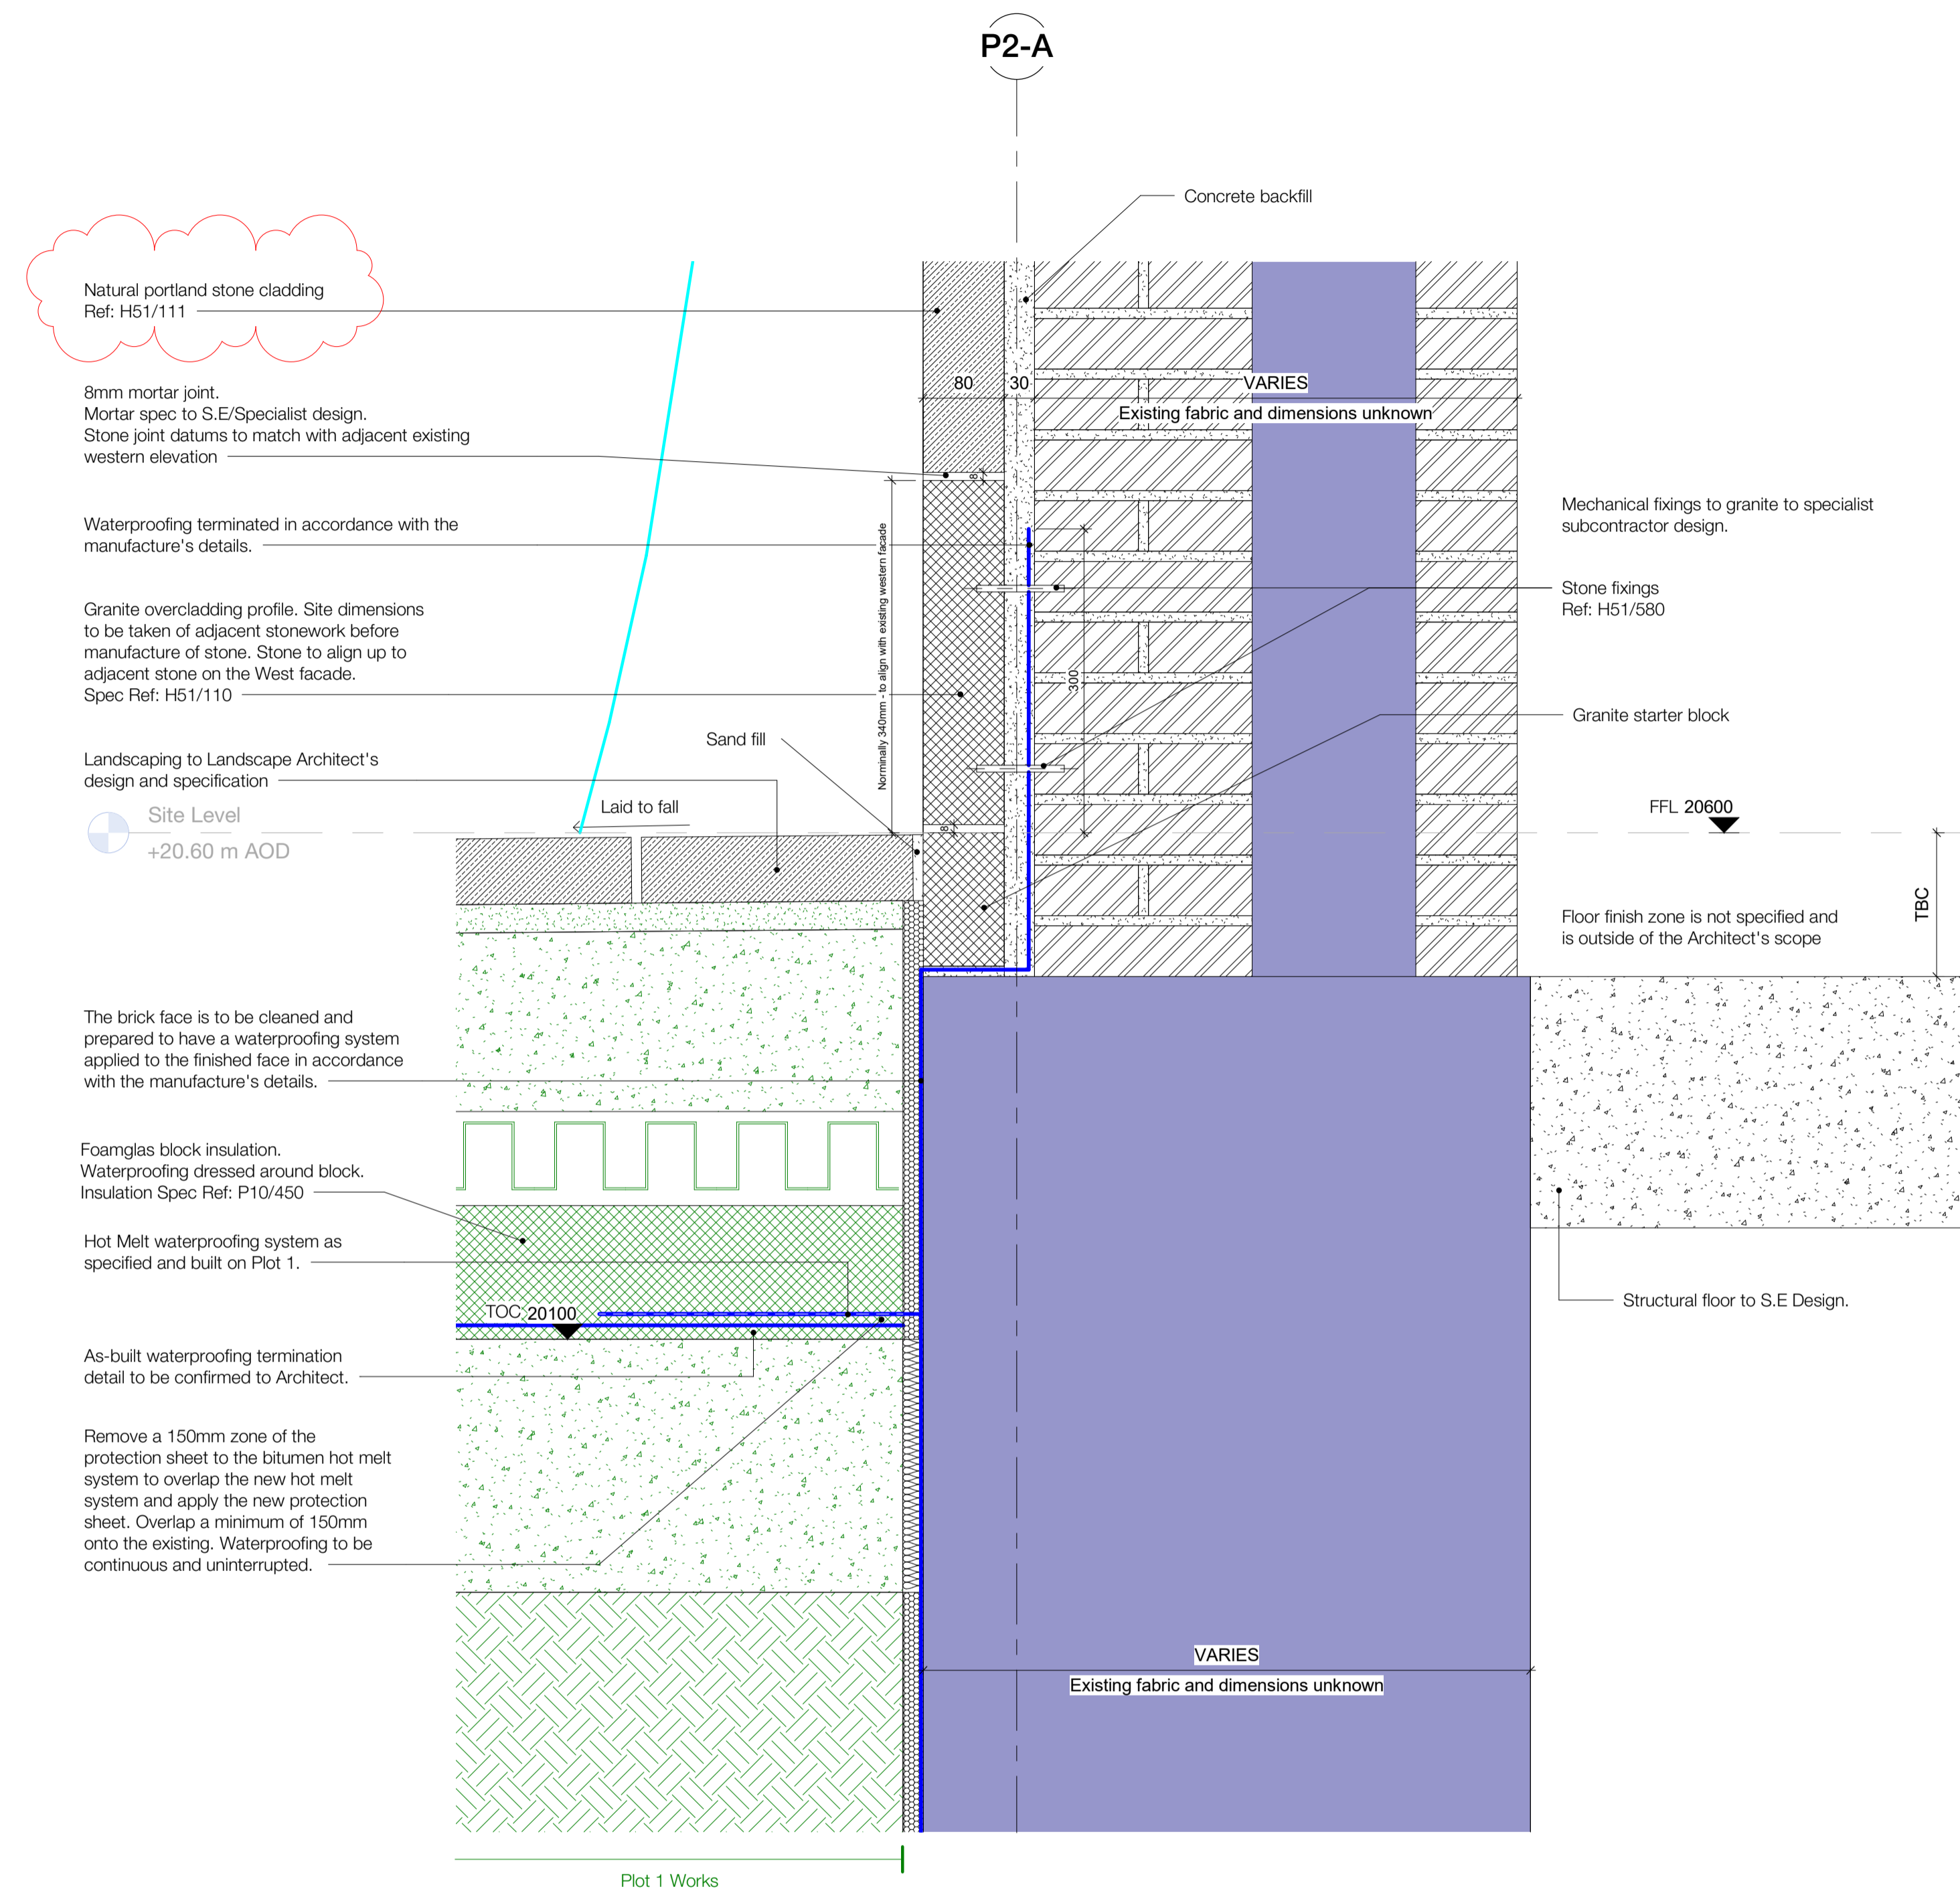
**Stone cladding base detail**  
1 : 5

Approximate location of existing fabric based on SES point cloud survey. Exact location to be determined on site.
