**23051 Holiday Inn Bloomsbury,
Coram Street,
London WC1N 1HT.**

Proposed Alterations to Existing Bar Windows and Entrance

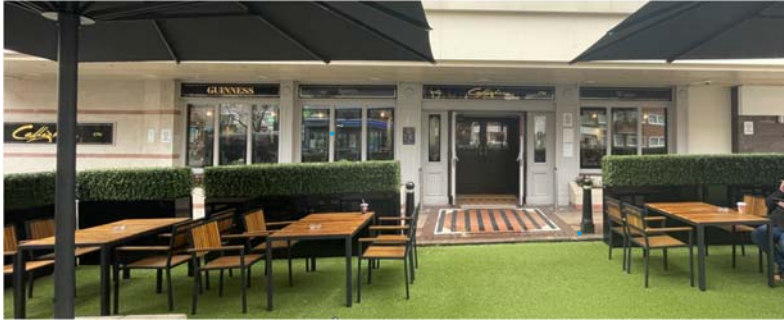
Photo 01. Looking south. Showing the existing bar entrance doors (outer pair of the lobby are open) and structure, dressed in timber. Paint finish. Polished stone cladding elsewhere. Decorative tiles to the entrance area. Area in front set out with astroturf and seating, for compliance with public area smoking. Signage above the doors and windows.

2.7 The existing external decorative tiling seen in photos 01, 02, 03 and 05, plus the below 06 are proposed to be replaced within the existing areas. (No additional area is proposed).

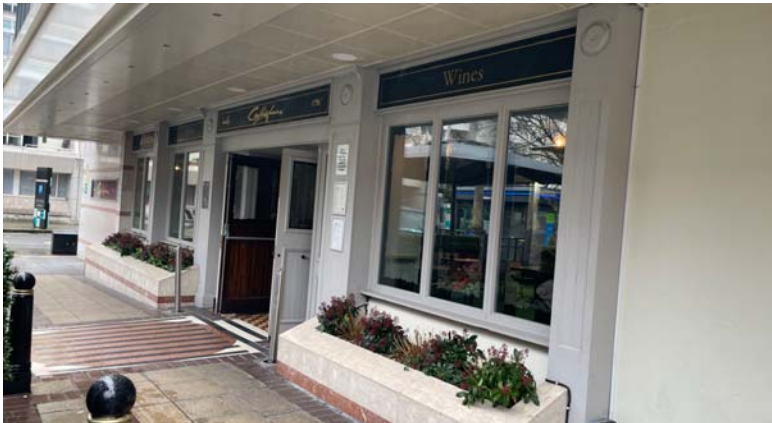
Photo 02, the same area. Existing bar entrance doors, planter, and windows. Timber, paint finish. The planter is in polished stone. The doors have no lower vision panel, contrary to current wheelchair access requirements.

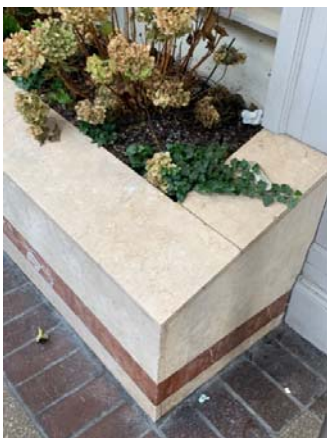
Photo 03 left, detail of the planter. Polished stone facings.

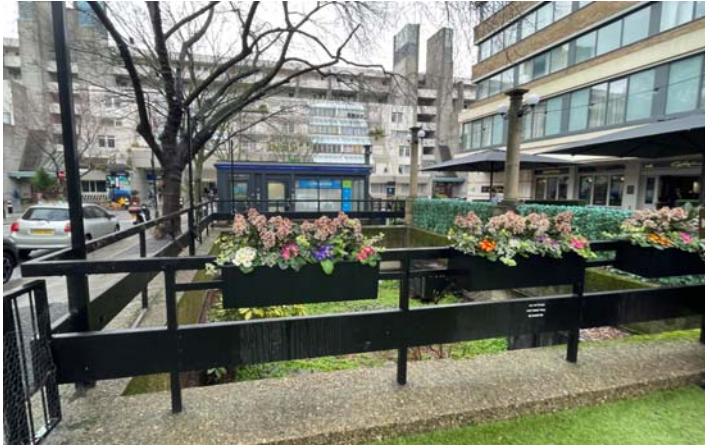
Photo 04, looking east, of the sunken garden area. Metal guarding painted black. The metal box structure in the background is the access point for the basement gym. This structure is also metal framed.

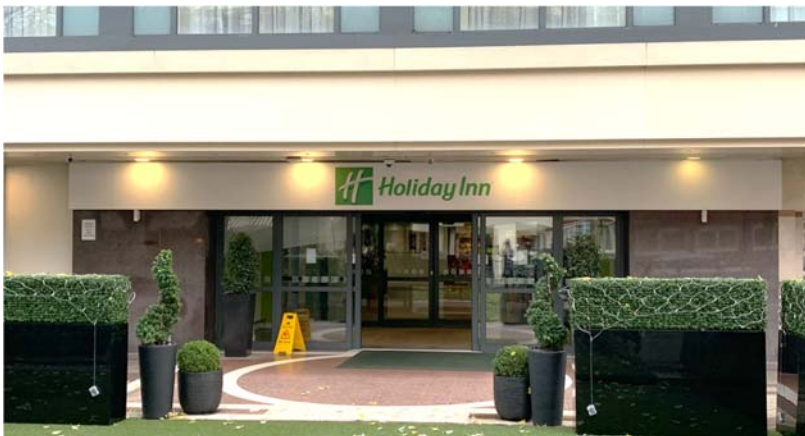
Photo 05 looking south at the main hotel entrance which is adjacent to the bar entrance. Note the use of metal frame for the doors and the windows, and polished stone cladding.

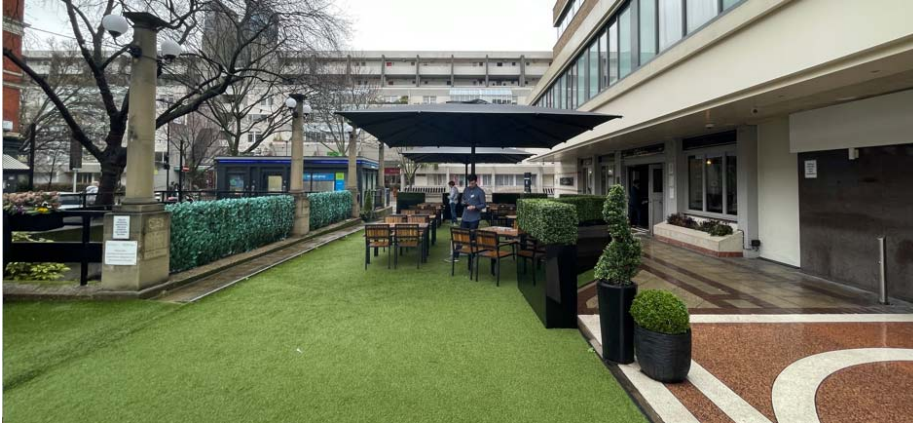
Photo 06 looking northeast, indicating the decorative tiling proposed to be replaced. The proposal is simply to provide better quality of impression to the guest upon arrival, reinforcing the internal enhancements they will encounter within the building.
