Arboricultural Impact Assessment Method Statement & Tree Protection Plan (to BS:5837 2012)

15 Crediton Hill, London

Prepared for Mr & Mrs Warren

Ref: TH 3771

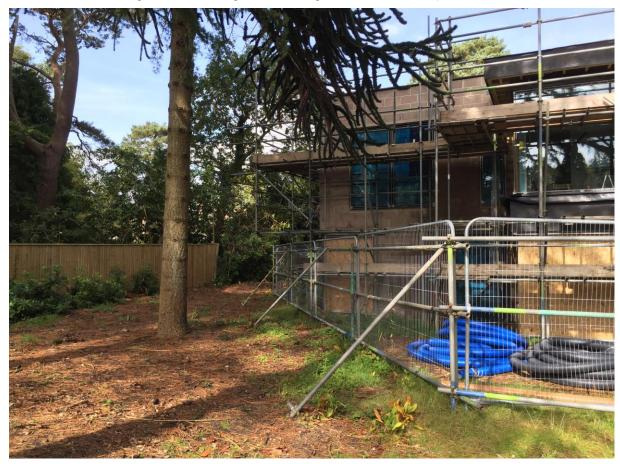
Photo 1: A worked example of the default specification for protective barrier (BS 837:2012)

The framework support (shown in Figure 2 and photo 1) is the usual method of support for 'Heras' fencing. Some variations are possible if site conditions are appropriate; i.e. support by wooden posts (75mm x 75mm x 2.75m) dug or concreted into the ground (dry mix concrete contained within a plastic bag), or if there is no pressure for access, a lighter form of netting on stakes.

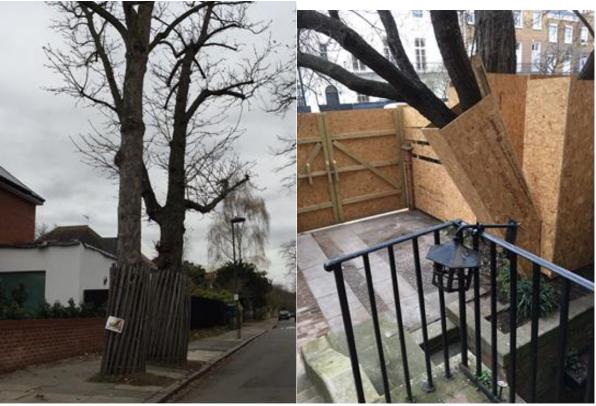
Photo 2: Trees protected by hessian & chestnut pale fencing / limbs protected by wooden boxing

Photo 2. https://greengridsystems.com/products/trunk-protecta

Where specified in the AMS, the tree(s) stem/s shall be boxed off with wooden ply boards or wrapped in hessian and chestnut pale fencing / trunk protection (see example below). This will help avoid any direct damage to tree stems from passing machinery (see photo 2).
