<b>TITLE:</b> Side Elevation, North-West (demolition)	<b>NO:</b> E210	<b>REV:</b> P2	<b>SANYA POLESCUK ARCHITECTS</b> 8a BELSIZE COURT GARAGES LONDON NW3 5AJ T:0207 431 8580 e-mail:enquiries@polescukarchitects.com
<b>PROJECT:</b> Flat 3, 51 Frognal, London NW3 6YA	<b>SCALE:</b> 1:50	<b>PAPER:</b> A3

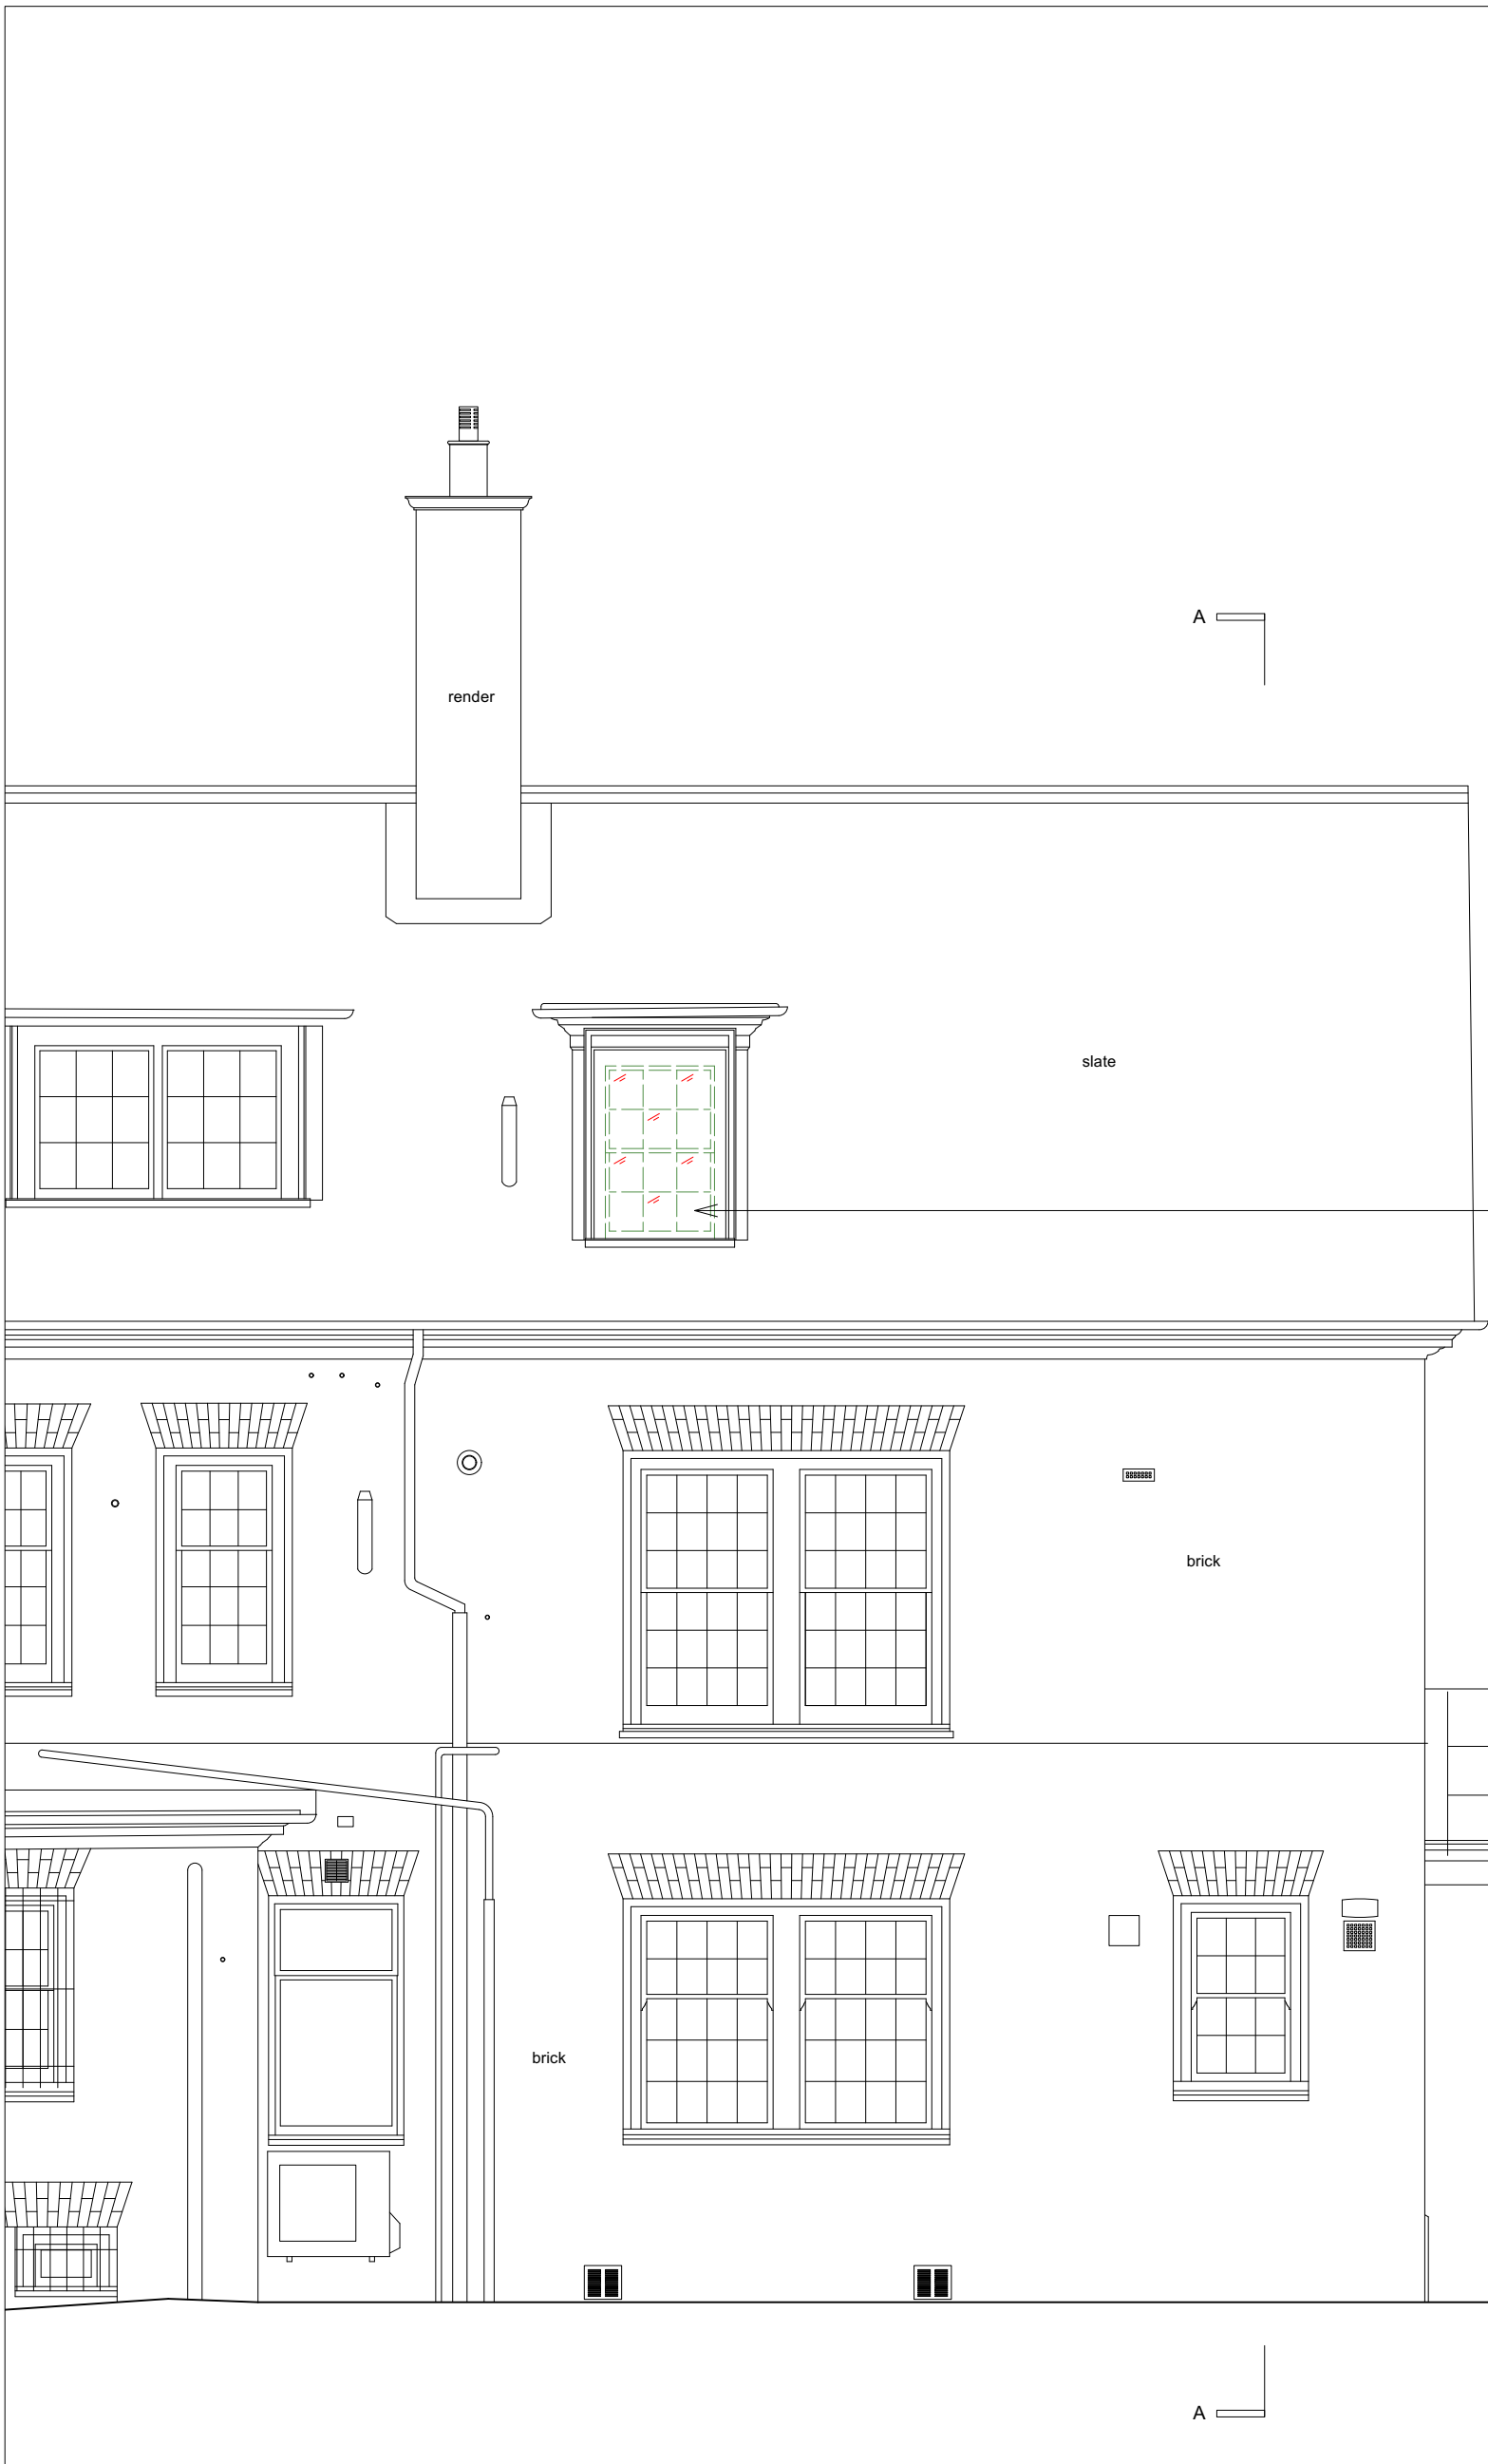
repair window and replace glazing only from single to Histoglass Mono RT+ (single)

remove leaking roof
