nadiments and sill stanswork	
pediments and cill stonework air to retained stonework of window	
	/ 24/01/2025 L.B.C. Issue. JKC JKC
	Rev.Date Notes Drawn Checked
	ARCHITECTS East Grinstead, West Sussex tel. 07495 980 757 jonathan@cerowski.co.uk
	client: University College School
	Project: Facade Repairs, UCS,
	Hampstead, NW3 6XH
	Drawing:
	Existing South Block, East Elevation
	Scale Drawn By Checked By Issued For 1:100@A3 JKC JKC Listed Building Consent
	Drawing No. Revision
	Drawing No. Revision /

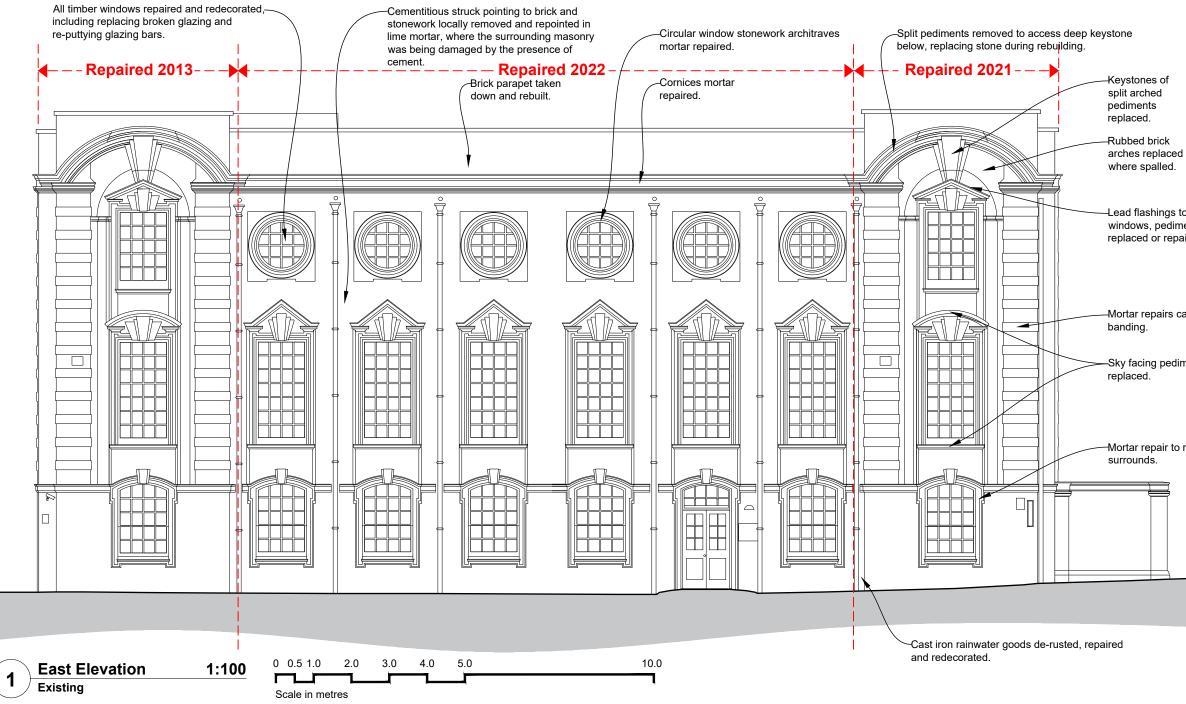
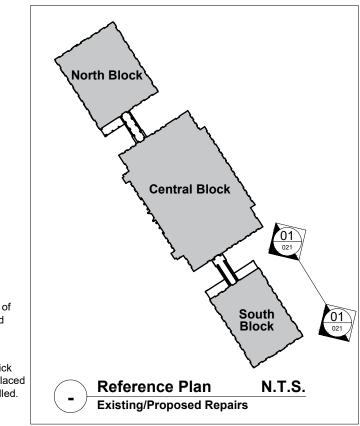
Lead flashings to sky facing stonework of windows, pediments, and cornicing, either replaced or repaired as necessary.

-Mortar repairs carried out to stone pilaster
