**1 West Elevation** 1:100  
Proposed Repairs

Project:  
Facade Repairs, UCS,  
Hampstead, NW3 6XH

Drawing:  
Proposed Repairs  
South Block, West Elevation

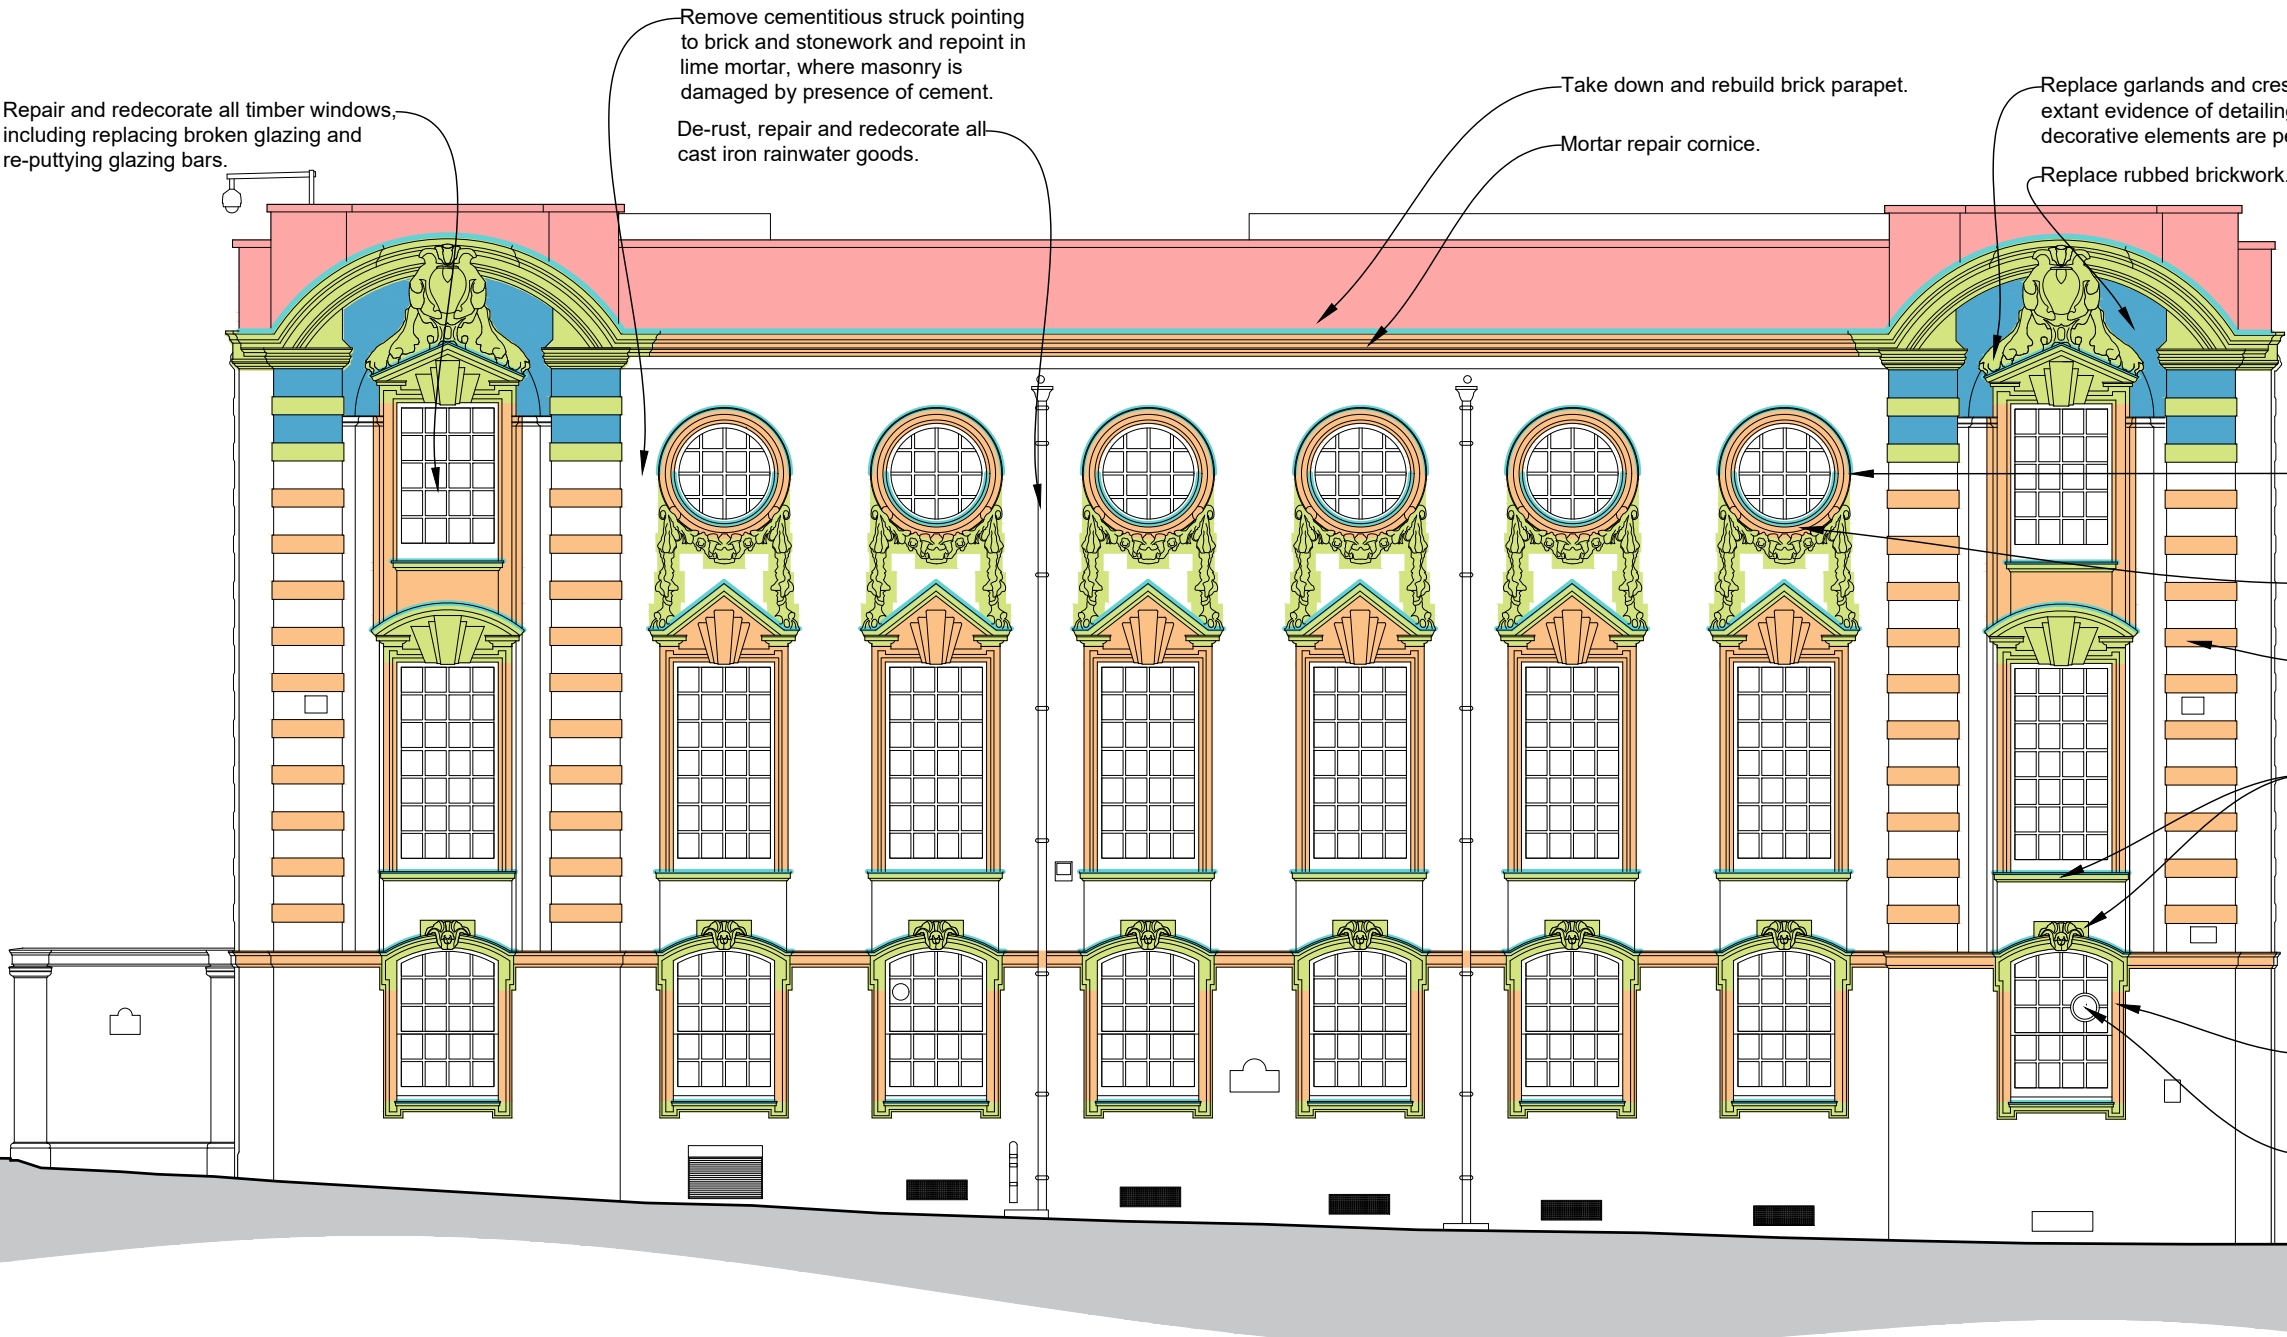
Replace or add (where not currently present) lead flashings to sky facing stonework of windows, pediments, and corncing.

Mortar repair circular window stonework architraves.

Mortar repair stone pilaster banding generally, allowing for replacement of bricks and stone to top two bands.

Replace sky facing pediment and cill stonework.

Mortar repair retained stonework of window surrounds.

Note: remove all redundant vents, grilles and fittings, making good surrounding built fabric to match existing.
